- At around 9:50 a.m. on June 10, 2025, the high flow rate alarm occurred at the liner drain of the spent fuel common pool (piping for detecting the possibility of leakage of pool water), and it was confirmed that liquid was flowing into the liner drain piping.

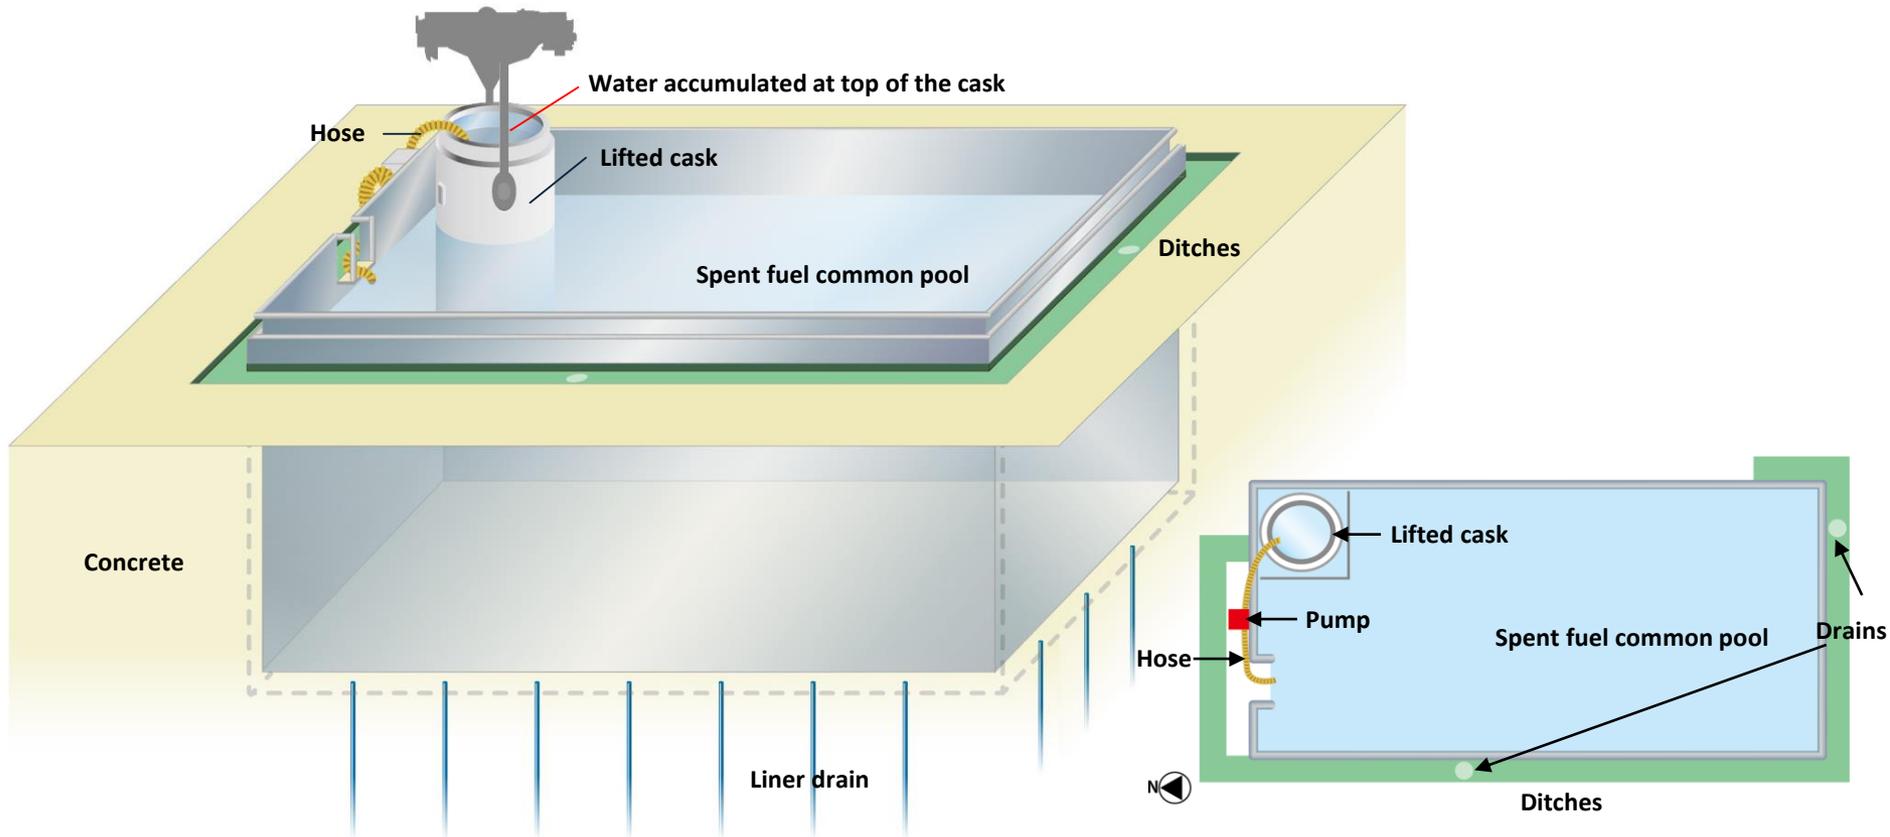
- On the same day, the water accumulated at the top of the cask was vacuumed by a hose and returned to the common pool for a dry cask containing spent fuel was being carried out. Upon checking the site, it was confirmed that the tip of the hose on the outlet side was displaced outside the pool, and there were traces of water flowing into the ditch around the pool.

- There was no significant change in the pool water level, and the flow rate through the liner drain decreased over time. It was assumed that the cause of the alarm was water (a mixture of pool water and filtered water for cask decontamination) coming out of the hose tip flowing into the liner drain, and it was determined that there was no problem with the integrity of the pool.

- We think the cause why the tip of the hose shifted out of the pool was because the fix of the hose was not enough.
- As for the way of fixing the hose, we have taken measures to prevent recurrence, such as changing the method of fixing the hoses from lashing with strings to using fixing fittings.

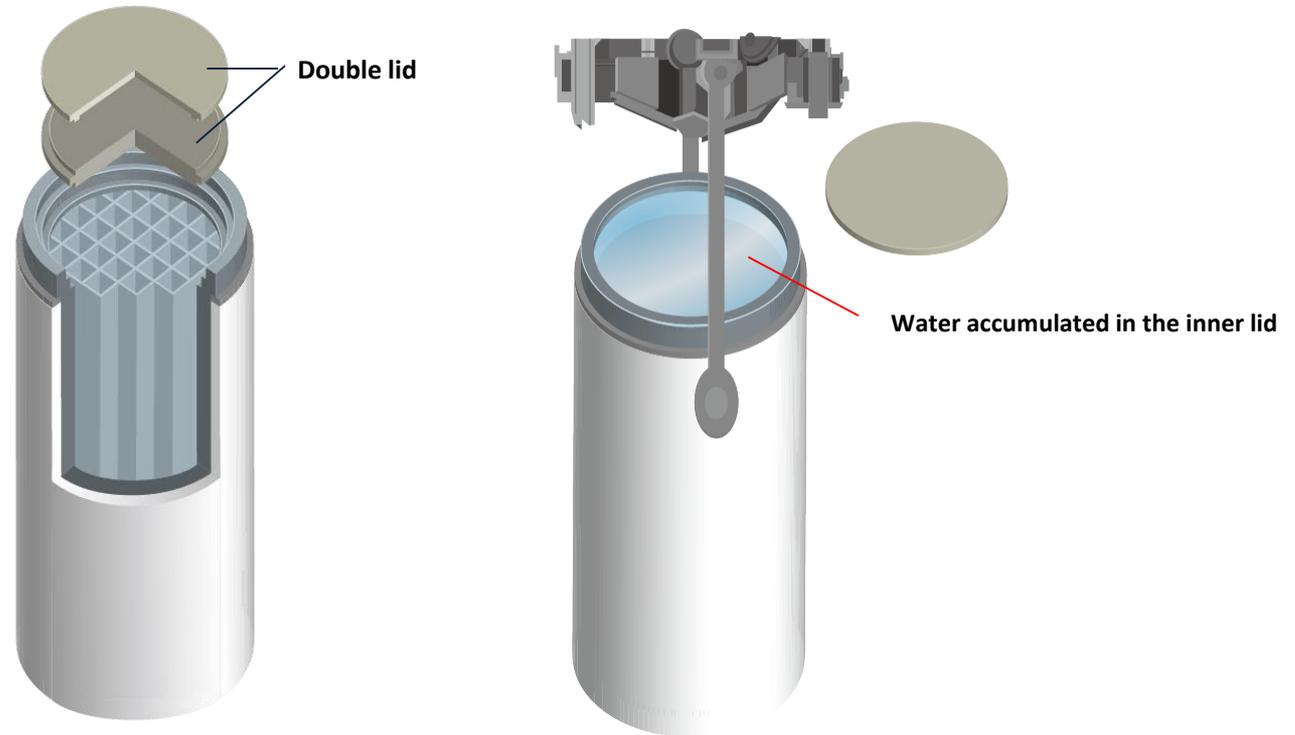
The dry cask has a double lid structure. When the inside lid is closed in the pool and the cask is pulled up, water accumulates at the top.
