Possibility of Debris (Assumed to be the Fuel Handling Machine Mast) Sinking in the Spent Fuel Pool at Debris Removal from the Upper Part of the Unit 3 Reactor Building at Fukushima Daiichi Nuclear Power Station (2)

February 8, 2013
Tokyo Electric Power Company

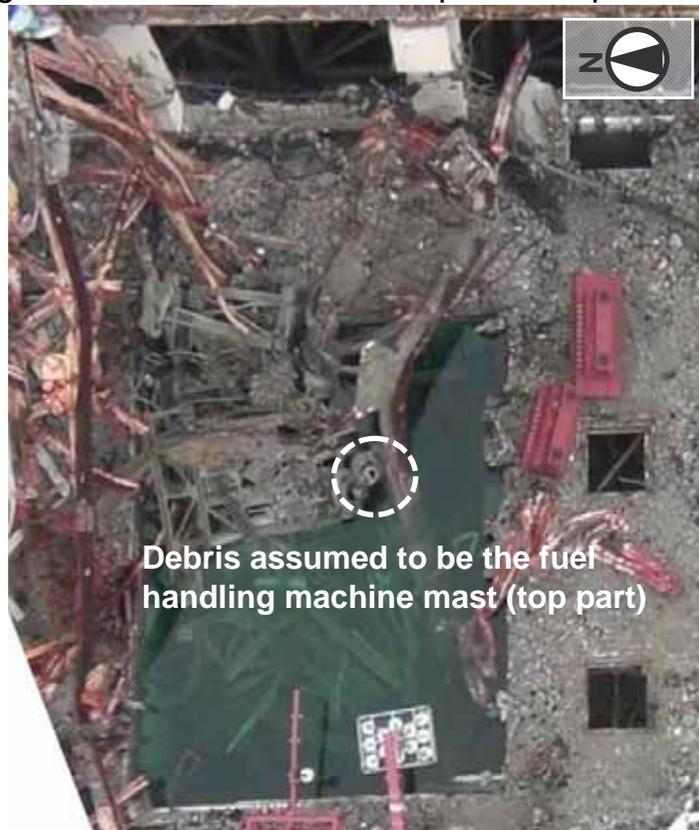
At the steel truss debris removal from the upper part of the spent fuel pool performed on February 6, 2013, the debris assumed to be the fuel handling machine mast* which was present before the steel truss removal was found to be missing in the image taken after the removal work. On February 7, we judged that there is a possibility that the missing debris has sunk into the pool.

Before steel truss debris removal (Photo taken on February 4, 2013)

Once the preparation is complete, we will investigate the condition of the sunken debris when we perform investigation of the inside of the spent fuel pool utilizing an underwater camera.

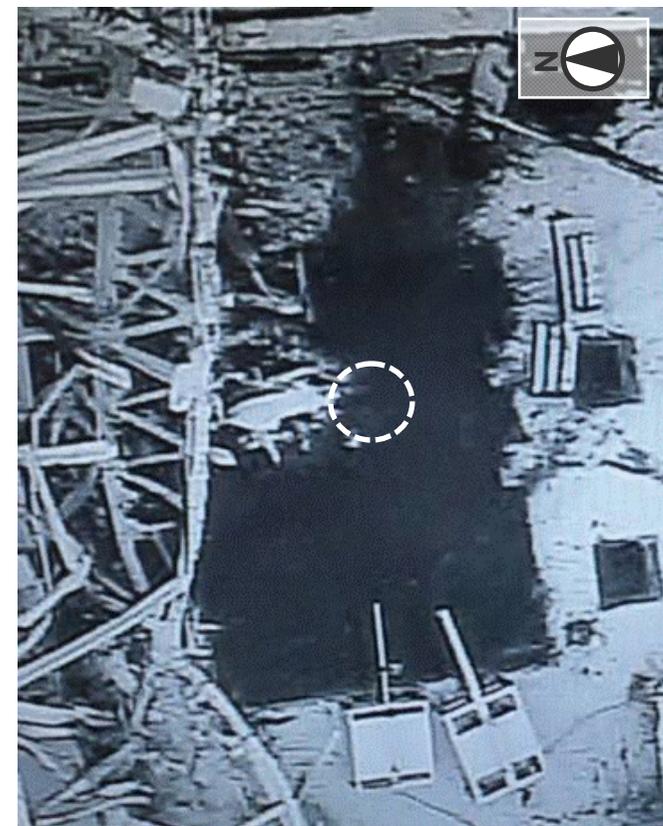
After steel truss debris removal (Photo taken on February 6, 2013)

No significant change was found with the following five items to confirm in the case that steel debris, etc. falls into the spent fuel pool.
