Progress of Investigation of Power Supply Facilities Failure at Fukushima Daiichi Nuclear Power Station

< Reference >
 March 25, 2013
 Tokyo Electric Power Company

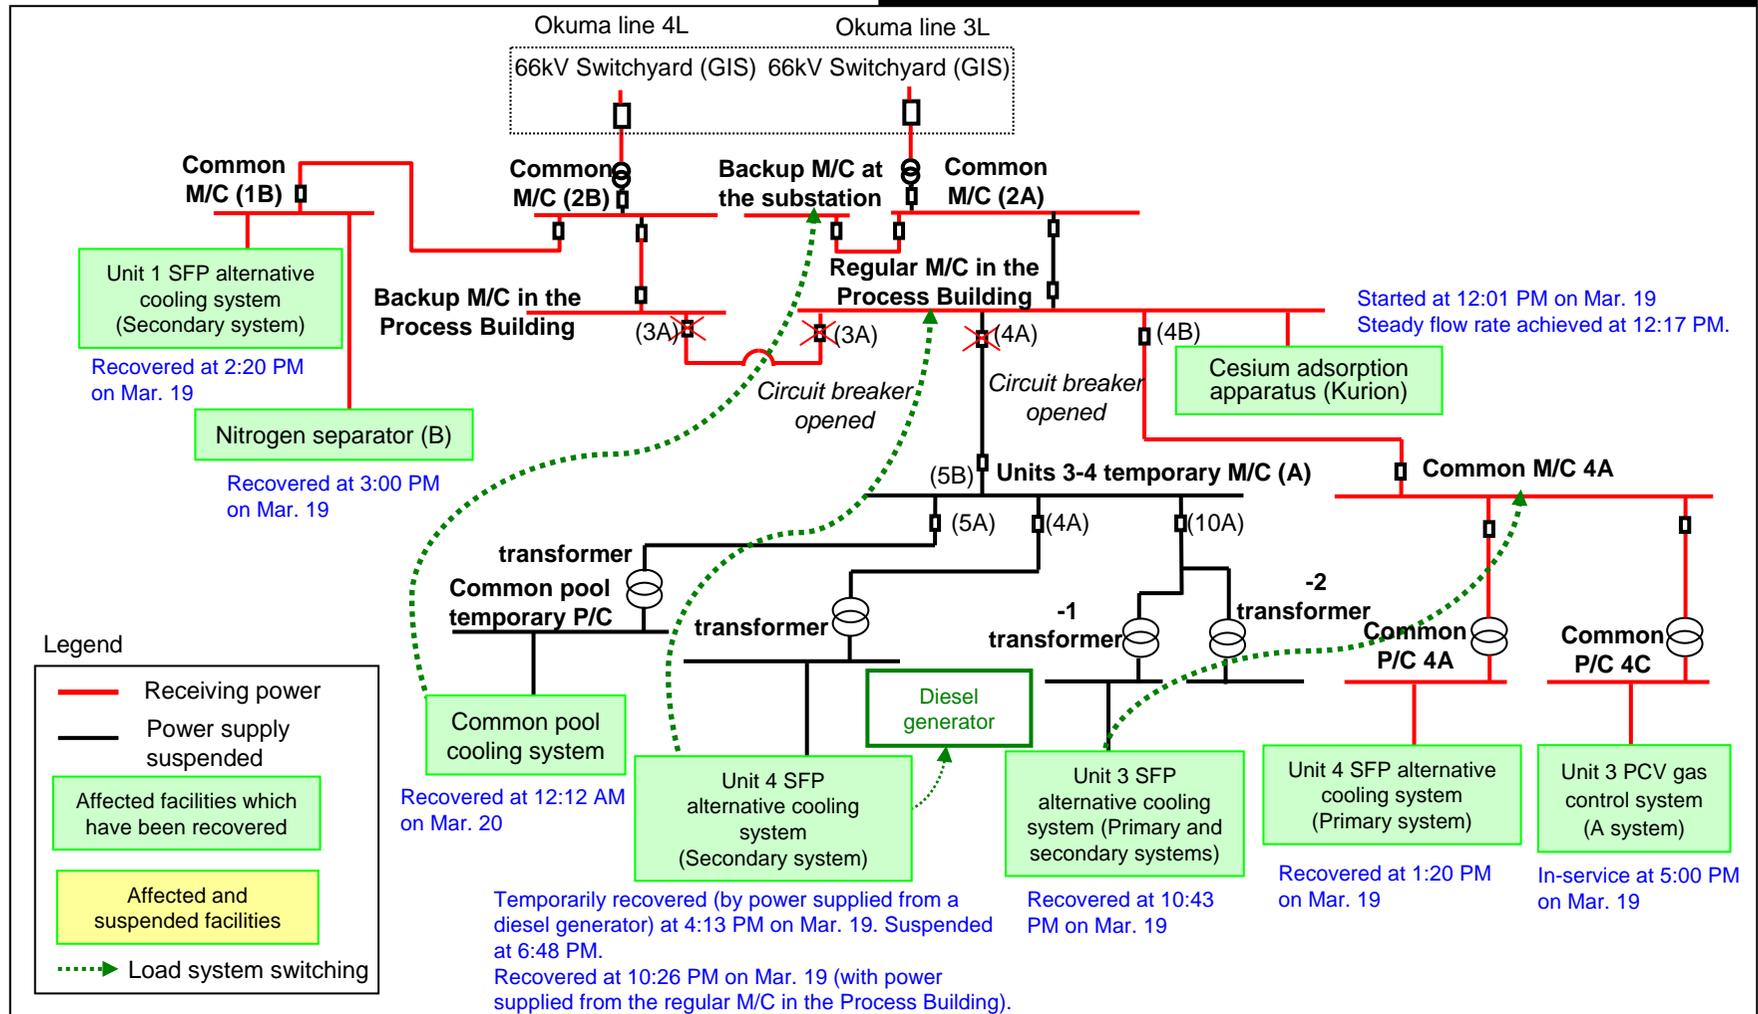
Power supply system structure of the affected facilities

At around 6:57 PM on March 18, 2013, there was an incident where the power supply facilities in the Main Anti-earthquake Building at Fukushima Daiichi Nuclear Power Station momentarily stopped. Upon investigation, the regular M/C (Metal-clad switch gear) in the Process Building, common M/C4A and Units 3-4 temporary M/C (A) were found to be stopped due to the incident.

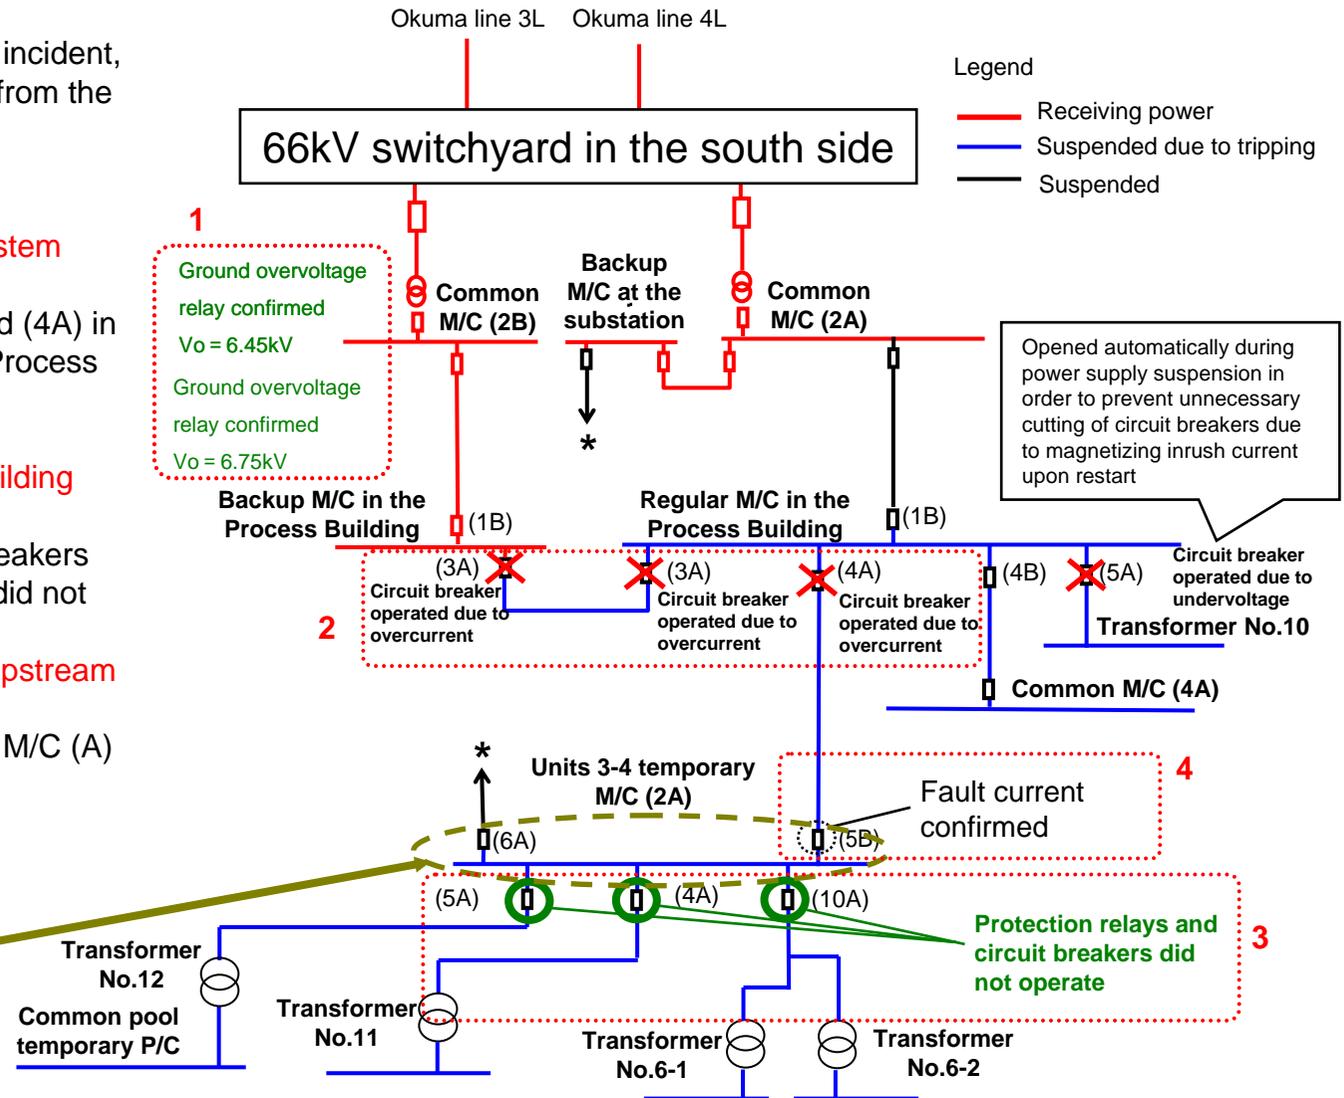
1. The ground relay in B system operated

: The failure is assumed to have occurred in B system and high voltage power supply system.

2. The circuit breakers of the regular M/C (3A) and (4A) in the Process Building and the backup M/C in the Process Building (3A) tripped due to overcurrent.

: The failure is assumed to have occurred in the downstream of the regular M/C in the Process Building (4A).

3. The ground directional relays and the circuit breakers of Units 3-4 temporary M/C (4A), (5A) and (10A) did not operate.

: The failure is assumed to have occurred in the upstream of the load systems of Units 3-4 temporary M/C.

4. Fault current was found in Units 3-4 temporary M/C (A) (5B).

: The failure is assumed to have occurred in the downstream of Units 3-4 temporary M/C (A) (5B).

The failure is assumed to have occurred in Units 3-4 temporary M/C (A).

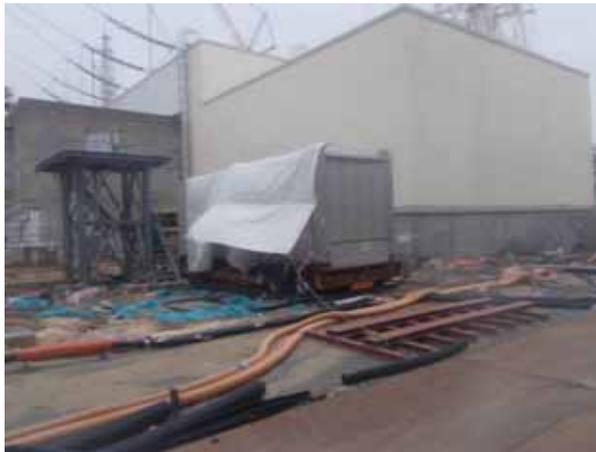
Full view of Units 3-4 temporary M/C (A)
(Units 3-4 switchyard)

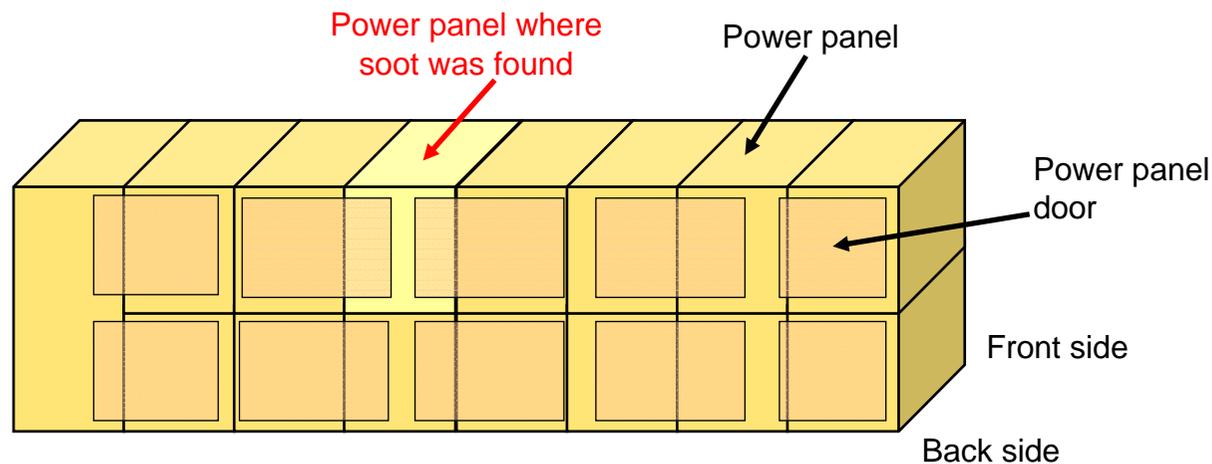
Units 3-4 temporary M/C (A) power panels and their doors

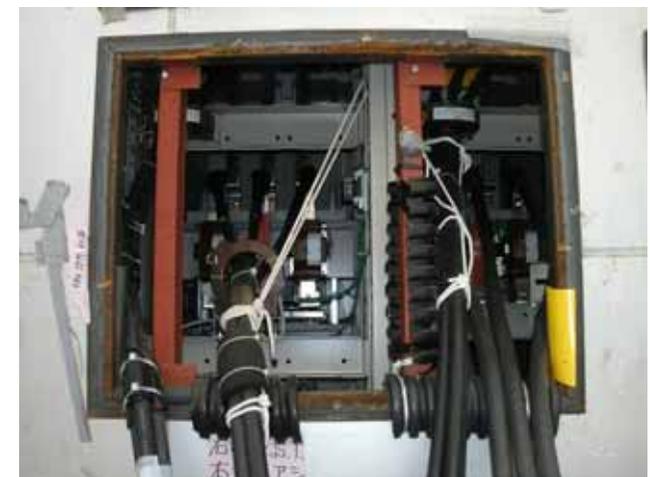
Units 3-4 temporary M/C with the power panel door opened (below the power panel where soot was found)

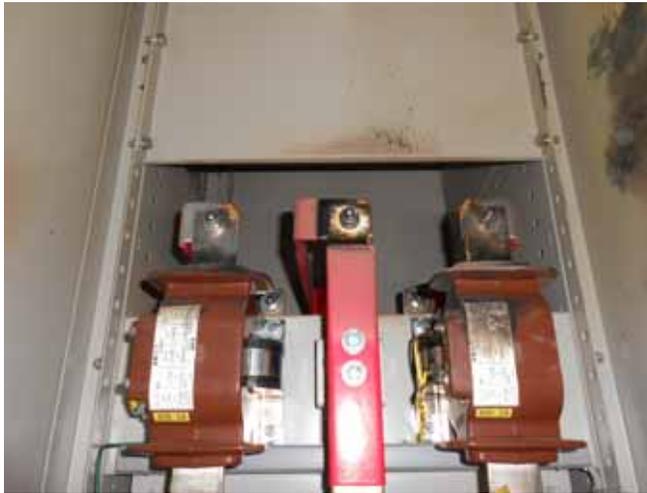
Soot found on the instrument current transformer (terminal) of Units 3-4 temporary M/C

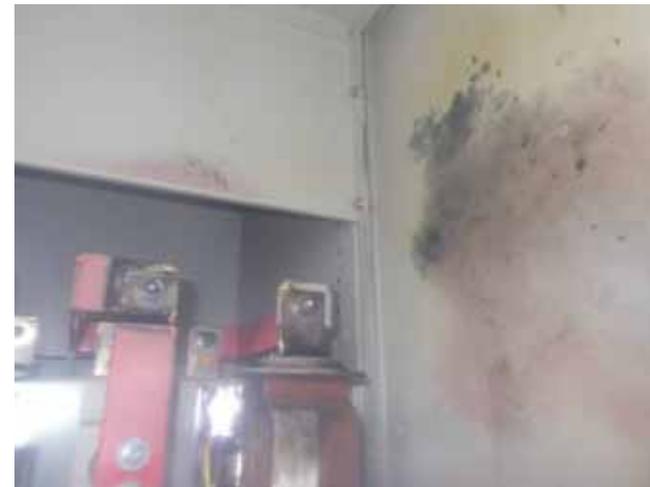
Soot found on the walls of Units 3-4 temporary M/C

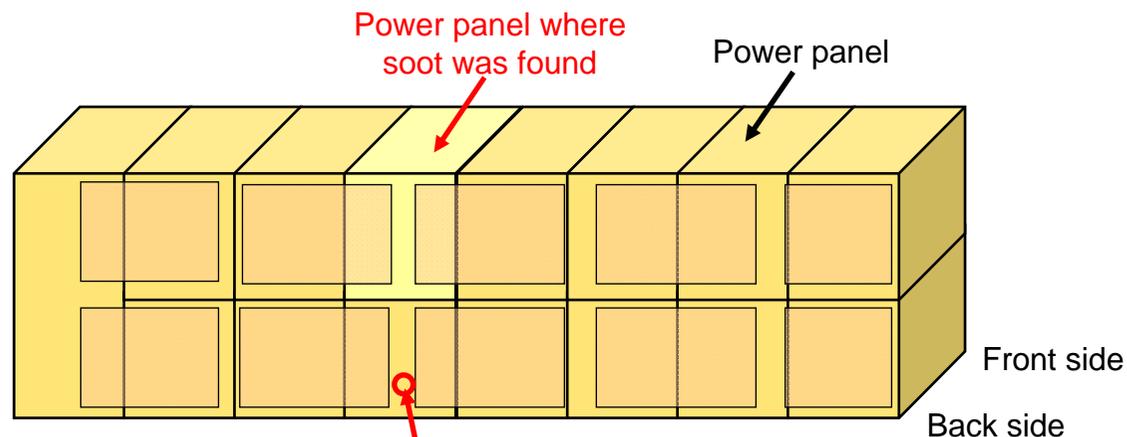
Location where a dead small animal (mouse) was found (on the power panel floor underneath the power panel where soot was found)

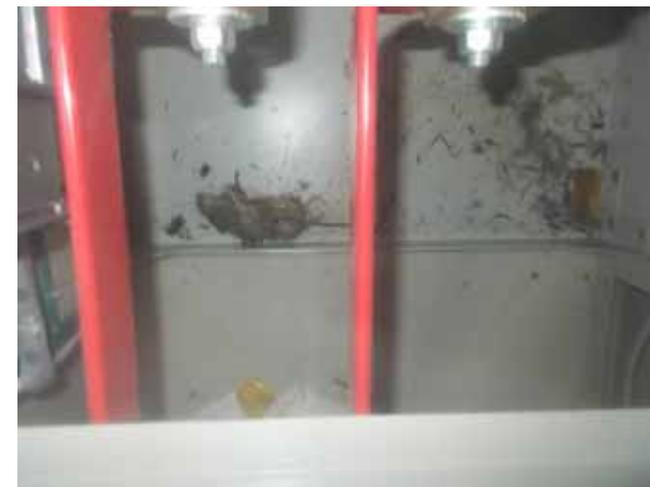
A small animal (mouse) found dead (Photo taken from above)

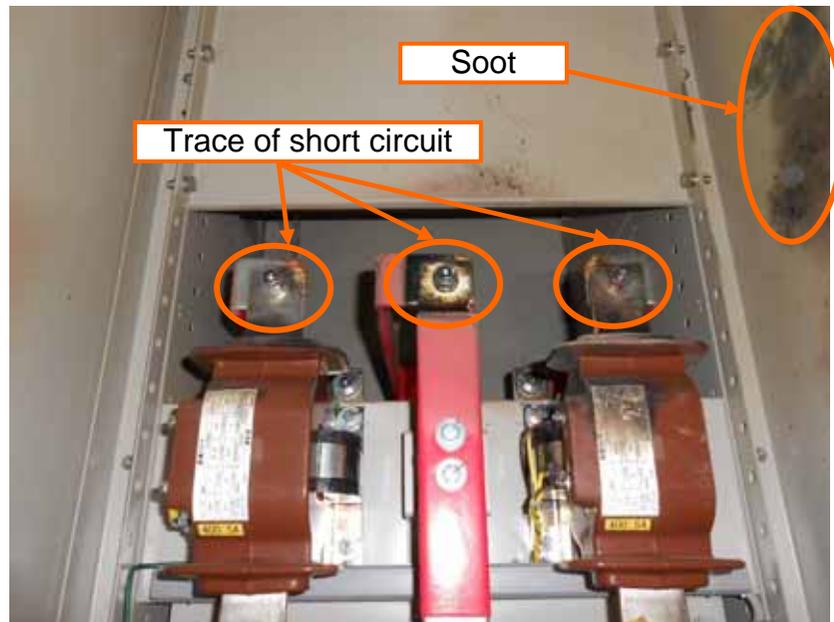
Inside the power panel (5A) after short circuit occurred

No problem was found with units other than 5A where short circuit occurred.

Photo 1: Inside the power panel after short circuit occurred

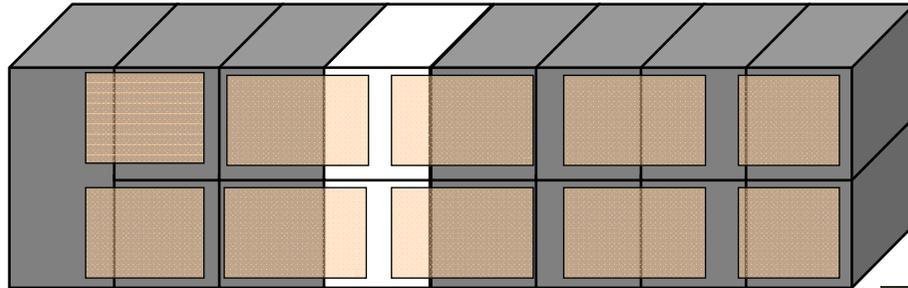
Back side of Units 3-4 temporary M/C (A)
and the power panel doors

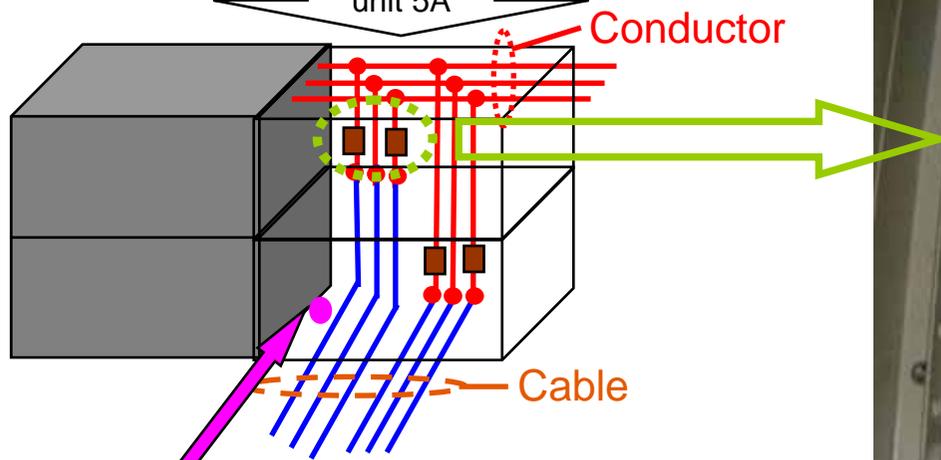
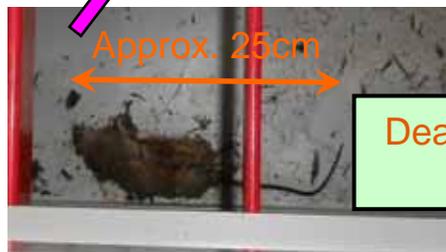
Enlarged
image of
unit 5A

Dead small animal
(mouse)

- A trace of short circuit was found on the conductor in the back of Units 3-4 temporary M/C (A) (5A). Also, a dead small animal (mouse) with an electric mark was found on the floor of the same unit.
- No trace of short circuit or foreign substance was found in other units in Units 3-4 temporary M/C (A) and the main line.

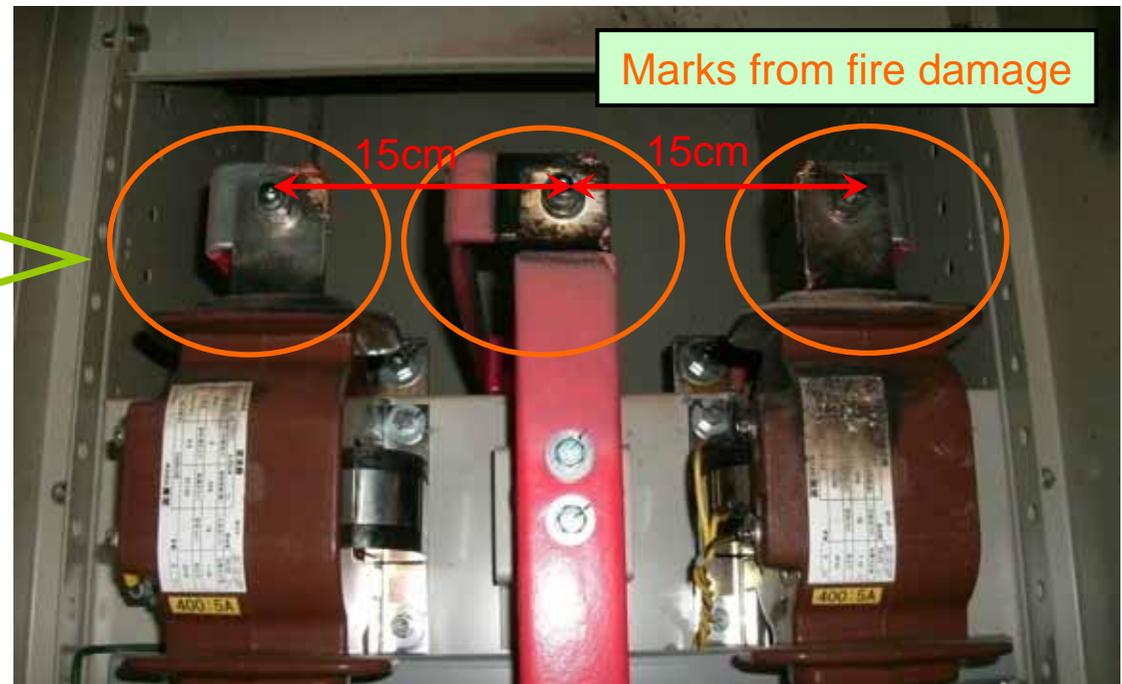
A small animal (mouse, 25cm long) getting close to the conductor generated an arc leading to a phase fault which developed into a three-phase short circuit.

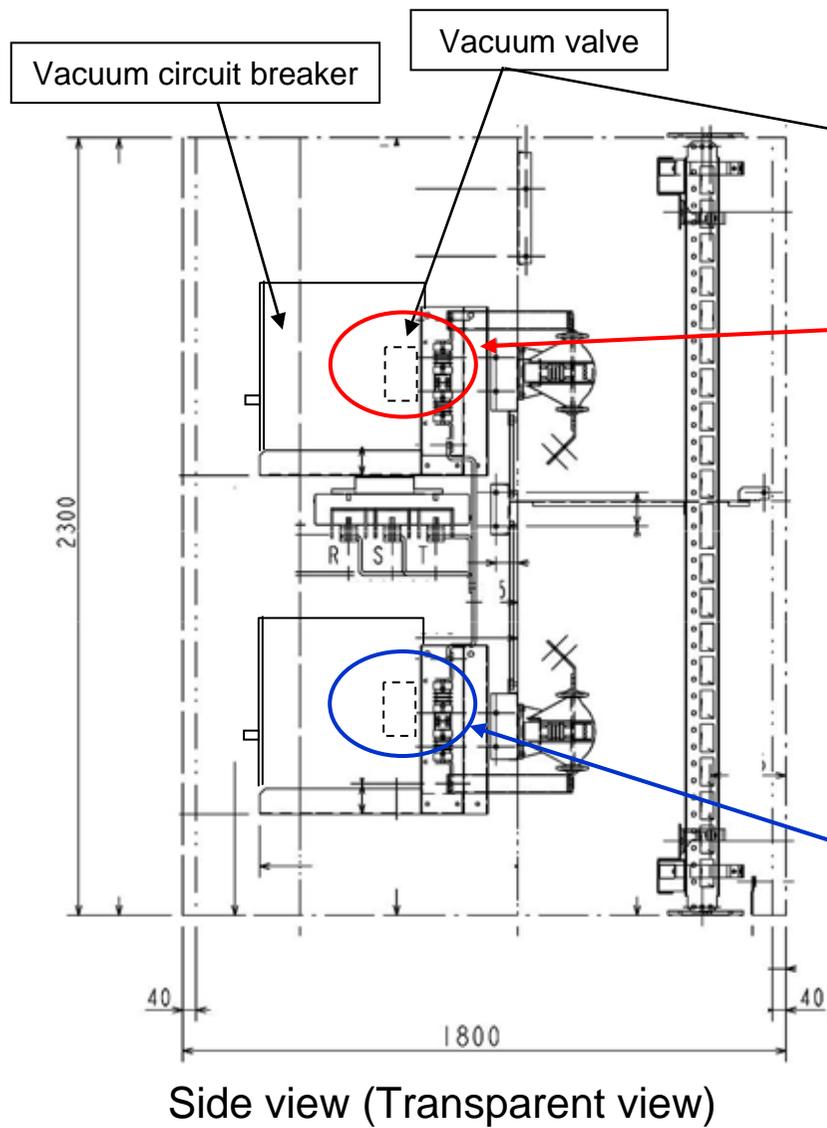
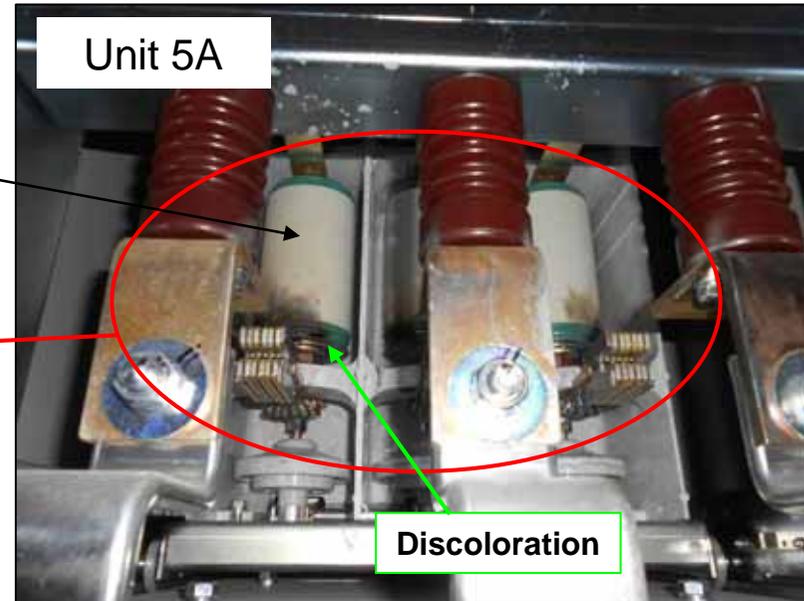
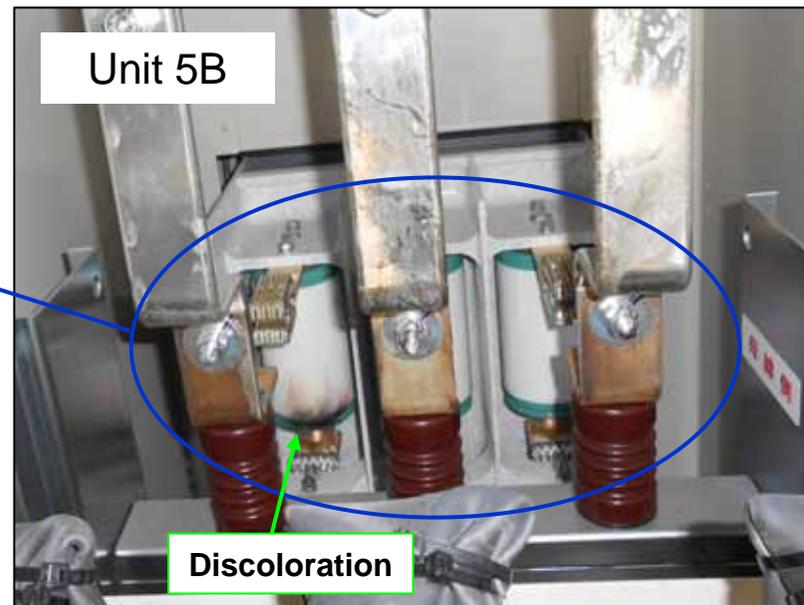
Discoloration of Units 3-4 M/C (A) Circuit Breakers

Traces of short circuit found near the terminal of unit 5A

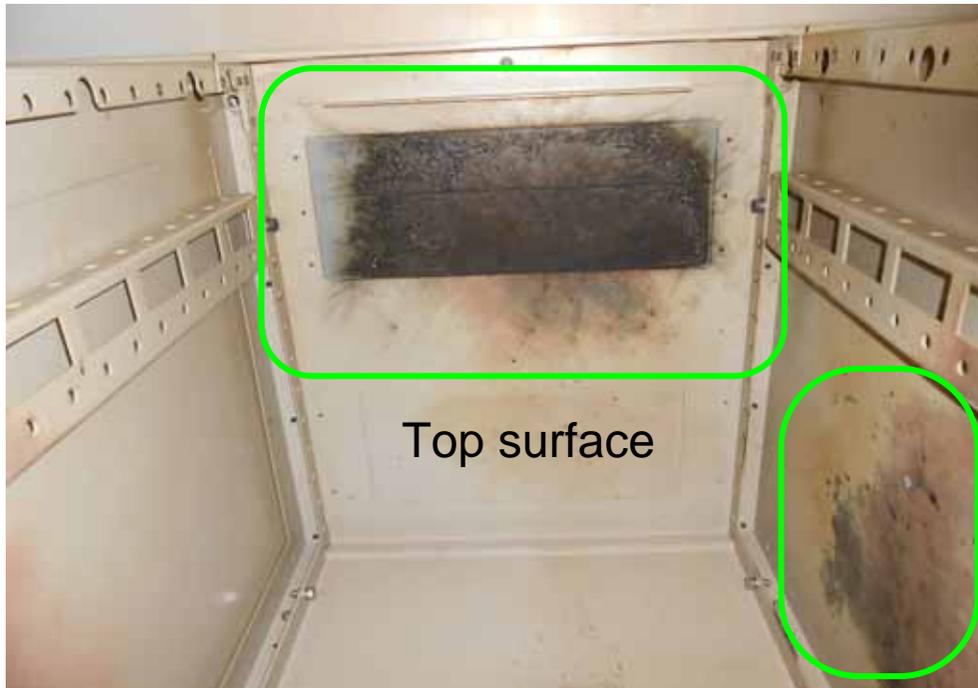
Traces of short circuit found on the top surface of unit 5A

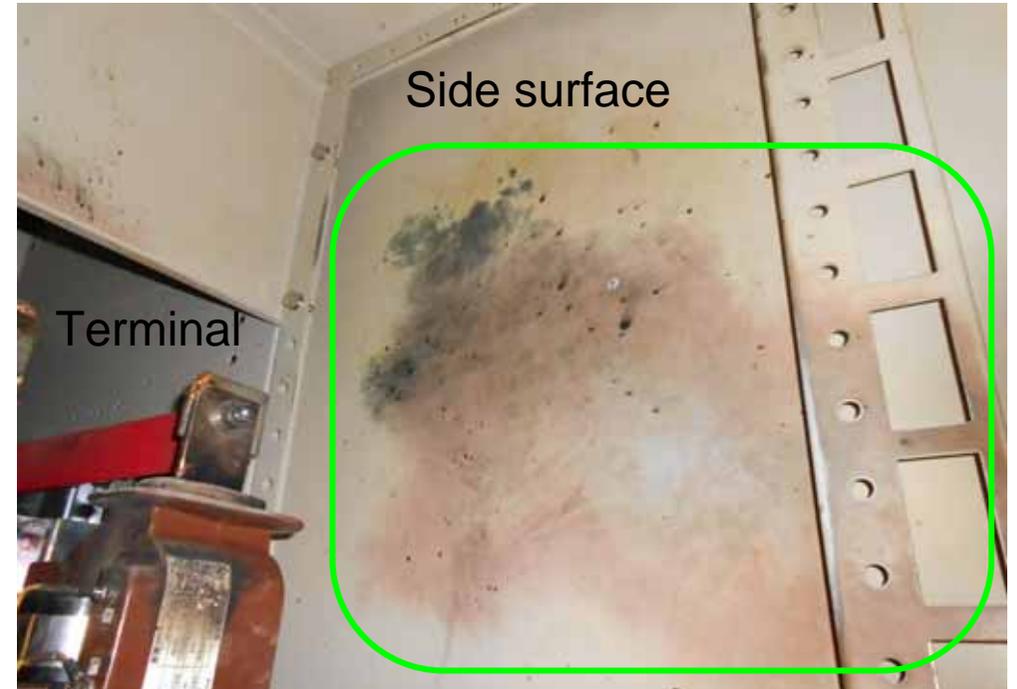
Traces of short circuit found on the side surface of unit 5A

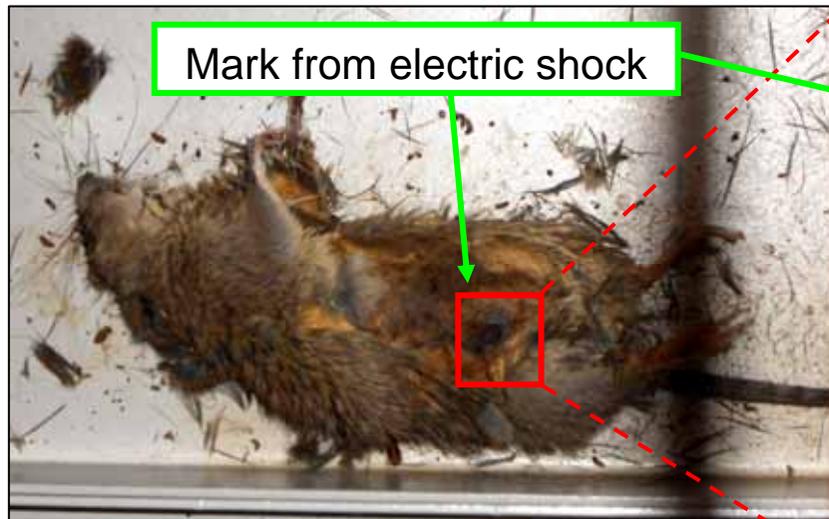
A dead small animal (mouse (photo 1)) was found on the floor of Units 3-4 temporary M/C (A) unit 5A. An electric mark (photo 2) was found on its

Photo 1: Dead small animal (mouse)
found in unit 5A

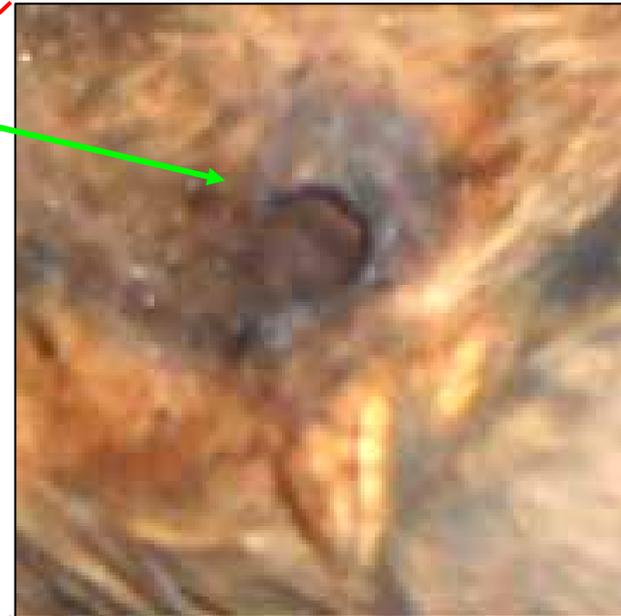
Photo 2: Enlarged image of the electric mark

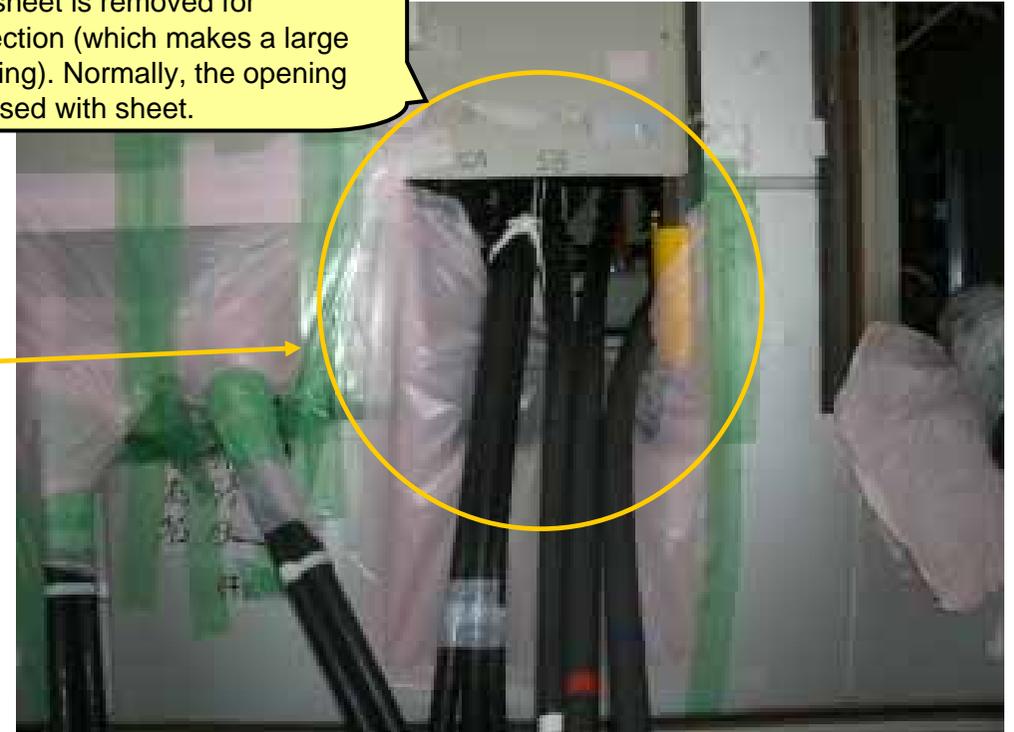
Location where the cable is drawn in
(Side surface of the container)

The opening found in the location
where the cable is drawn in has
been closed with a sheet.

The sheet is removed for
inspection (which makes a large
opening). Normally, the opening
is closed with sheet.

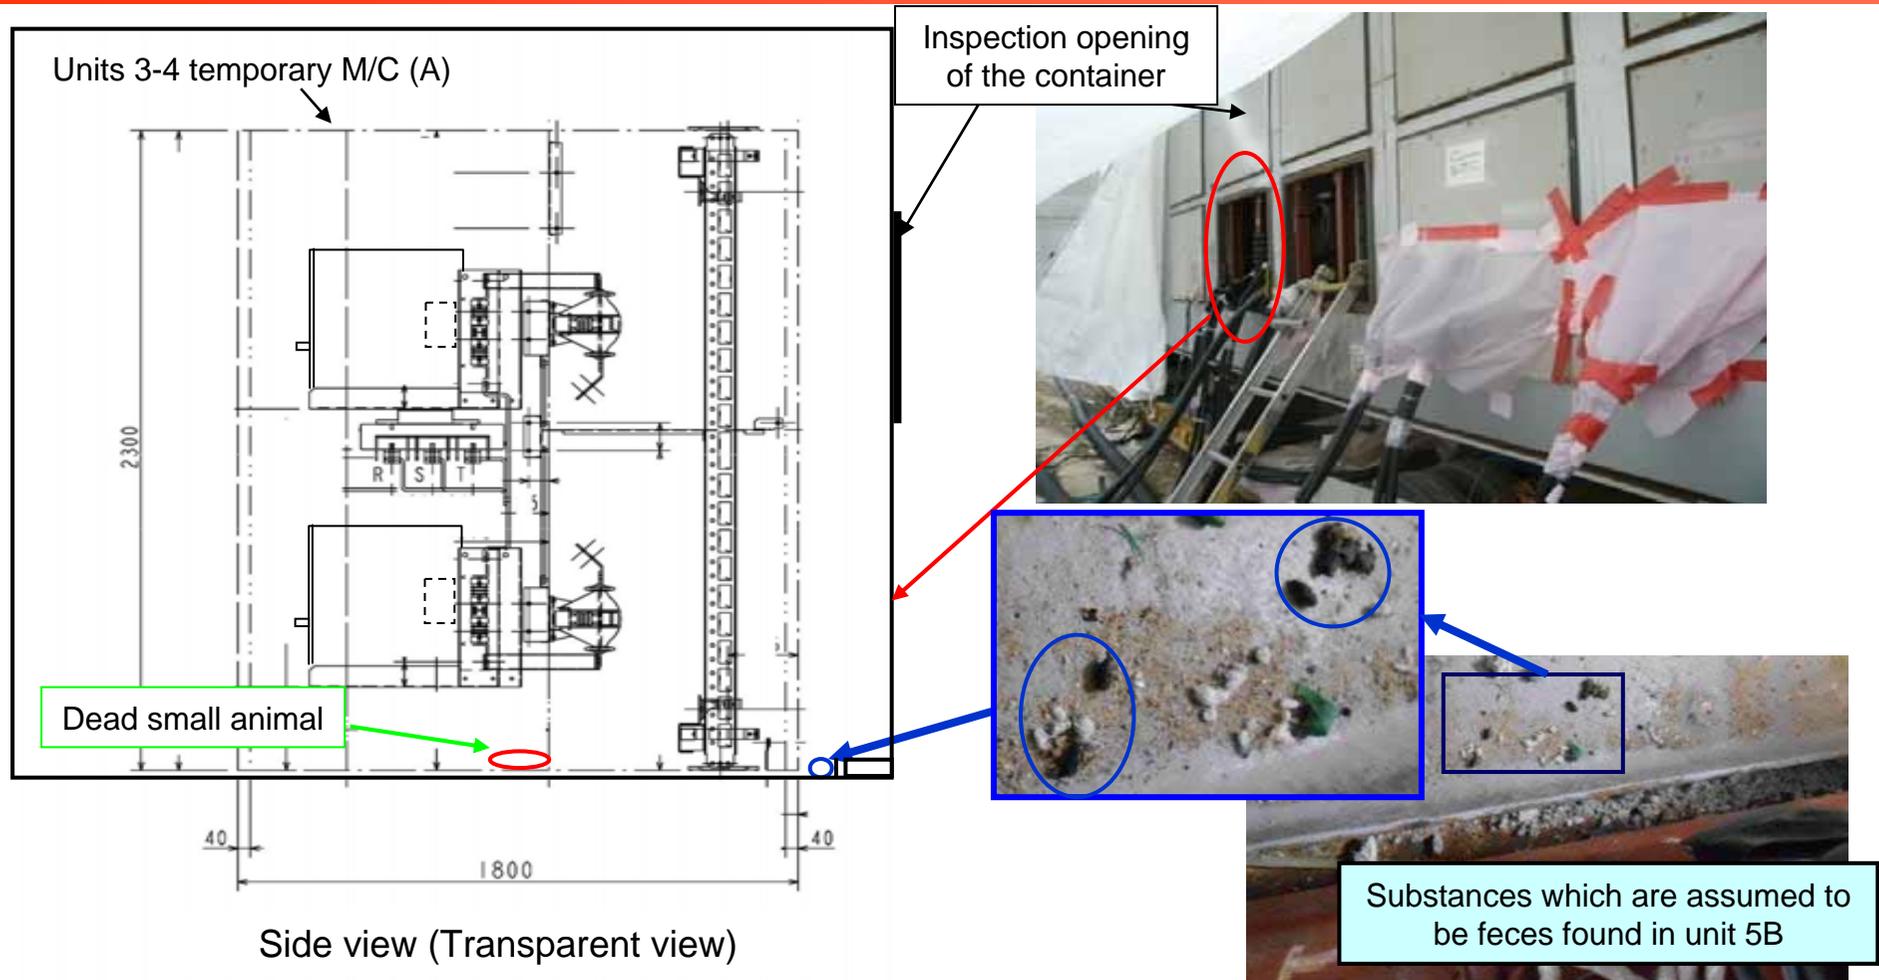
Feces of Small Animal Found in Units 3-4 Temporary M/C (A)

- A small animal (mouse) may have gotten into the unit from the opening generated by sheet partially coming off.
- Since the sheet was removed for investigation, trace of small animal (mouse), etc. could not be confirmed.
- Substances which are assumed to be feces of the dead small animal (mouse) were found on the floor of Units 3-4 temporary M/C (A) unit 5B.
- No abnormality was found with the appearance of the sheet, etc. at the time of inspection performed in the morning of March 18.
