Decreases of Water Levels inside H4 and H4 East Tank Area Dikes at Fukushima Daiichi NPS

< Reference > December 25, 2013 Tokyo Electric Power Company

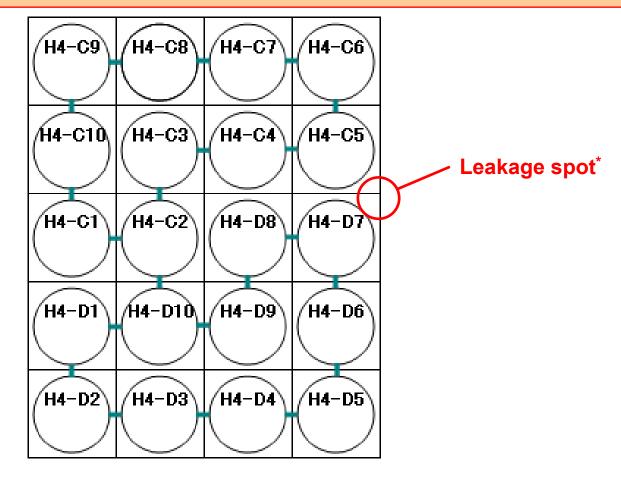
3. Spot of water leakage from the inside of the dike to the outside of the dike in the H4 tank area

- At around noon on December 25, a TEPCO employee on patrol found a small amount of water leaking to the outside of the dike at the south side of in the H4 tank area where repair work (replacement of caulking agent) of the dike foundation was then underway in response to the water level decrease inside the dike.
- O Later, the leakage stopped as the repair work (replacement of caulking agent) was completed.
 - < Dose measurement results for this area > *High doses were not detected.
 - Atmosphere dose

- Dose at the relevant part (leakage spot)
 (At the 5cm distance*) 70 μ m dose equivalent rate (gamma and beta rays) 0.03mSv/h
- Surface dose inside the dike (At the 5cm distance*) 70 μ m dose equivalent rate (gamma and beta rays) 0.04mSv/h *Position that is 5 cm away from a spot subject to measurement.

^{*:} The location of the leakage spot was incorrect in the previous version and was corrected. (The correction was made on December 25, 2013.)

* We coped with this leakage by pumping up water from the inside of the dikes and applying water stop treatment using epoxy resin to masonry joints of the dike foundations.
