The integrity evaluation of the reactor building at unit4 in the Fukushima Daiichi nuclear power station

May 2012

Government and TEPCO's Mid-to Long Term
Countermeasure Meeting Management Council

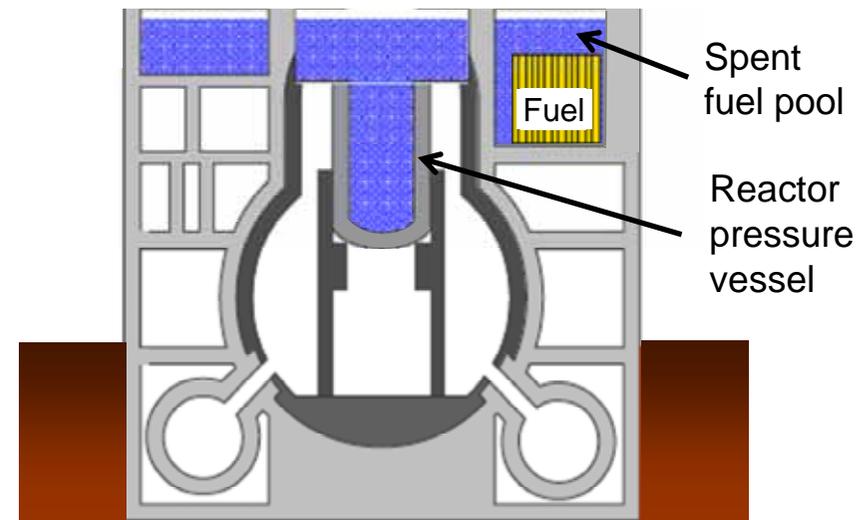
Image of the Unit 4 R/B

- The top of the unit 4 R/B was damaged by the hydrogen explosion, BUT we confirmed that
 - the building, including the spent fuel pool, has a sufficient margin of seismic resistance even if an earthquake equivalent to the Tohoku-Pacific Ocean Earthquake (JMA Seismic Intensity Scale 6+) occurs in the area.
 - the building has not tilted

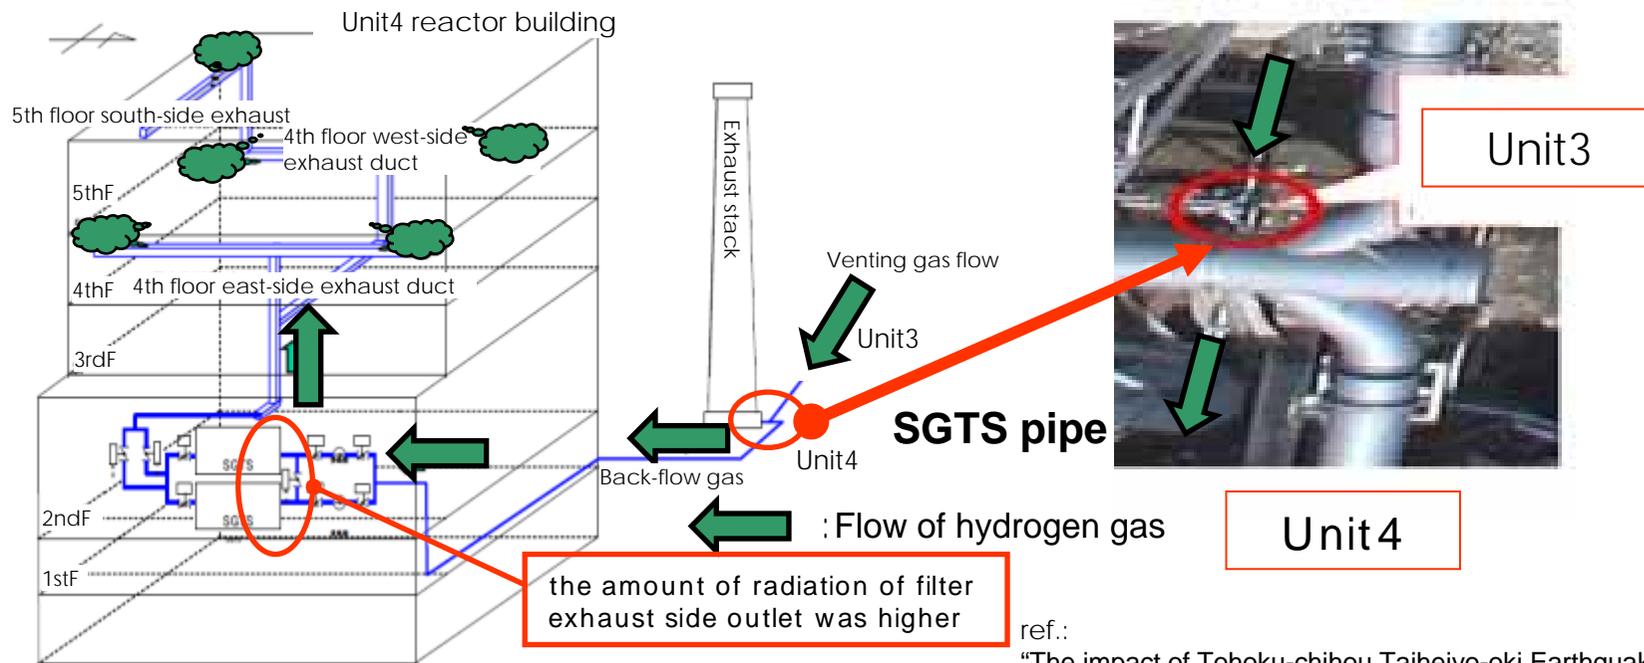
Flow path of the PCV venting gas flow from Unit3 to Unit4

- It is considered that the venting inflow, which comprised hydrogen gas originated from unit3, might have flowed into unit4 through SGTS piping and exhaust ducts, resulting in a hydrogen explosion.
- This was caused by the fact that the valves of unit4 SGTS were open though unit3 and unit4 a common exhaust stack.

According to TEPCO's investigation results, the amount of radiation in SGTS filter exhaust side outlet (downstream side) was a few orders higher than the amount of radiation on the upstream side filter. It is therefore unlikely that the explosion was caused by the gas generated in unit4.

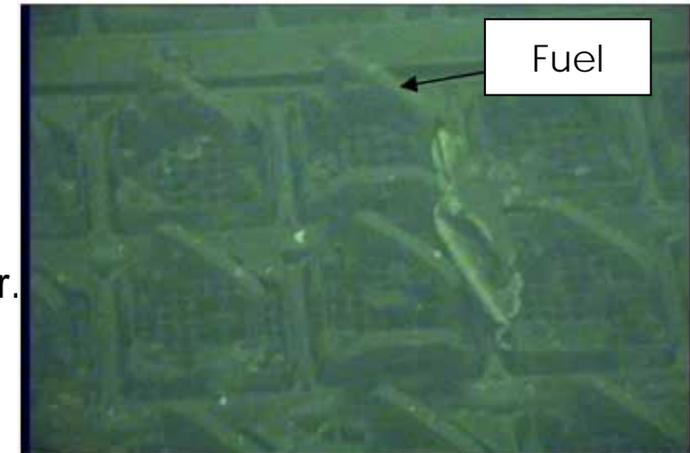
- ✓ So far the situation in the pool was filmed by TEPCO several times.
(Apr. 29, 2011, May 7, 2011, Feb. 9, 2012)
- ✓ Also, the investigation of the rubble distribution conditions inside the spent fuel pool was performed.(Mar. 15-21, 2012)
- ✓ The results showed that no abnormalities of fuel racks were recognized.

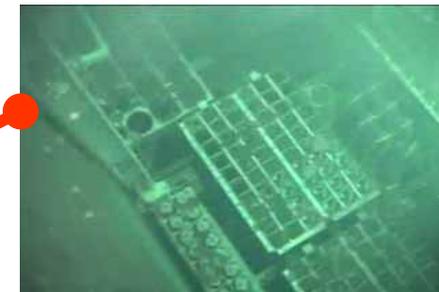
Photo Situation in the spent fuel pool

Water injection status into the spent fuel pool was confirmed by the camera attached to the tip of the concrete pump vehicle. And also, it was confirmed that there is no leakage of the 2nd floor, which is underneath the spent fuel pool.

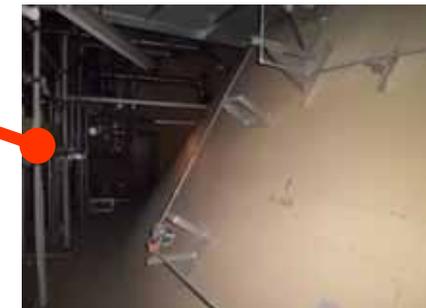
Photo Situation of the 2nd floor shell wall

As the results of the visual inspection inside R/B, it was confirmed that there was no damage to the shell wall on the 1st and 2nd floor. As for the 3rd floor, the shell wall was enough thick (1855mm). Hence it was also evaluated that there was no damage.

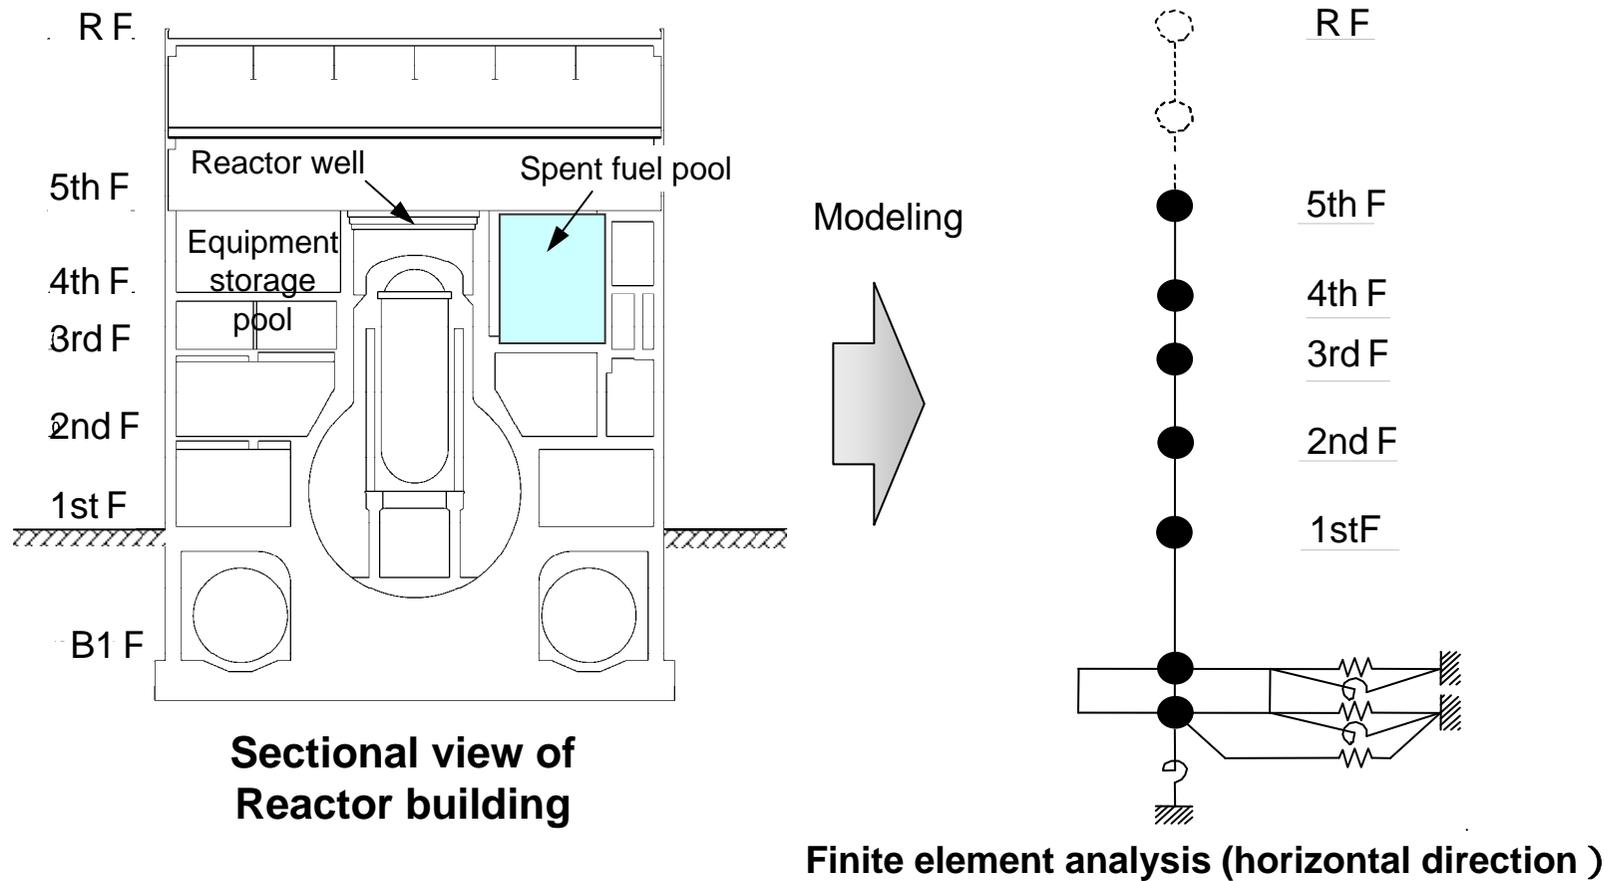
- Using lumped mass model reflecting the damage state of the reactor building after the hydrogen explosion, we conducted an evaluation of the reactor building against the future big earthquake (JMA Seismic Intensity Scale 6+) equivalent to the Tohoku-Pacific Ocean Earthquake and confirmed that the reactor building has a sufficient margin of seismic resistance. (1)

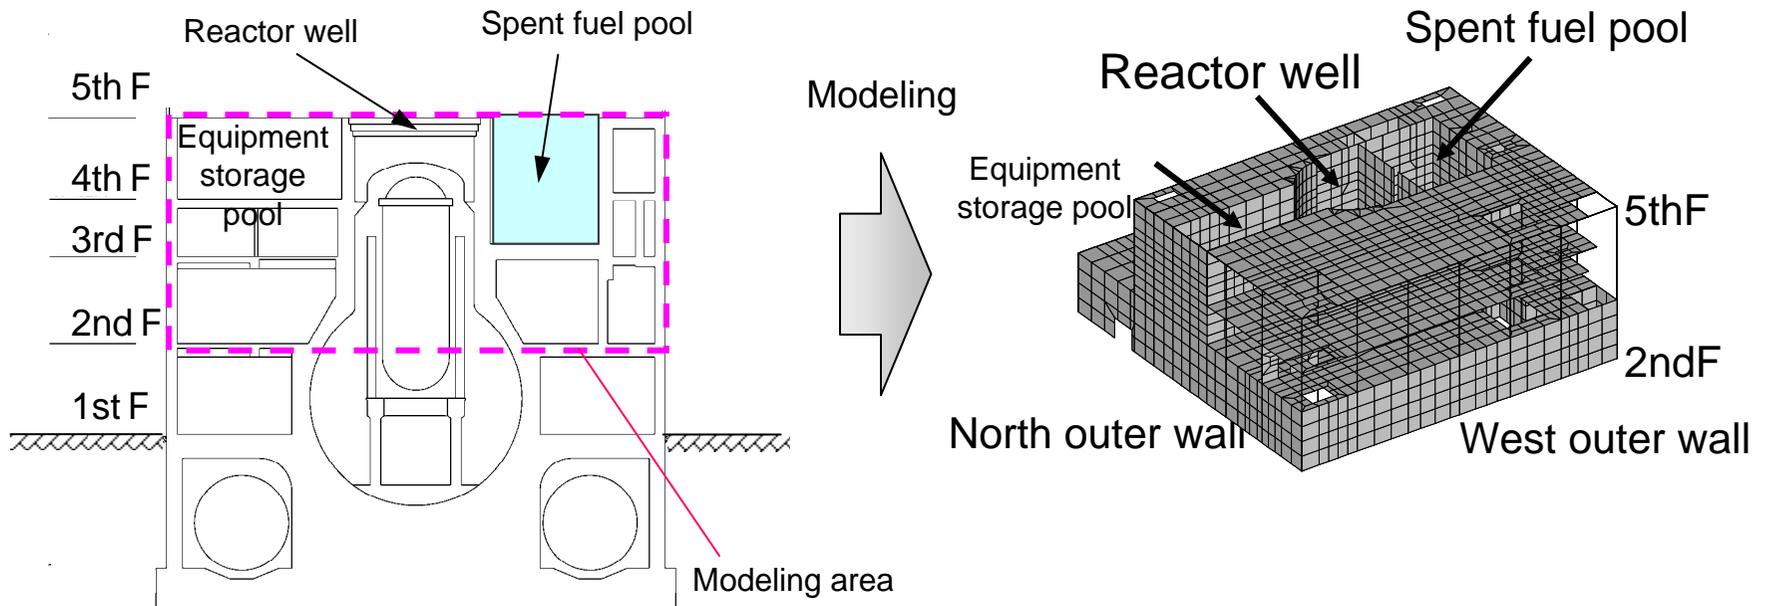
**Sectional view of
Reactor building**

- Additionally, we conducted a detailed evaluation with lumped mass model considering the building damage or conditions of the pool water at high temperatures and confirmed that the spent fuel pool has a sufficient margin of seismic resistance (1)

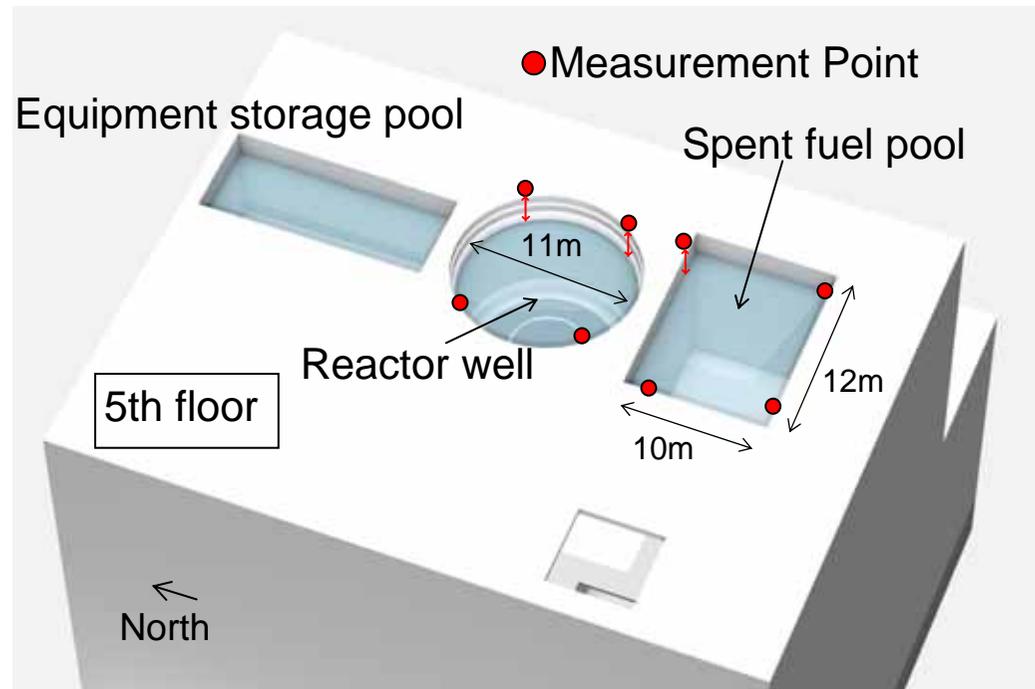
Measurement Point (on the 5th floor)

- We measured the distance between the water surface of the spent fuel pool and the floor surface of the building, and confirmed that the building has not tilted

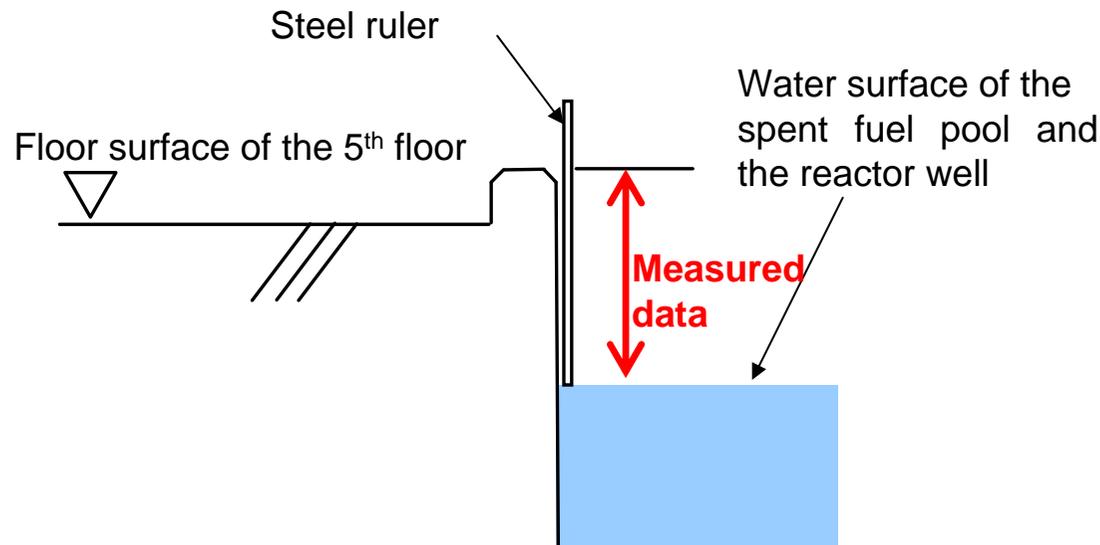
Measurement Method

- We conducted the measurements twice on February 7 and April 12, 2012 and the measured data at the 4 corners were almost the same. Thus, we confirmed that the floor surface of the 5th floor, water surfaces of the spent fuel pool and the reactor well were parallel.
