Status of investigation on estimating situation of cores and containment vessels

1. Introduction

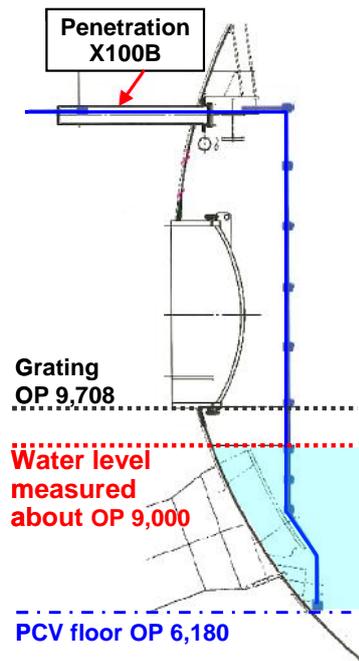
Figure 2-1 Measured level of water retained in Unit-1 PCV

The level of water retained was measured by lowering the CCD camera cable down to the water surface through the grating above in the PCV. The water level was found to be about 2.8m above the DW floor (as of October 10th, 2012) (Figure 2-1).

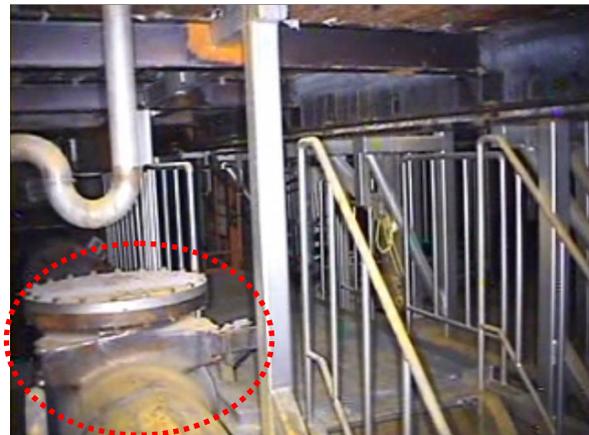
Figure 2-3 Camera photo of an S/C vacuum breaker in the torus room of Unit-1

No water leaking position in the S/C has been located yet. At least, no leak was confirmed on the flange of one of the eight vacuum breakers, as far as the camera photos showed (Figure 2-3).

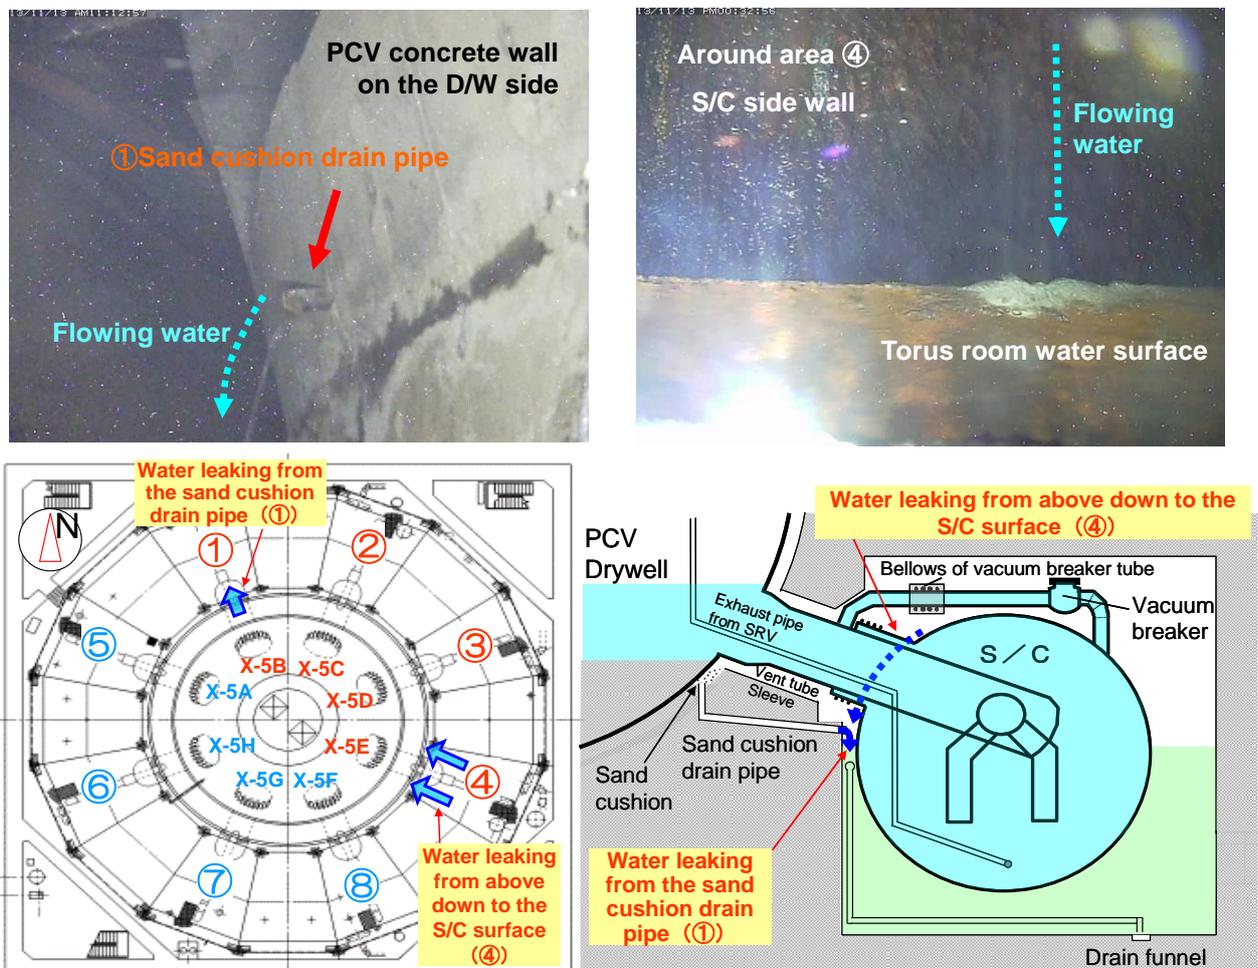
Figure 2-4 Camera images taken below the vent tubes in Unit 1 torus room (part)

Camera imaging confirmed water leaks at the following locations (Figure 2-4).

- Vent tube X-5B (① in the figure): water flowing from the displaced sand cushion drain pipe*
- Vent tube X-5E (④ in the figure): water flowing down on the S/C surface with 2 streams around both sides of the vent tube

*Water leaks at ① were confirmed since the vinyl chloride pipe (connecting the sand cushion drain tube and drain funnel with an insertion-type joint) had been displaced. Water leaks could not be confirmed at locations ② to ⑧, since the drain tubes had not been displaced. The concrete seams (joints) below the sand cushion drain piping were observed to be wet all around on the concrete wall.

Water leaks into the sand cushion occur only when water leaks directly from the drywell. The leakage is probably from a low position of the drywell below the water level (for example, the containment vessel shell, pipe penetrations, etc.). The low location of the water leaks in the drywell would indicate the possible influence of molten fuel that fell to the PCV bottom. This information is of critical significance in estimating the conditions of the core and PCV.

Meanwhile, the water leakage down to the S/C surface around both sides of the vent tube X-5E indicates the possibility of water leaks from the vacuum breaker tube (its bellows, for example) immediately above the vent tube. This elevation of the vacuum breaker tube is about the same level as that of the upper limit of PCV water level which was reached in an attempt to flood the PCV by increasing the amount of water injected in May 2011; where the PCV water level was calculated from the injected nitrogen gas pressure. The nitrogen gas pressure was stopped from changing at a specified level, which means the PCV water level was leveled off, i.e., an indication of leak hole existence at the level (Figure 2-5) [5].

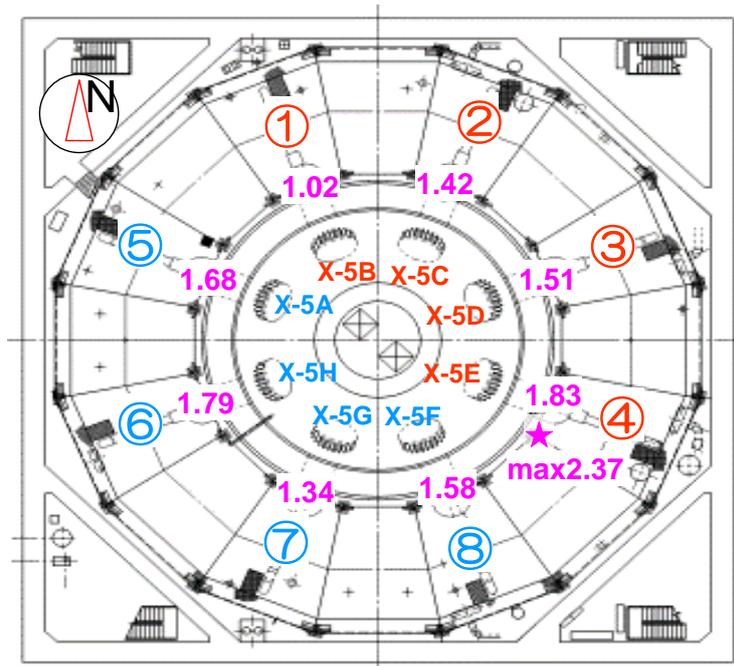
Figure 2-6 Dose distribution measured during the torus room investigation underneath vent tubes of Unit 1

The vertical distribution of radiation doses measured when lowering the instrumentation boat in November 2013 was similar to that measured in February 2013 (in the area surrounding the torus). Dose distribution along the boat traveling route was about 1 to 2 Sv/h, and the highest spots were in the southeast area (Figure 2-6).

In June 2011, steam blown from the pipe penetrations was witnessed at the southeast corner of the first floor of the reactor building. This would mean that radioactive materials carried by the steam were blown to the torus room after the accident and they deposited on the walls and structure surfaces there. The dose distribution in the torus room is considered to be the sum of doses due to these contamination sources. The estimated radiation dose levels on the water surface due to water-retained radionuclides (7.3×10^4 Bq/cm³ of Cs-134 and 1.5×10^5 Bq/cm³ of Cs-137, sampled on February 22, 2013) are about 100 mSv/h and not a dominant contributor to the 1 to 2 Sv/h dose measured [6].

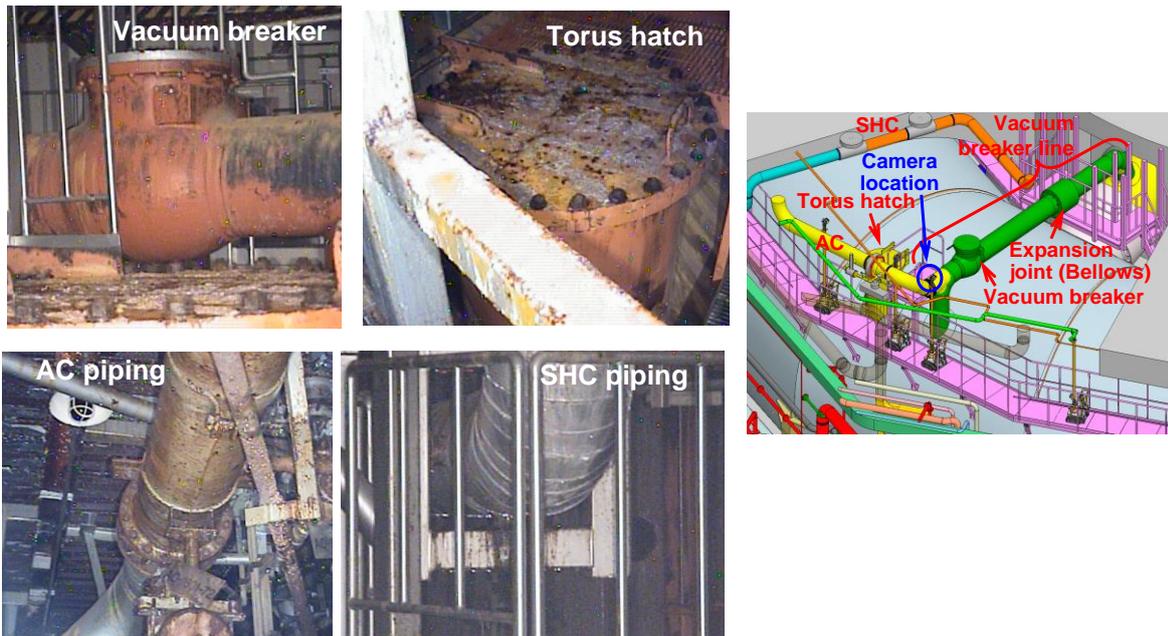
Figure 2-7 Camera images of Unit-1 S/C top area exploration (around vent tube X-5E) (Part)

In May 2014, survey instrumentation robot was introduced through a drilled hole in the northwest area of the first floor of the Unit1 reactor building to explore the S/C top area in order to locate the leak source near the vent tube X-5E, where leaking had been confirmed. By using the outer catwalk, the instrumentation robot made a camera survey around the vent tube X-5E, and the water leak was confirmed to be from the protective cover of the expansion joint on the vacuum breaker line. No leaks were noticed from the vacuum breaker valve, torus hatch, Shutdown cooling system (SHC) piping or Atmospheric control system (AC) piping (Figure 2-7) [7].

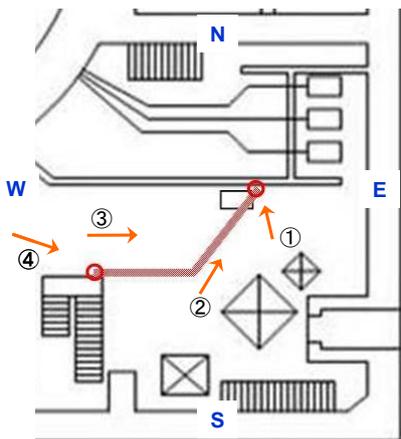
Figure 2-8 Gamma camera images in the southern area of Unit 1 reactor building 1st Floor (part)

In December 2013, contamination was surveyed on the first floor of the Unit-1 reactor building by radiation dose measurements and gamma camera images taken using a robot. It was found that contamination was relatively high on the Atmospheric control system (AC) piping and Drywell humidity control system (DHC) piping (Figure 2-8) [8].

Hot spots confirmed along piping

The AC piping is where the steam passed through when the wetwell (W/W) venting was carried out during the accident. Its high contamination is considered to be due to venting flows, and the situation was similar to that for the area near the standby gas treatment system (SGTS) train entrance room or near the SGTS piping connected to the main stack, where high dose rate had

The DHC piping is connected to the Reactor building closed cooling water system (RCW), and therefore its high dose is considered to be due to the same mechanism as that of RCW piping, where high dose rate had been already confirmed.

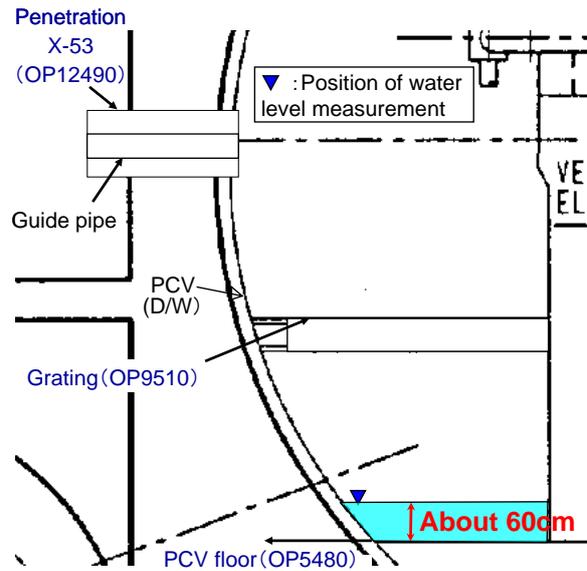
Figure 3-1 Measured level of retained water in Unit-2 PCV

The level of water retained was confirmed to be about 60 cm above the D/W floor by the video image scope (as of March 26th, 2012) (Figure 3-1).

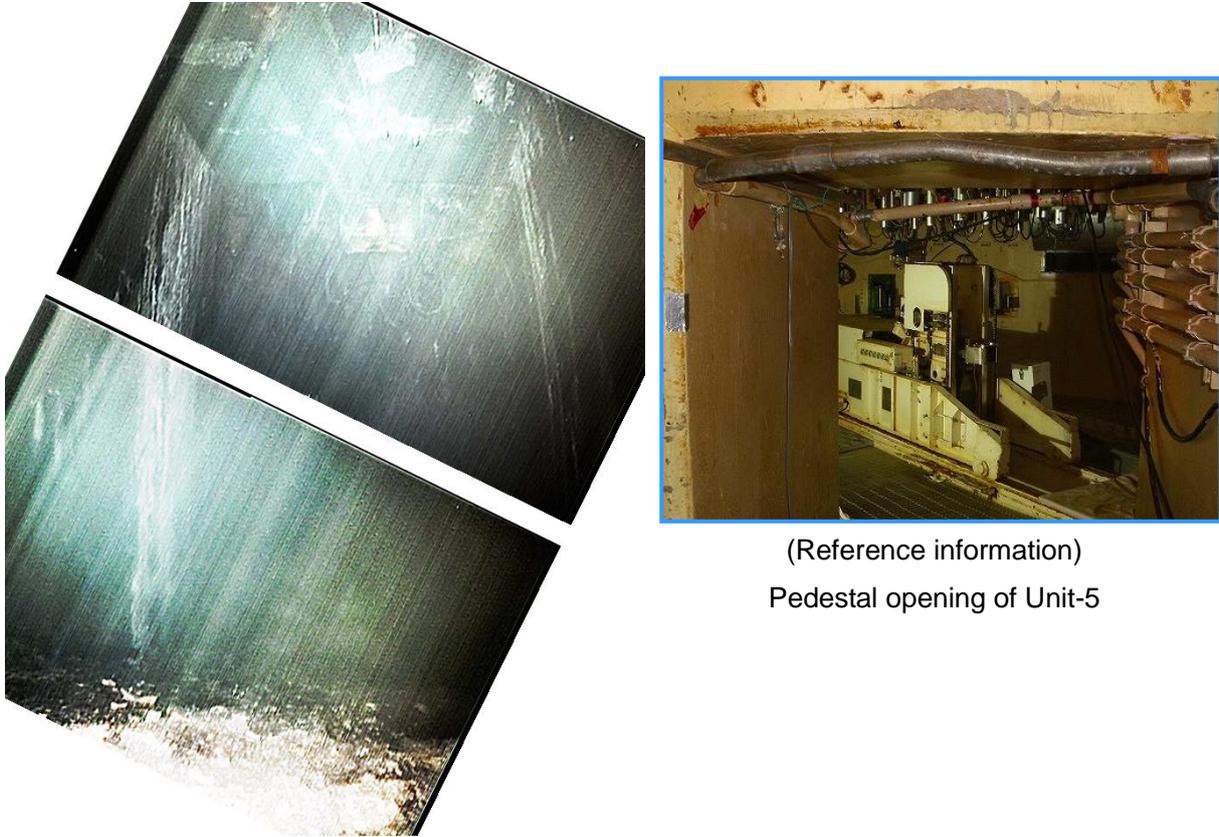
Figure 3-3 Photos inside the PCV pedestal taken at the pedestal opening (processed image)

photo processing for noise and contrast, they confirmed the position of the control rod position indicator probe (PIP) cables in the upper part of the pedestal opening, but no clear information was obtained regarding what was in the lower part inside the pedestal (Figure 3-3).

Dosimeters measured the dose rates as far as the top of the CRD replacement rails. The values were about 45 – 80 Sv/h. As supplementary information, dose rates were estimated from the camera image noises; they were about 30 Sv/h near the landing point in replacement rail and

about 36 Sv/h near the pedestal opening. No clear indication was obtained about gaining access to fuel debris, even via the pedestal opening on the CRD replacement rail because access to fuel debris will result in rapid dose rate increase.

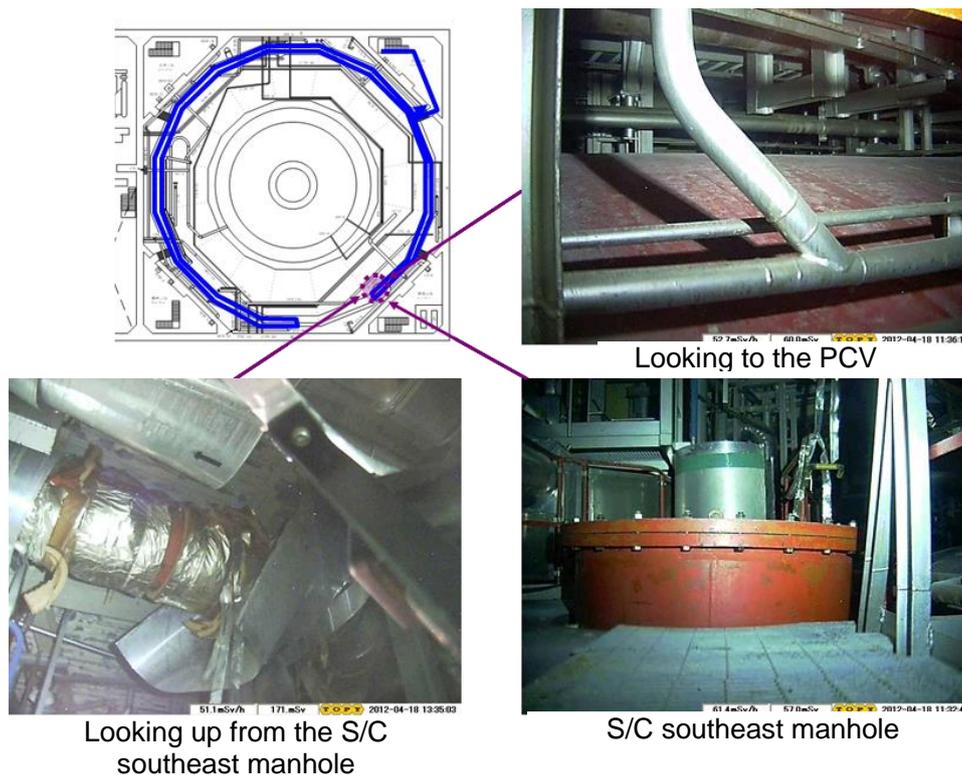
Figure 3-5 Camera photos in the torus room of Unit-2 (part)

No water leaking position in the S/C has been located yet. At least, no leak was confirmed on the flange, etc. of the S/C manholes, as far as the camera photos show (Figure 3-5).

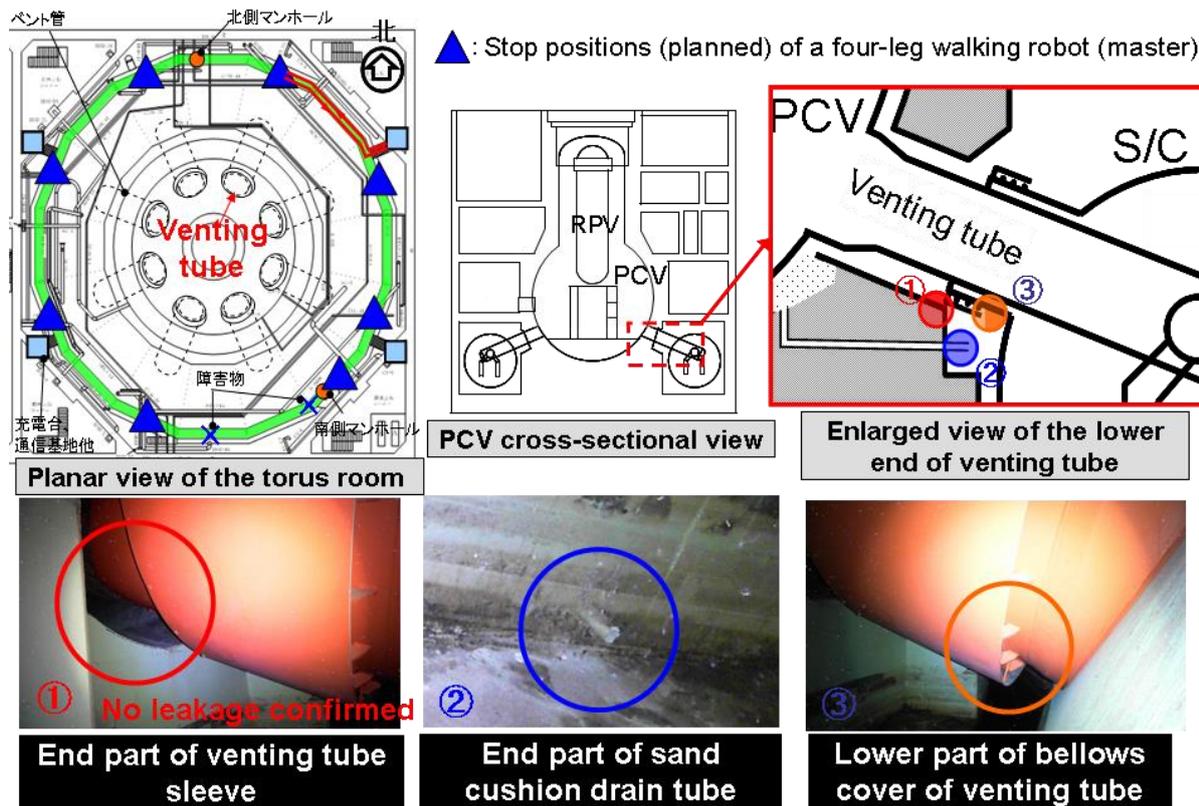
Figure 3-6 Camera photos around the lower end of the venting tubes in the torus room of Unit-2 (part)

No water leaking position in the S/C has been located yet. At least, no leak was confirmed from the lower end of venting tubes within the visible range (Figure 3-6).

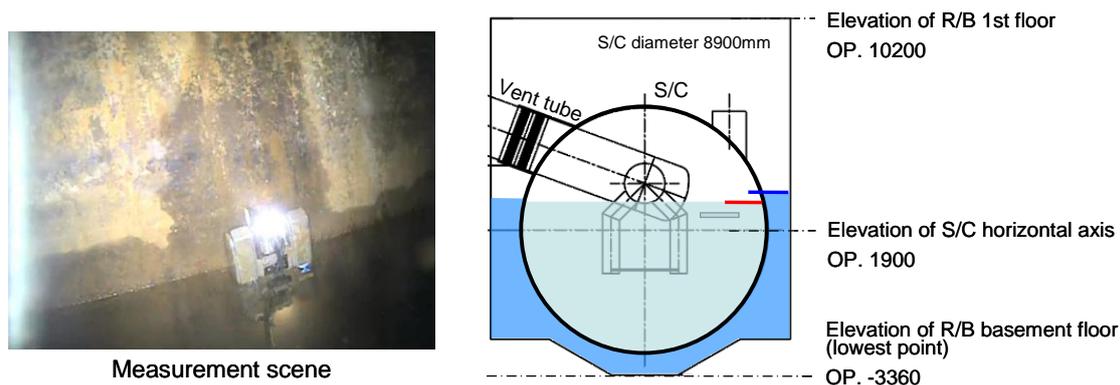
Figure 3-7 S/C water level measurements of Unit-2

The S/C water level is in correspondence with the level of water retained in the torus room. This is consistent with the water level estimated earlier by the nitrogen gas injection tests. This information confirms that water leaks occurred at the S/C lower position (including piping).

(Note) S/C water level seems to be affected by water level retained in the torus room

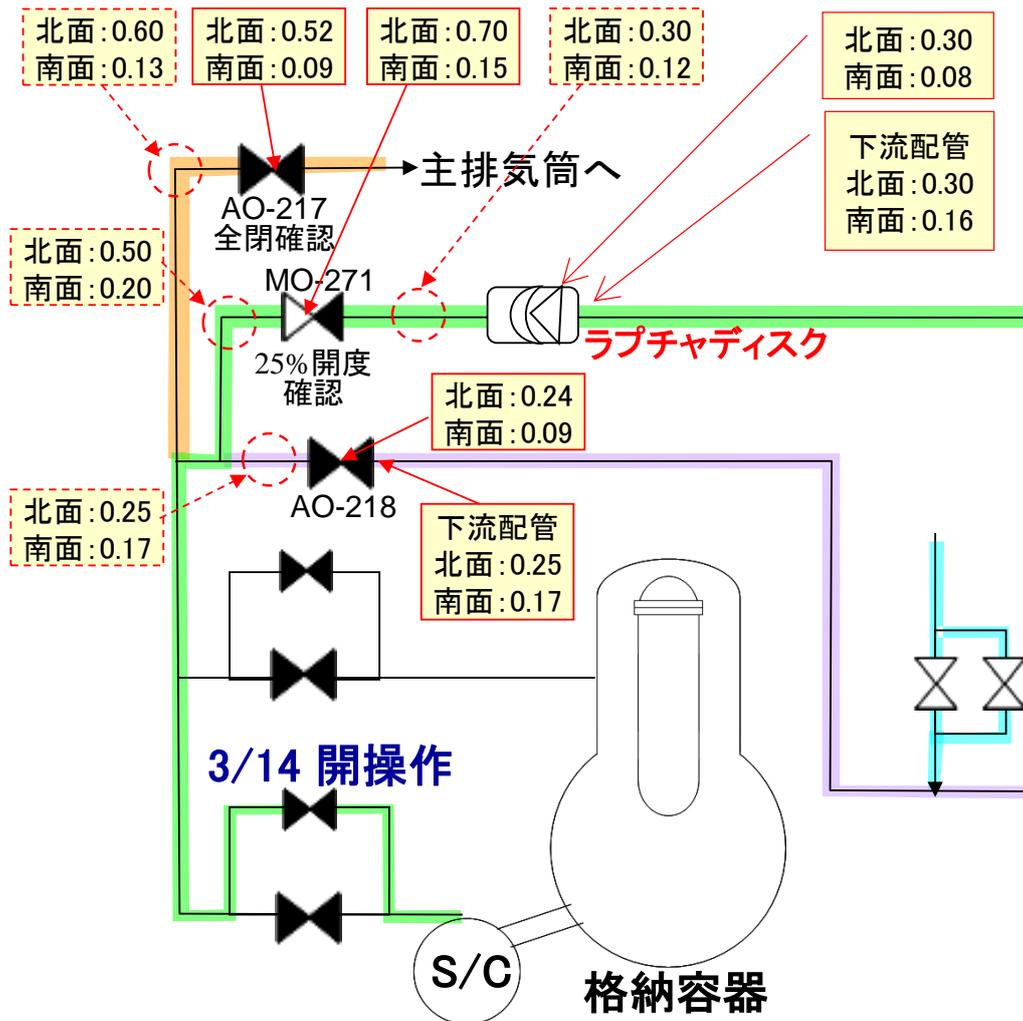
Figure 3-9 Radiation levels observed around the rupture disk (mSv/h)

Figure 3-9 shows the results of radiation measurement around the rupture disk. The measurement was done on October 8th, 2014. The radiation level measured was 0.30mSv/h from the north face, while it was 0.08mSv/h from the south face. Both were at about the same level of 0.30mSv/h (north face) and 0.12mSv/h (south face) before the rupture disk on the venting line, or 0.30mSv/h (north face) and 0.16mSv/h (south face) after the disk. These values indicate that the area is not contaminated to the extent predictable for such lines as the Unit-1 venting line, through which gas containing a large amount of radioactive materials went.

Furthermore, there exists a consistent tendency in the surrounding area that the levels on the north face are higher than those on the south face. This may indicate that the observed radiation levels were influenced by some unknown high level radioactive source existing on the north side of

the rupture disk area, i.e., the radiation levels observed on the north face of the venting line and the rupture disk were actually measurements of radiation coming from that unknown high level radioactive source on the north side without the shielding effect of the piping, while the radiation levels obtained on the south face were actually measured after being shielded by the piping. Therefore, it is highly likely that the rupture disk and the piping around the disk are the least contaminated.

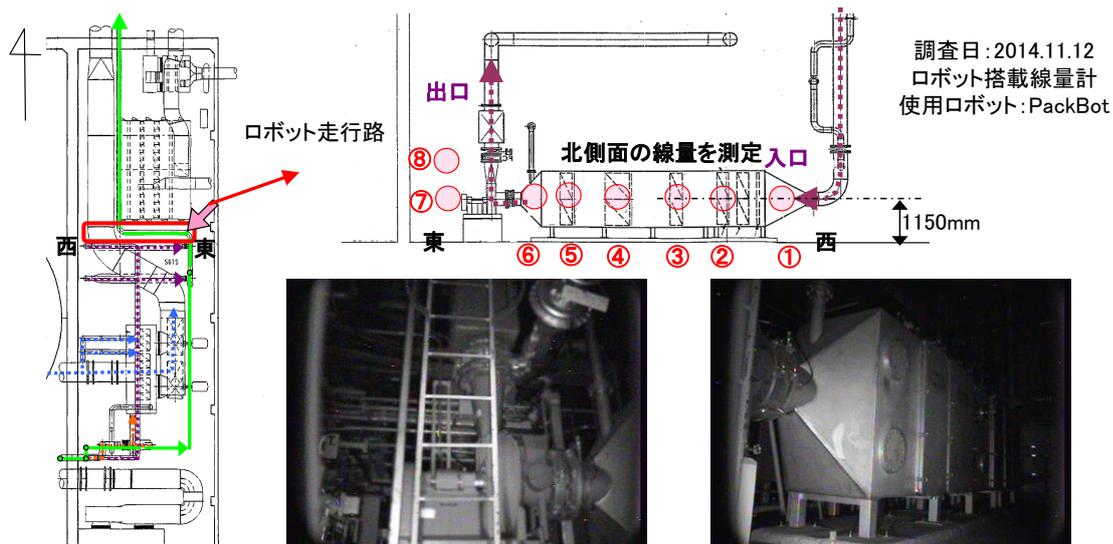
Figure 3-10 Radiation level observed (SGTS filter (A))

Figures 3-10 and 3-11 show the radiation measurement results around the SGTS filters (A) and (B), respectively. For both filters (A) and (B), radiation levels as high as about 1Sv/h were obtained. The maximum contamination has been observed on the HEPA filter at the SGTS filter outlet. Generally, the SGTS filter captures radioactive materials from its inlet side, which means that the results observed may indicate the gas containing the radioactive materials flowed into the SGTS filter from the opposite direction (backward flow). As clearly recognizable from Figure 3-8, there are two possible paths for this backward flow: from the Unit-2 venting line and the Unit-1 venting line (this is the same situation as having occurred when hydrogen gas flowed backward from Unit-3 to Unit-4).

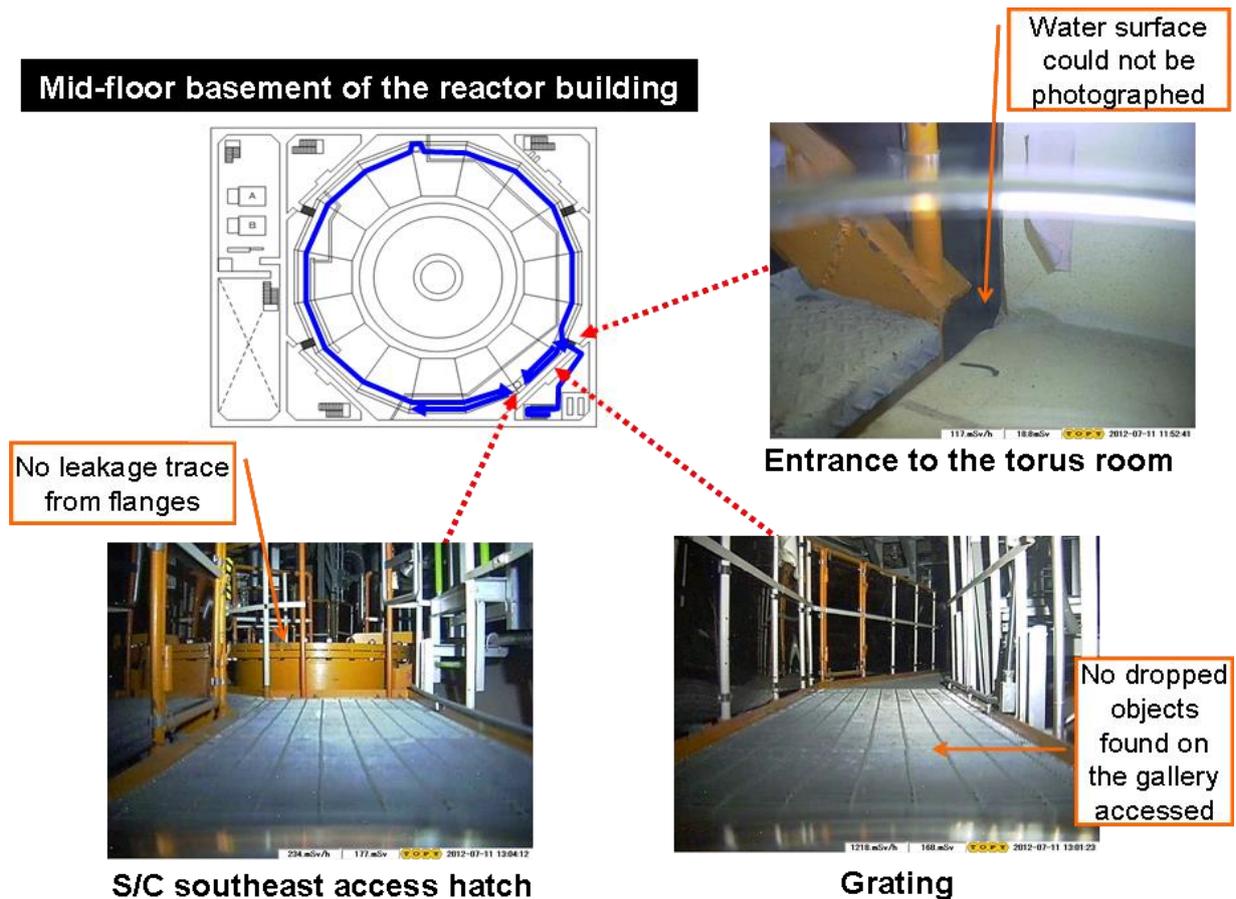
Figure 4-1 Camera photos in the torus room of Unit-3 (part)

No water leaking position in the S/C was located yet. At least, no leak was confirmed on the flange, etc. of the S/C manholes, as far as the camera photos show (Figure 4-1).

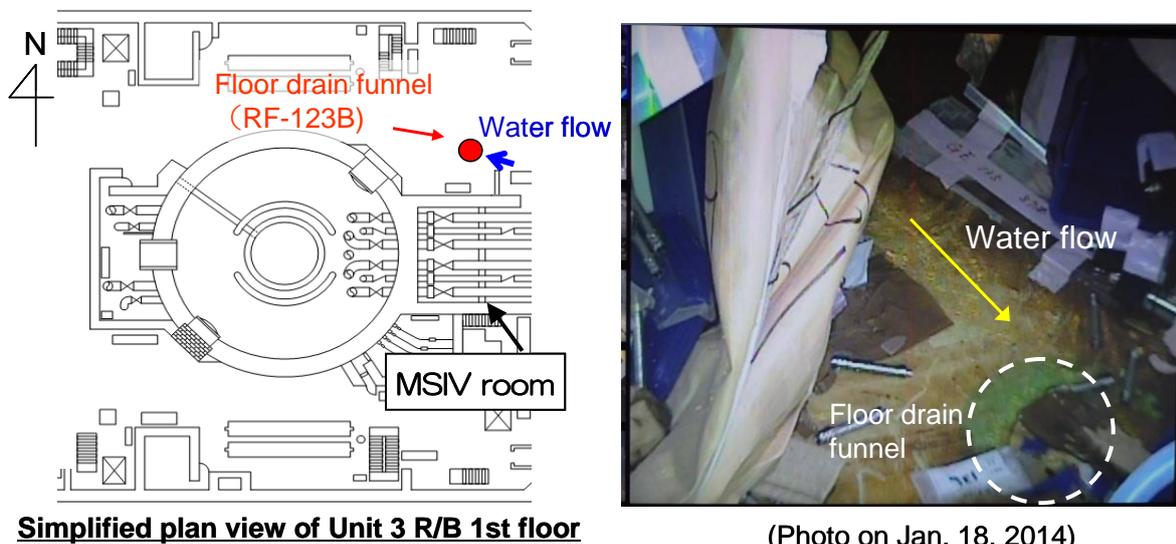
Figure 4-2 Water leak near the MSIV room door of Unit-3

In January 2014, while camera photos taken by the rubble and wreckage removal robot in the Unit 3 reactor building were being checked, water was seen to be flowing from near the main steam isolation valve (MSIV) room door in the northeast area of the reactor building first floor. The water was flowing towards a nearby floor drain funnel (Figure 4-2) [18].
