# Fukushima Daiichi Nuclear Power Station Investigation Results for the inside of the Unit 3 Personal Access Lock and Past Investigation Results for each penetration

October 30, 2025

Tokyo Electric Power Company Holdings, Inc.

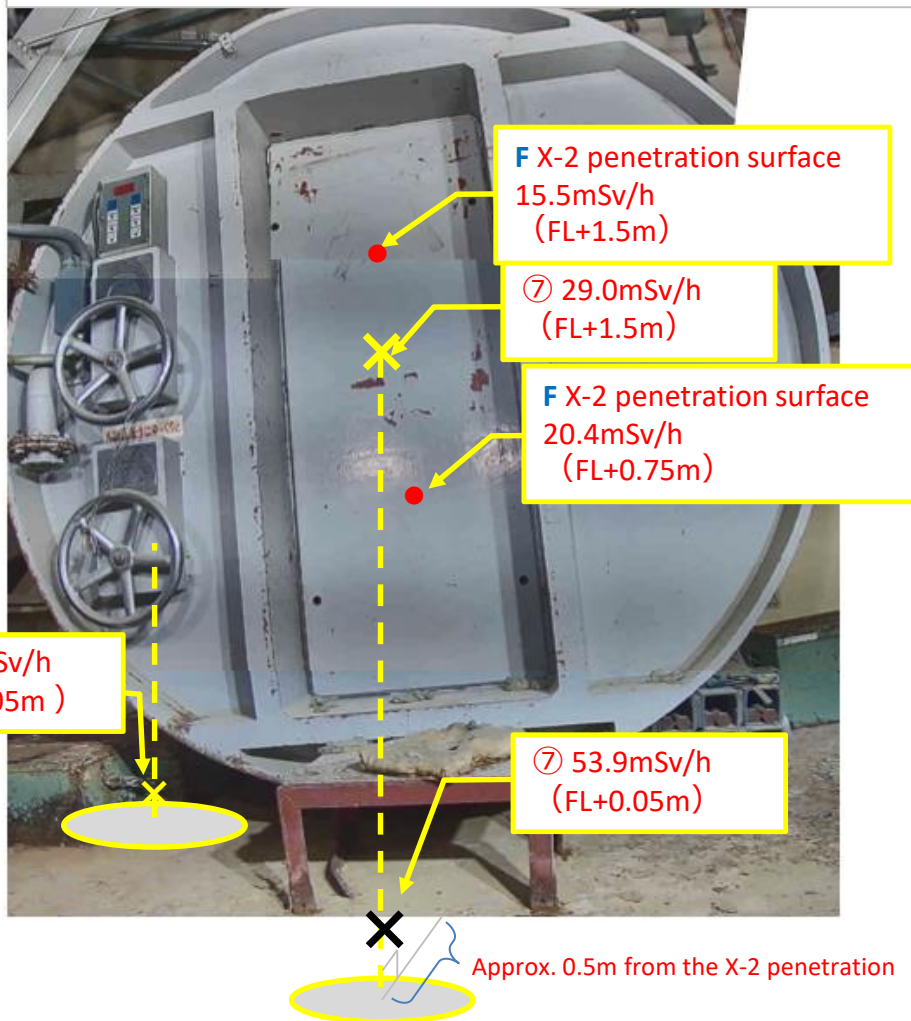
**Arrow I** (Front of X-2 penetration (Near No.⑦) )

- No adhesion of molten material was found on the surface of the X-2 penetration flange like that found in the front chamber of the Unit 2 X-6 penetration, and no signs of leakage or deformations were confirmed.

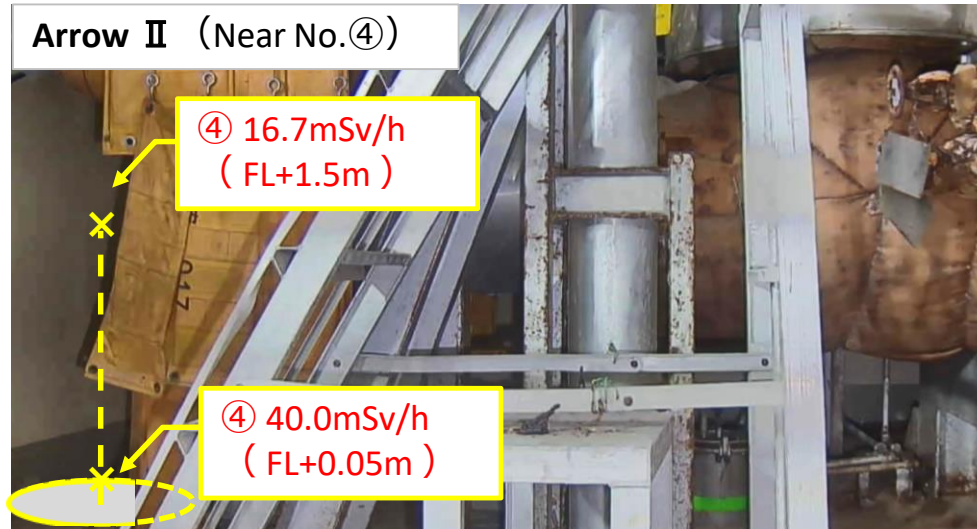
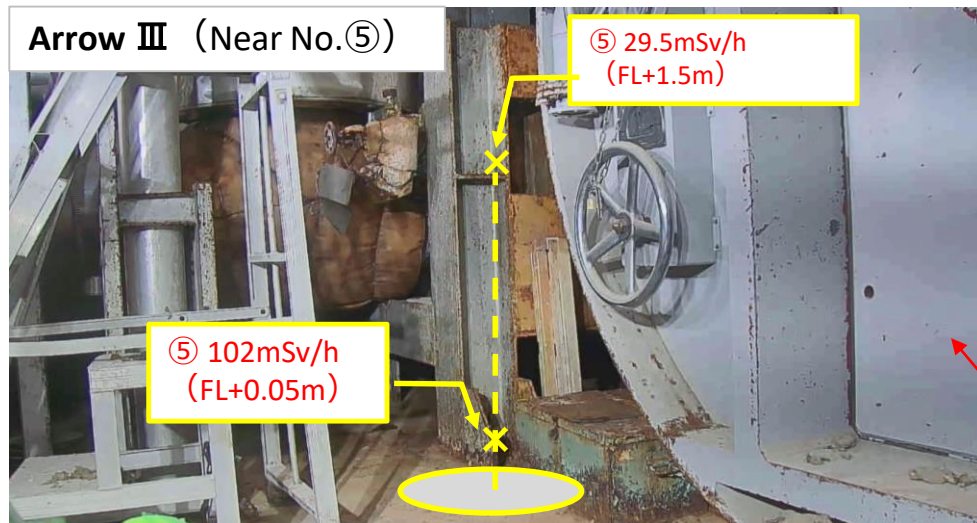
- Some corrosion was found inside the P/A room, but no deformities were confirmed.

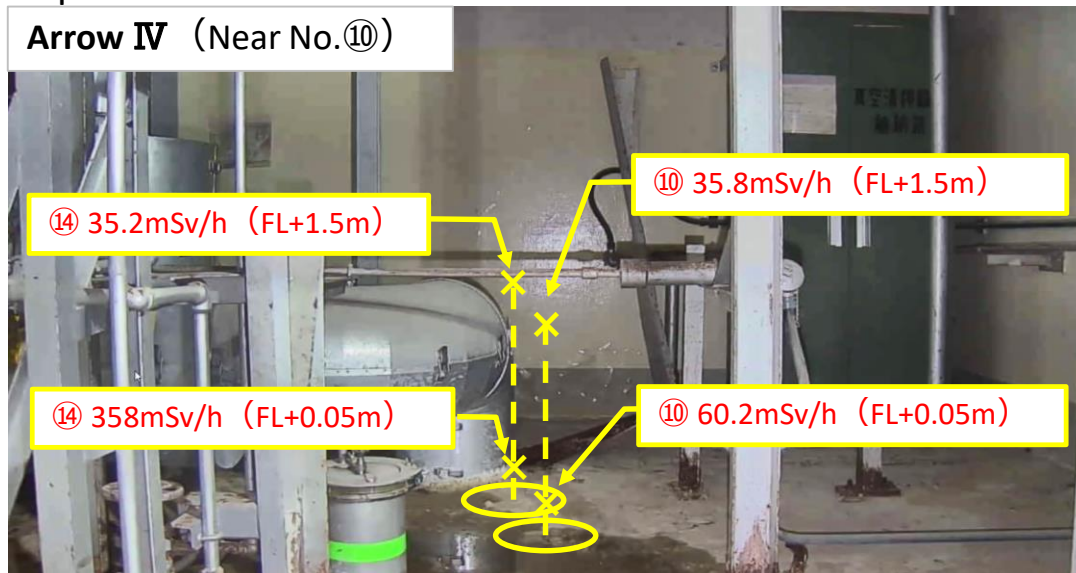
**Arrow IV** (Near No.⑩)

- A strong hotspot of max 1,120mSv/h was confirmed near the floor on the south side of the X-2 penetration.

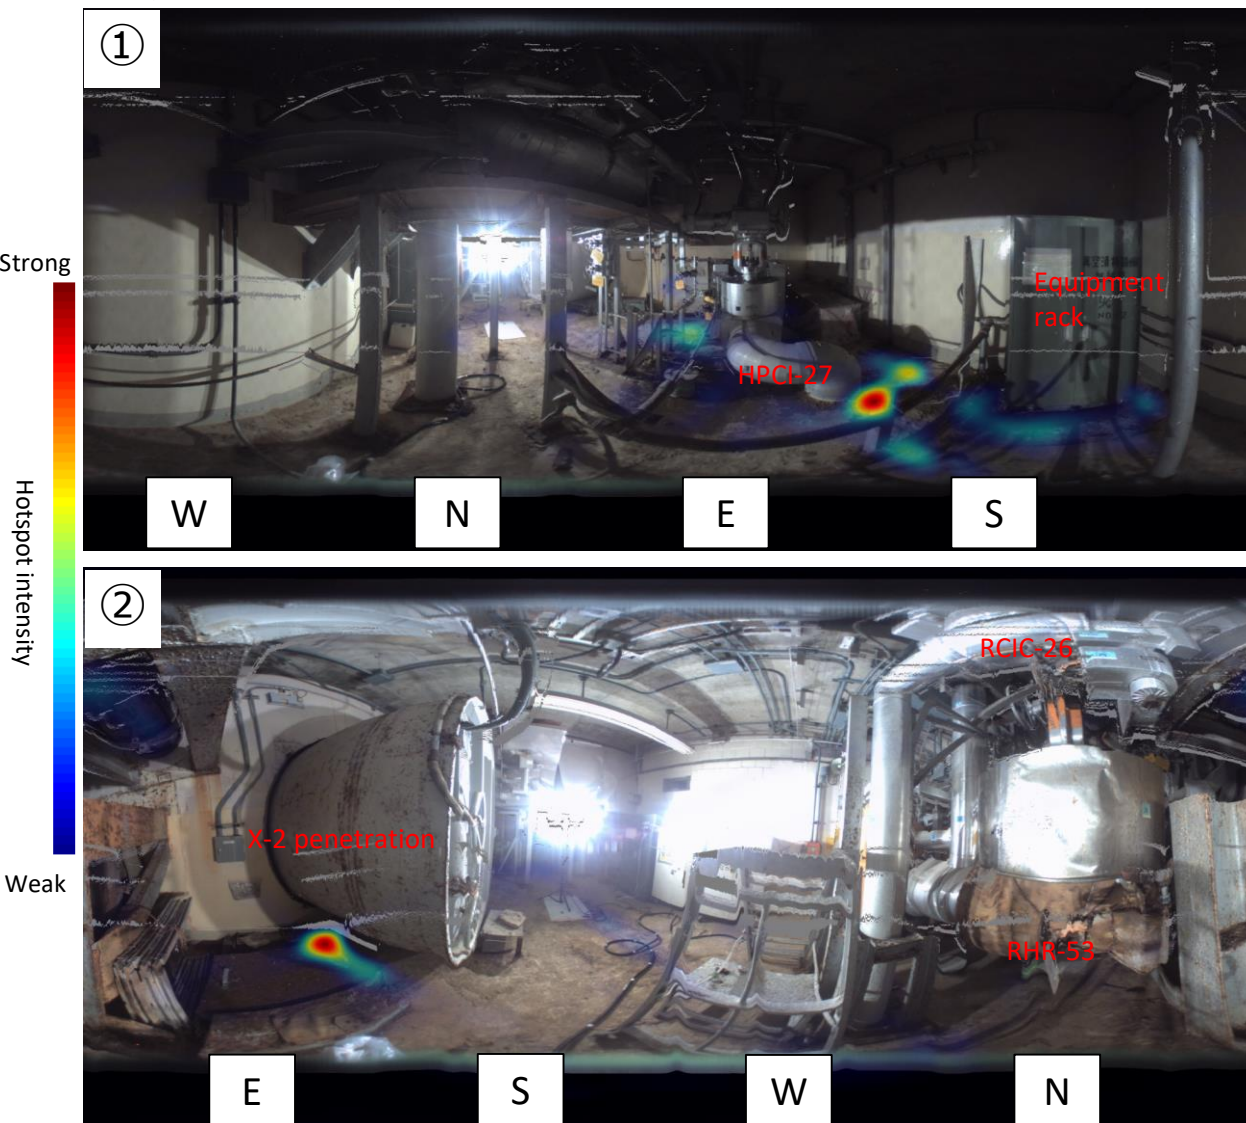
- Dose measurement results show hot spots to exist in the same locations where high doses were measured.
- Hotspots were mainly found on the floor.

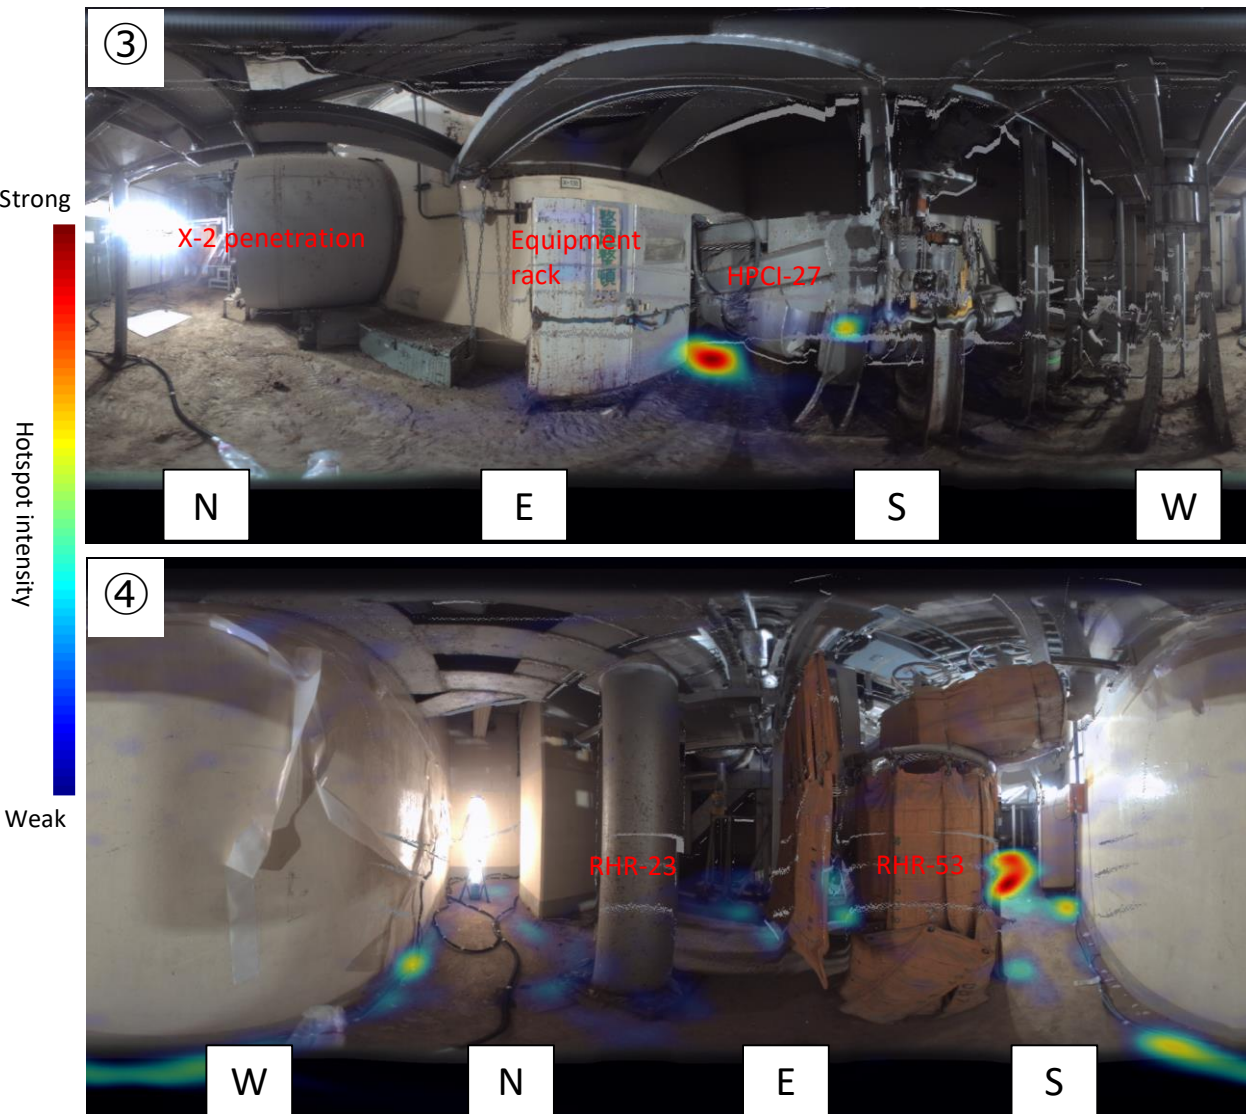
- Dose measurement results show hotspots to exist in the same locations where high doses were measured.
- G/I measurement ④ hotspot is assumed to contribute greatly to the doses from the back of the P/A room.

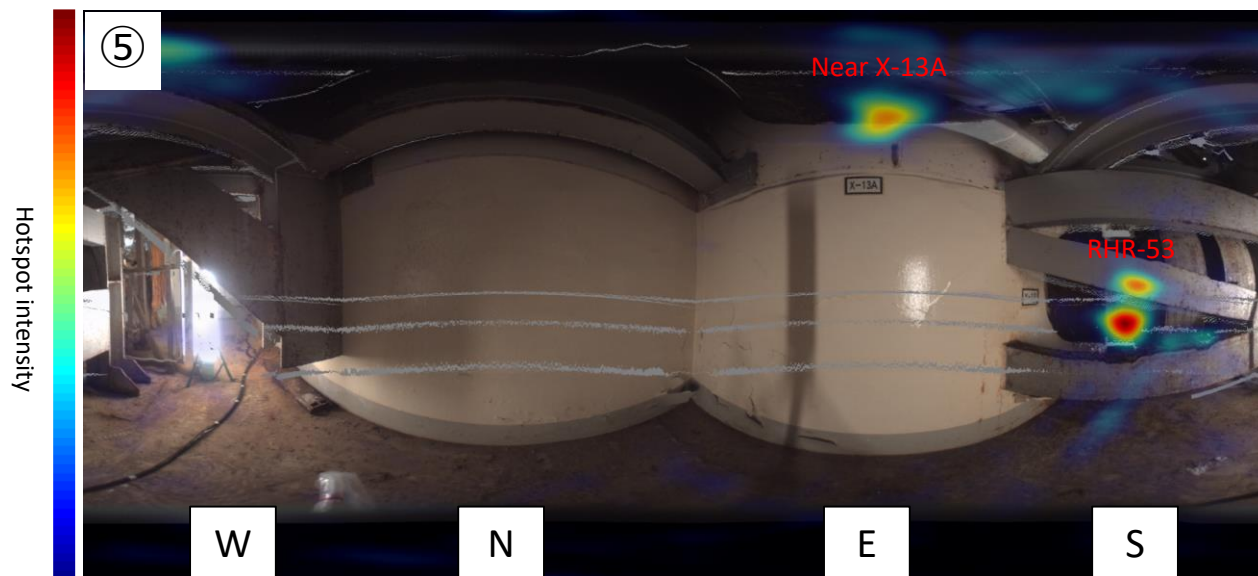
- G/I measurement ⑤ hotspot was found in the direction of the upper penetration (X-13A) and the RHR-53 piping.
- The hotspot in the direction of the RHR-53 piping is assumed to be a contribution from the hotspot found on the north side of the X-2 penetration behind the piping.

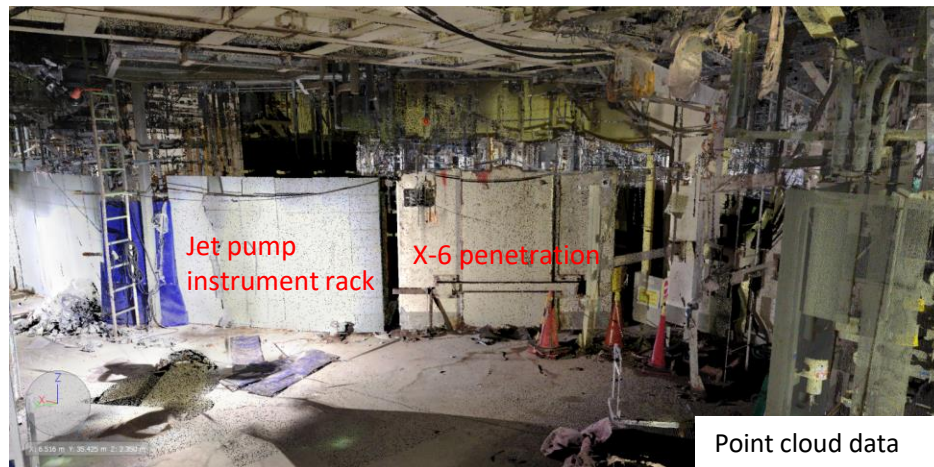
- 124mSv/h was measured near the surface of the Unit 3 X-6 penetration flange, but surface dose is low compared to the investigation results from the Unit 2 X-6 penetration flange surface taken in 2015. Furthermore, molten deposits found on the floor of Unit 2 were not found in Unit 3.
- Steel (concrete block filled) shielding walls have been installed around the X-6 penetration front chamber. Dose investigations and dose reduction measures inside the penetration will be deliberated after removing the shield walls.

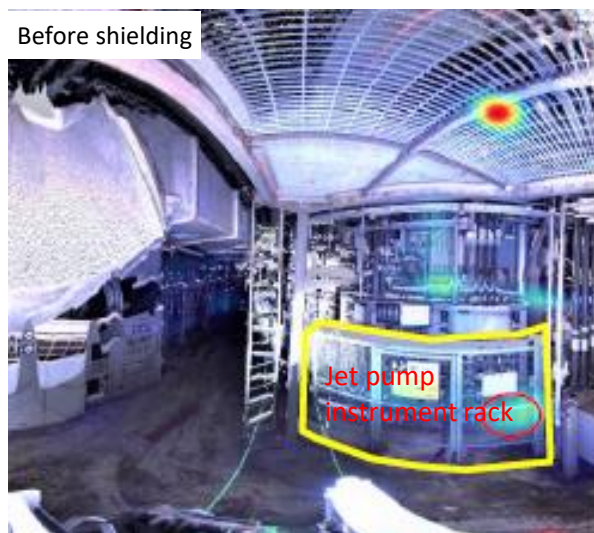
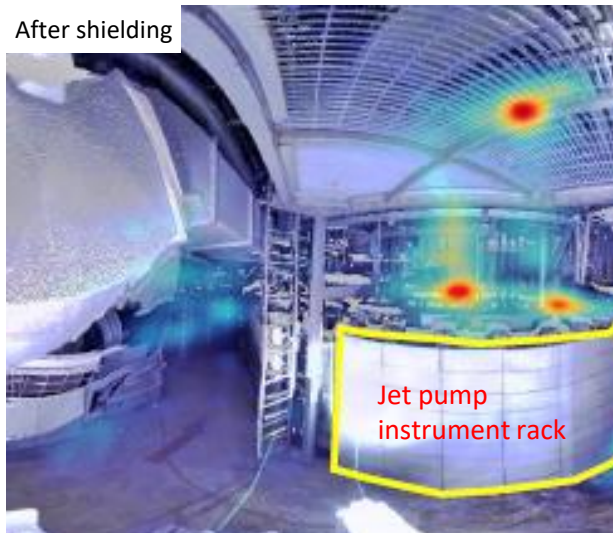
<G/I measurement >  
measurements taken  
between 2019-2020

- The HCU (north side) is greatly affected by doses from the jet pump instrument rack, and it is not clear whether there are any other radiation sources.
- The HCU and jet pump instrument rack, which are the main radiation sources, have been shielded, and the air dose rate around the X-6 penetration is between 3~5mSv/h, thereby prohibiting workers from remaining in the area for a long period of time.

- Dose reduction measures for the jet pump instrument rack closest to the X-6 penetration are being deliberated.
- Due to the difficulty of work implementation, it is expected that much time will be needed to reduce doses in the HCU.

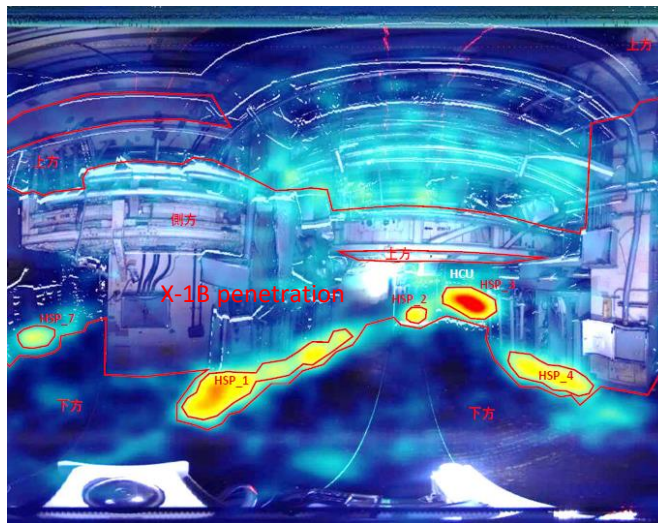
### <G/I Measurement>

- The dose contributions from the HCU (south side) and parts of the floor are substantial, and it is not clear whether there are any other radiation sources.
- The HCU, which is the main radiation sources, has been shielded, and the air dose rate around the X-1B penetration is between 5~8mSv/h, thereby prohibiting workers from remaining in the area for a long period of time.

- Since floor surface contamination is concentrated around the places where existing panels are installed and the edges of the walls, we are deliberating the removal of the existing panels.
- Due to the difficulty of work implementation, it is expected that much time will be needed to reduce doses in the HCU.

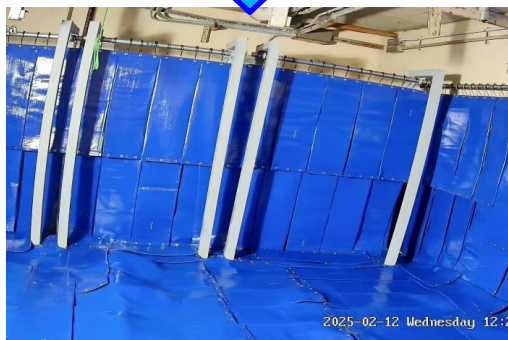
After dose reductions in the TIP room

⇒ Average dose of 1.2mSv/h has been achieved

- ① Equipment and sludge removal
- ② Wall decontamination through water spraying
- ③ Pressure wash stripping decontamination of floor surfaces
- ④ Decontamination through mechanical stripping
- ⑤ Shield installation

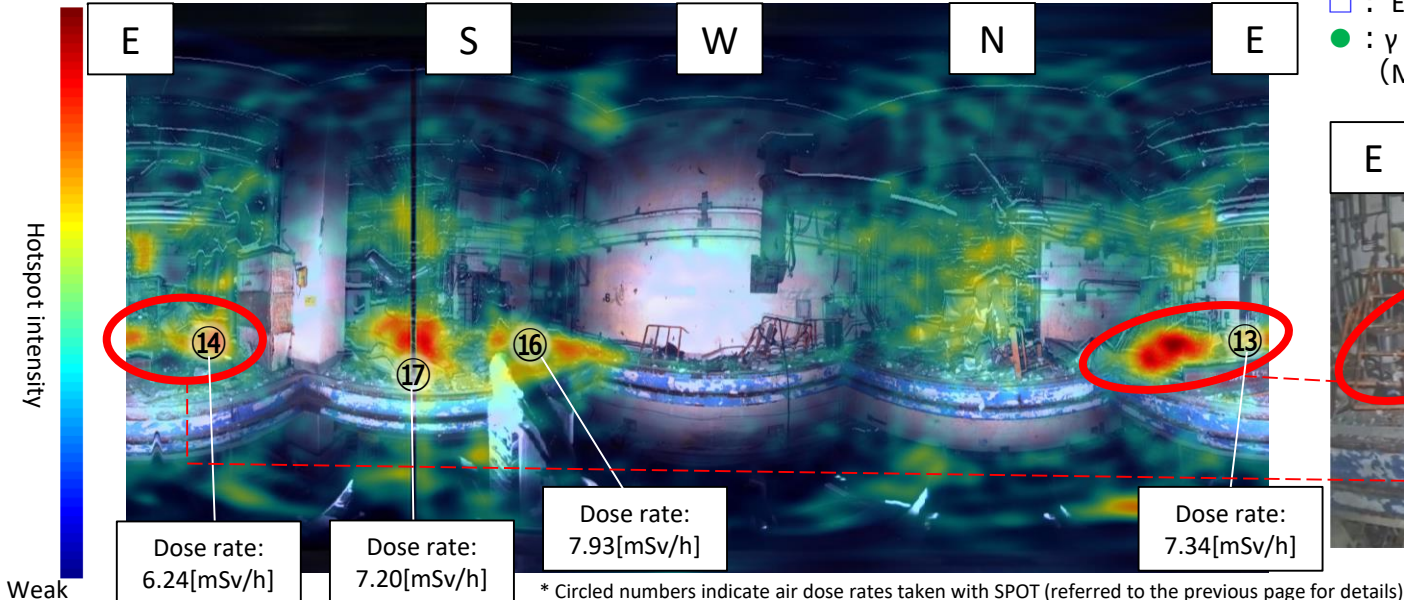
- $\gamma$  ray distribution by  $\gamma$  imager measurement.
- On the 2nd floor, it was confirmed that the hot spot was around the rubble near the floor.

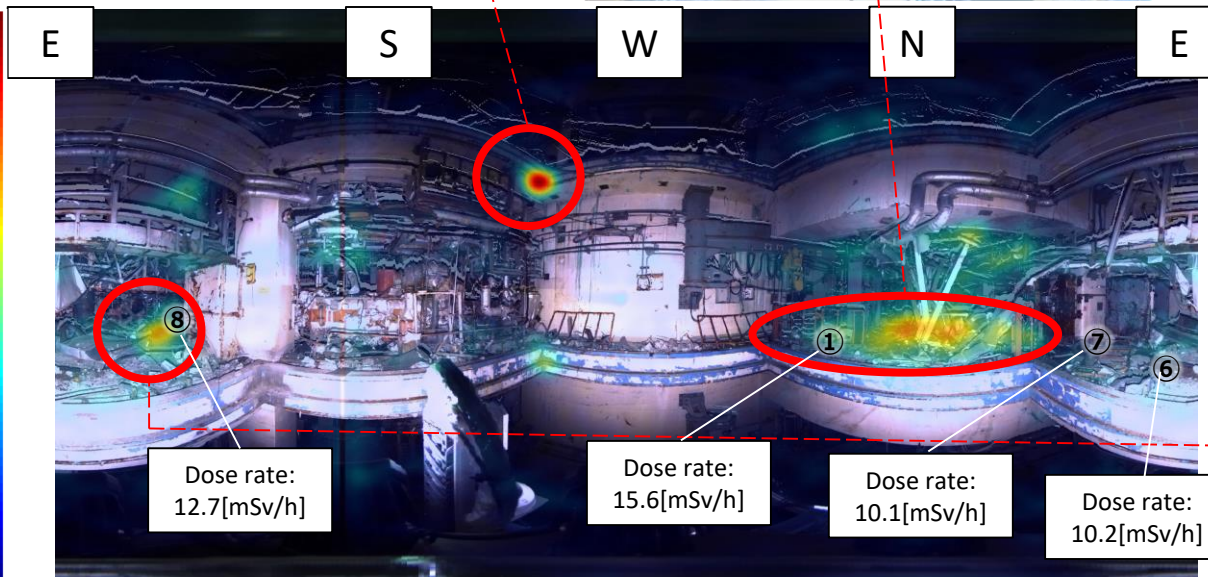
- $\gamma$  ray distribution by  $\gamma$  imager measurement
- On the 3rd floor, it was confirmed that the hot spot was around the edge of the top of the equipment hatch and around the rubble near the floor.

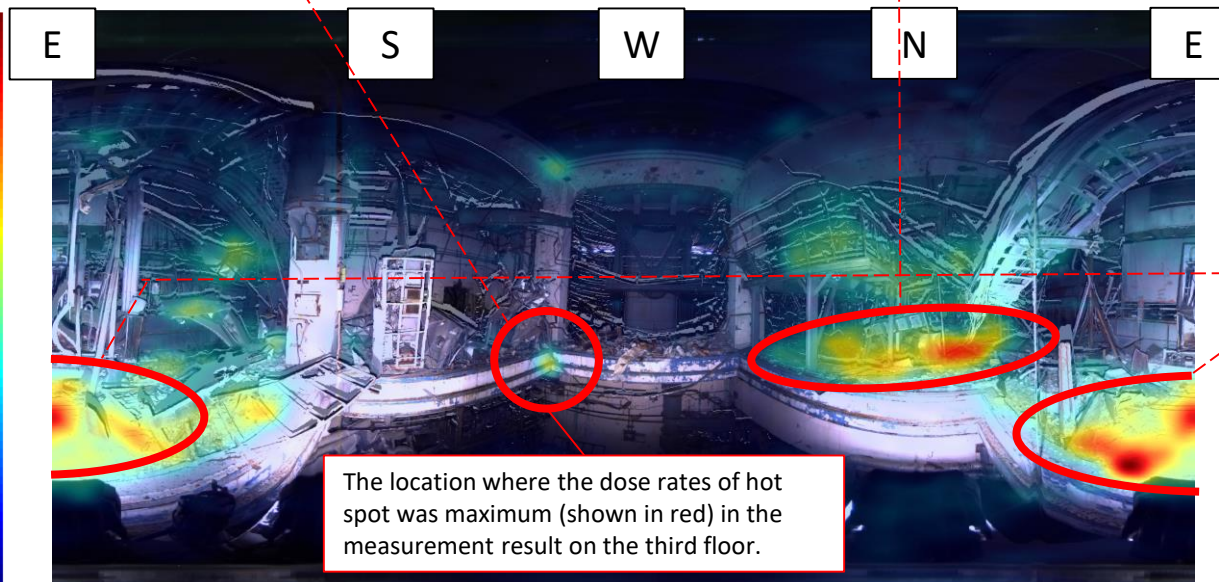
- Gamma ray distribution by gamma imager measurement
  - On the 4th floor, it was confirmed that the hot spot was around the rubble near the floor.
  - Since the intensity of the hot spot on the 3rd floor are relatively weak, it is assumed that dose rates on the 4th floor are higher
