Sampling Results Regarding the Water Leak at a Tank in the H4 area in Fukushima Daiichi Nuclear Power Station

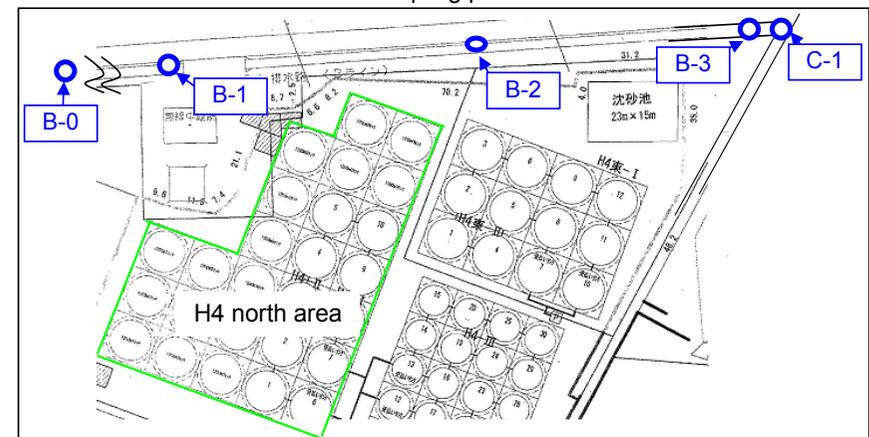
<Reference> Locations of each sampling point

Seawater of the south water outlet ^{Note 1} (near the exit of the side ditch) (T-2)	Confluence of drainage channel B and C ^{Note 2} (C-1)	Sampling points in drainage channel B			
			Upper stream of B-1 (B-0)	Location where high radiation was detected on August 21 (B-1)	Downstream of B-1 (B-2)	In front of the confluence of drainage channel C (B-3)
Date of Sampling	Aug 22, 2013	Aug 22, 2013	Aug 22, 2013	Aug 22, 2013	Aug 22, 2013	Aug 22, 2013
Time of sampling	11:45 AM	12:10 PM	4:10 PM	3:55 PM	3:40 PM	3:25 PM
Cs-134(Approx. 2 years)	2.3	ND(18)	35	58	ND(20)	ND(19)
Cs-137(Approx.30 years)	3.8	ND(27)	49	150	ND(27)	39
All β	ND(21)	200	71	330	250	580

Note 1: Approx. 330m south from Unit 1-4 water outlet (T-2)

Note 2: Same sampling point as side ditch in front of the core warehouse sampled on August 19 (announced on August 20) and August 20 (announced on August 21)
