Sampling Results Regarding the Water Leak at the Tanks in the H4 area and the B area in Fukushima Daiichi Nuclear Power Station (South Water Outlet, Drainage Channel)

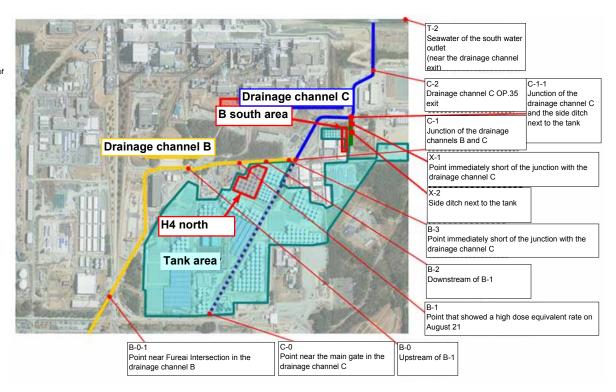
Seawater of the		Side ditch next to the tank (X-2)	Side ditch next to the tank (point immediately short of the junction with the drainage channel C) (X-1)	drainage channel C and the side ditch	Sampling points of the inside of drainage channel B					
		Junction of the drainage channels B and C Note 2 (C-1)				high dose equivalent	Downstream of B-1 (B-2)	Point immediately short of the junction with the drainage channel C (B-3)	Intersection in the	date in the drainage	Drainage channel C
Date of Sampling	Oct 19, 2013	Oct 19, 2013	Oct 19, 2013	Oct 19, 2013	Oct 19, 2013	Oct 19, 2013	Oct 19, 2013	Oct 19, 2013	Oct 19, 2013	Oct 19, 2013	Oct 19, 2013
Time of sampling	10:35 AM	11:52 AM	10:55 AM	11:00 AM	11:09 AM	* Note 4	* Note 4	11:55 AM Note 4	11:35 AM	11:42 AM	10:50 AM
Cs-134(Approx. 2 years)	ND(1.1)	ND(18)	42	98	ND(18)	* Note 4	* Note 4	100 Note 4	ND(20)	ND(19)	ND(19)
Cs-137(Approx.30 years)	1.7	ND(26)	88	230	ND(27)	* Note 4	* Note 4	260 Note 4	ND(26)	ND(26)	ND(26)

ΑΙΙ β	ND(21)	83	800	1,600	110	* Note 4	* Note 4	12,000 Note 4	ND(14)	ND(14)	150

Note 1: Approx. 330m south from Unit 1-4 water outlet (T-2)

Note 2: Same sampling point as side ditch in front of the core warehouse sampled on August 19 (announced on August 20) and August 20 (announced on August 21)

- Note 3: Water inflow location of drainage channel to the tank area
- Note 4: Collection of accumulated water and cleaning of the ditch are ongoing.
