Sampling Results Regarding the Water Leak at the Tanks in the H4 area and the B area in Fukushima Daiichi Nuclear Power Station (South Water Outlet, Drainage Channel)

<Reference>
November 1, 2013
Tokyo Electric Power Company

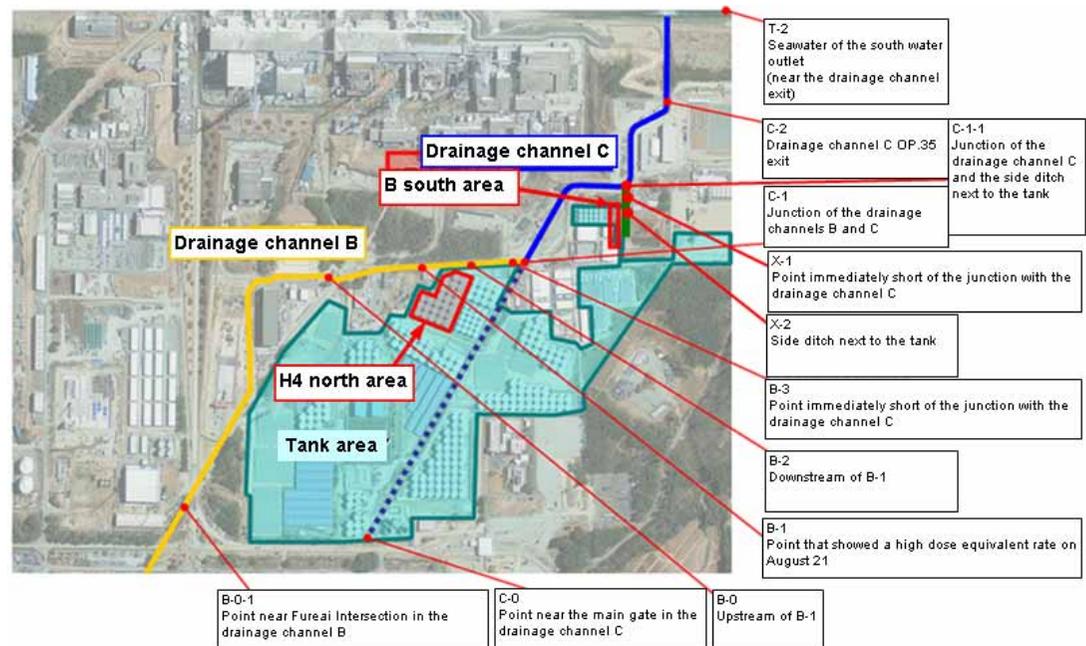
Seawater of the south water outlet ^{Note 1} (near the drainage channel exit) *1 (T-2)	Junction of the drainage channels B and C ^{Note 2} (C-1)	Side ditch next to the tank (X-2)	Side ditch next to the tank (point immediately short of the junction with the drainage channel C) (X-1)	Junction of the drainage channel C and the side ditch next to the tank (C-1-1)	Sampling points of the inside of drainage channel B			Point near Fureai Intersection in the drainage channel B ^{Note 3} (B-0-1)	Point near the main gate in the drainage channel C ^{Note 3} (C-0)	Drainage channel C OP.35 exit (C-2)
						Point that showed a high dose equivalent rate on August 21 (B-1)	Downstream of B-1 (B-2)	Point immediately short of the junction with the drainage channel C (B-3)			
Date of Sampling	Oct 31, 2013	Oct 31, 2013	Oct 31, 2013	Oct 31, 2013	Oct 31, 2013	Oct 31, 2013	Oct 31, 2013	Oct 31, 2013	Oct 31, 2013	Oct 31, 2013	Oct 31, 2013

Junction of the drainage channel C and the side ditch next to the tank (C-1-1)	Sampling points of the inside of drainage channel B		
		Point that showed a high dose equivalent rate on August 21 (B-1)	Downstream of B-1 (B-2)	Point immediately short of the junction with the drainage channel C (B-3)
Cs-134(Approx. 2 years)	25 [10/22]	140 [9/13]	22 [10/2]	300 [9/15]
Cs-137(Approx.30 years)	56 [10/22]	290 [9/13]	43 [10/2]	670 [9/15]
All β	2,900 [10/24]	15,000 [10/23]	140,000 [10/23]	110,000 [10/24]

Point near Fureai Intersection in the drainage channel B ^{Note 3} (B-0-1)	Point near the main gate in the drainage channel C ^{Note 3} (C-0)	Drainage channel C OP.35 exit (C-2)
Cs-134(Approx. 2 years)	70 [9/4]	ND	45 [9/26]
Cs-137(Approx.30 years)	190 [9/4]	39 [9/15, 9/26]	130 [9/26]
All β	380 [9/2]	75 [9/26]	2,500 [10/24]
