Work Performed Today (April 18) in Response to the Leakage from the Underground Reservoirs Tokyo Electric Power Company

Cause Investigation of the Leakage

Measures to Prevent the Expansion of Contaminated Water Leakage from the Underground Reservoirs

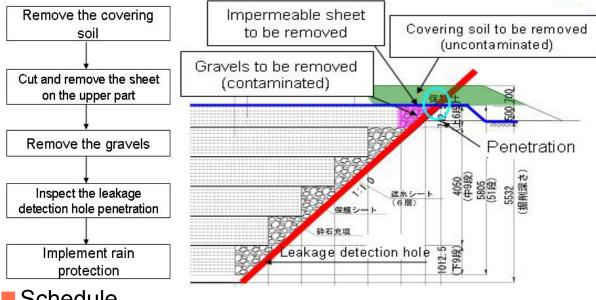
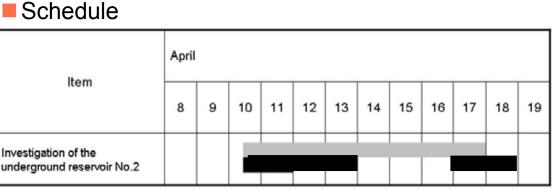
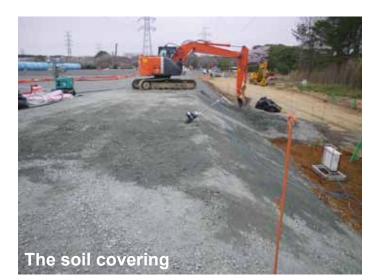
Photos of the work performed today

- Outline
 - Visually inspect the conditions of the impermeable sheet and the leakage detection hole in the leakage detection hole penetration in the northeast side of the underground reservoir No. 2 where the leakage is suspected.

The soil covering of the leakage detection hole penetration
Restoration work will being continued tomorrow.
