The seawall area at Fukushima Daiichi NPS

<Reference>
November 27, 2013
Tokyo Electric Power Company

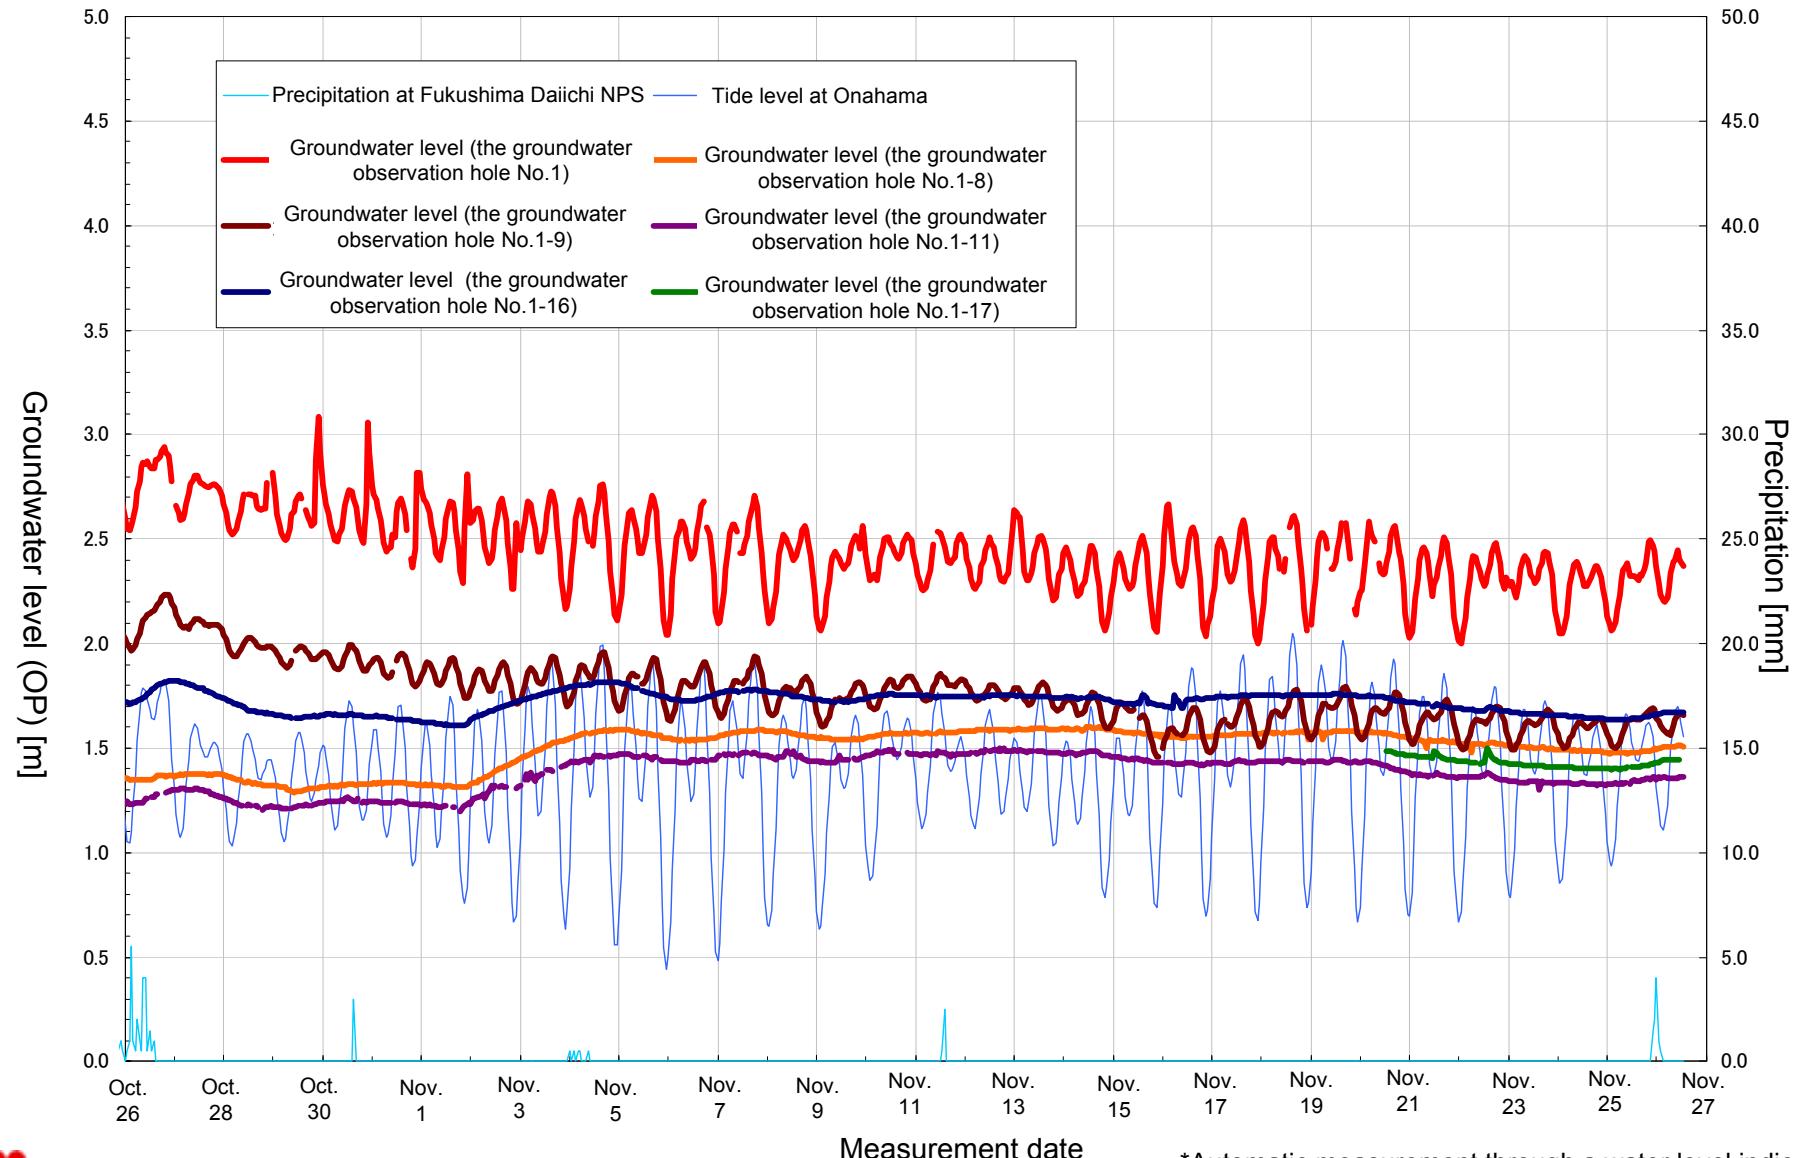
Movement in groundwater (Between Unit 1 and 2: From Oct. 26 to Nov. 26)

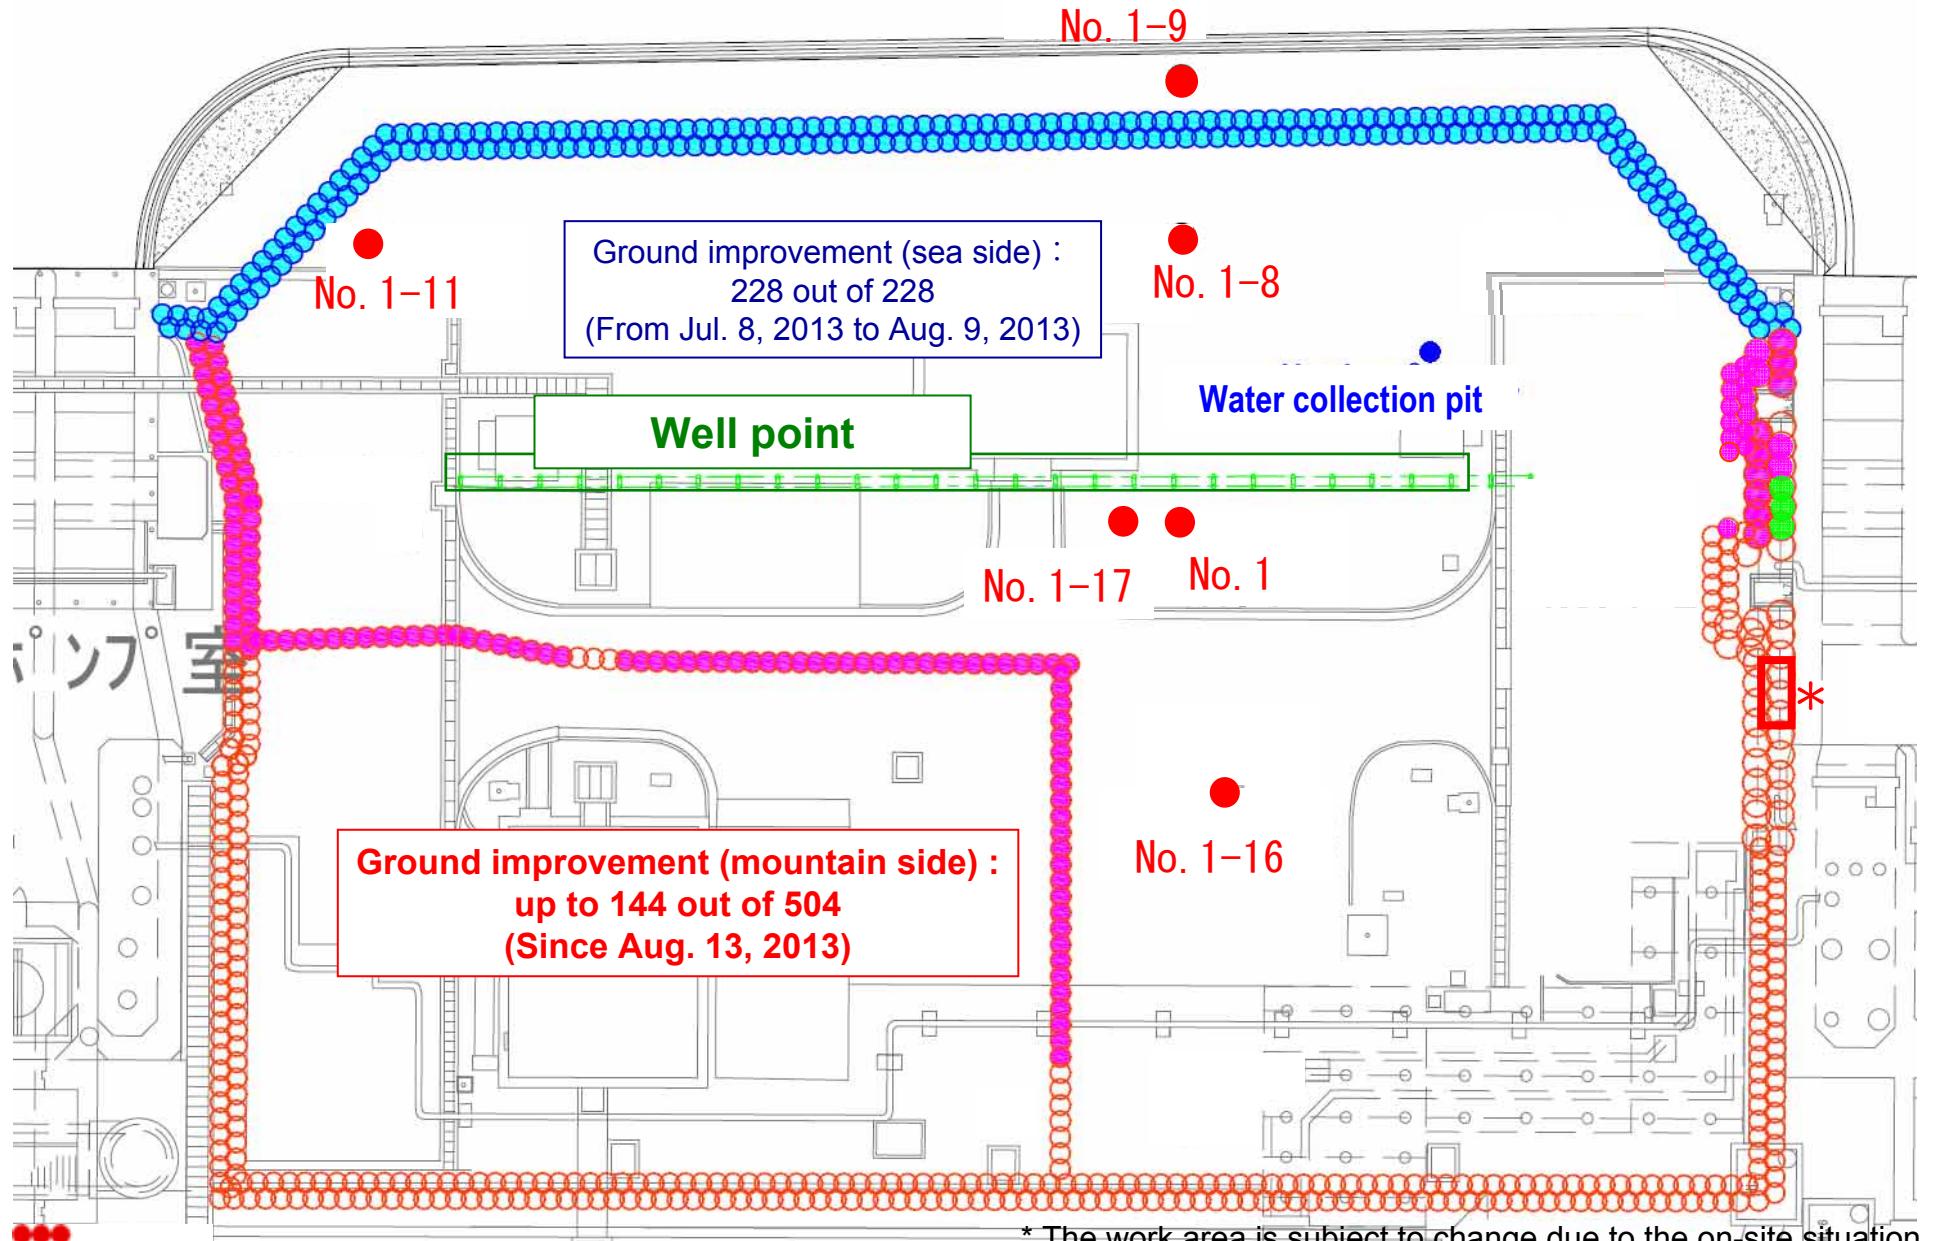
Progress in the ground improvement work between Unit 1 and 2 (As of in the morning on Nov. 27)

*Chemical injection was implemented NOT in this range, but in the range of green color. We would like to correct it and apologize for the misinformation. (Revised on December 12, 2013)

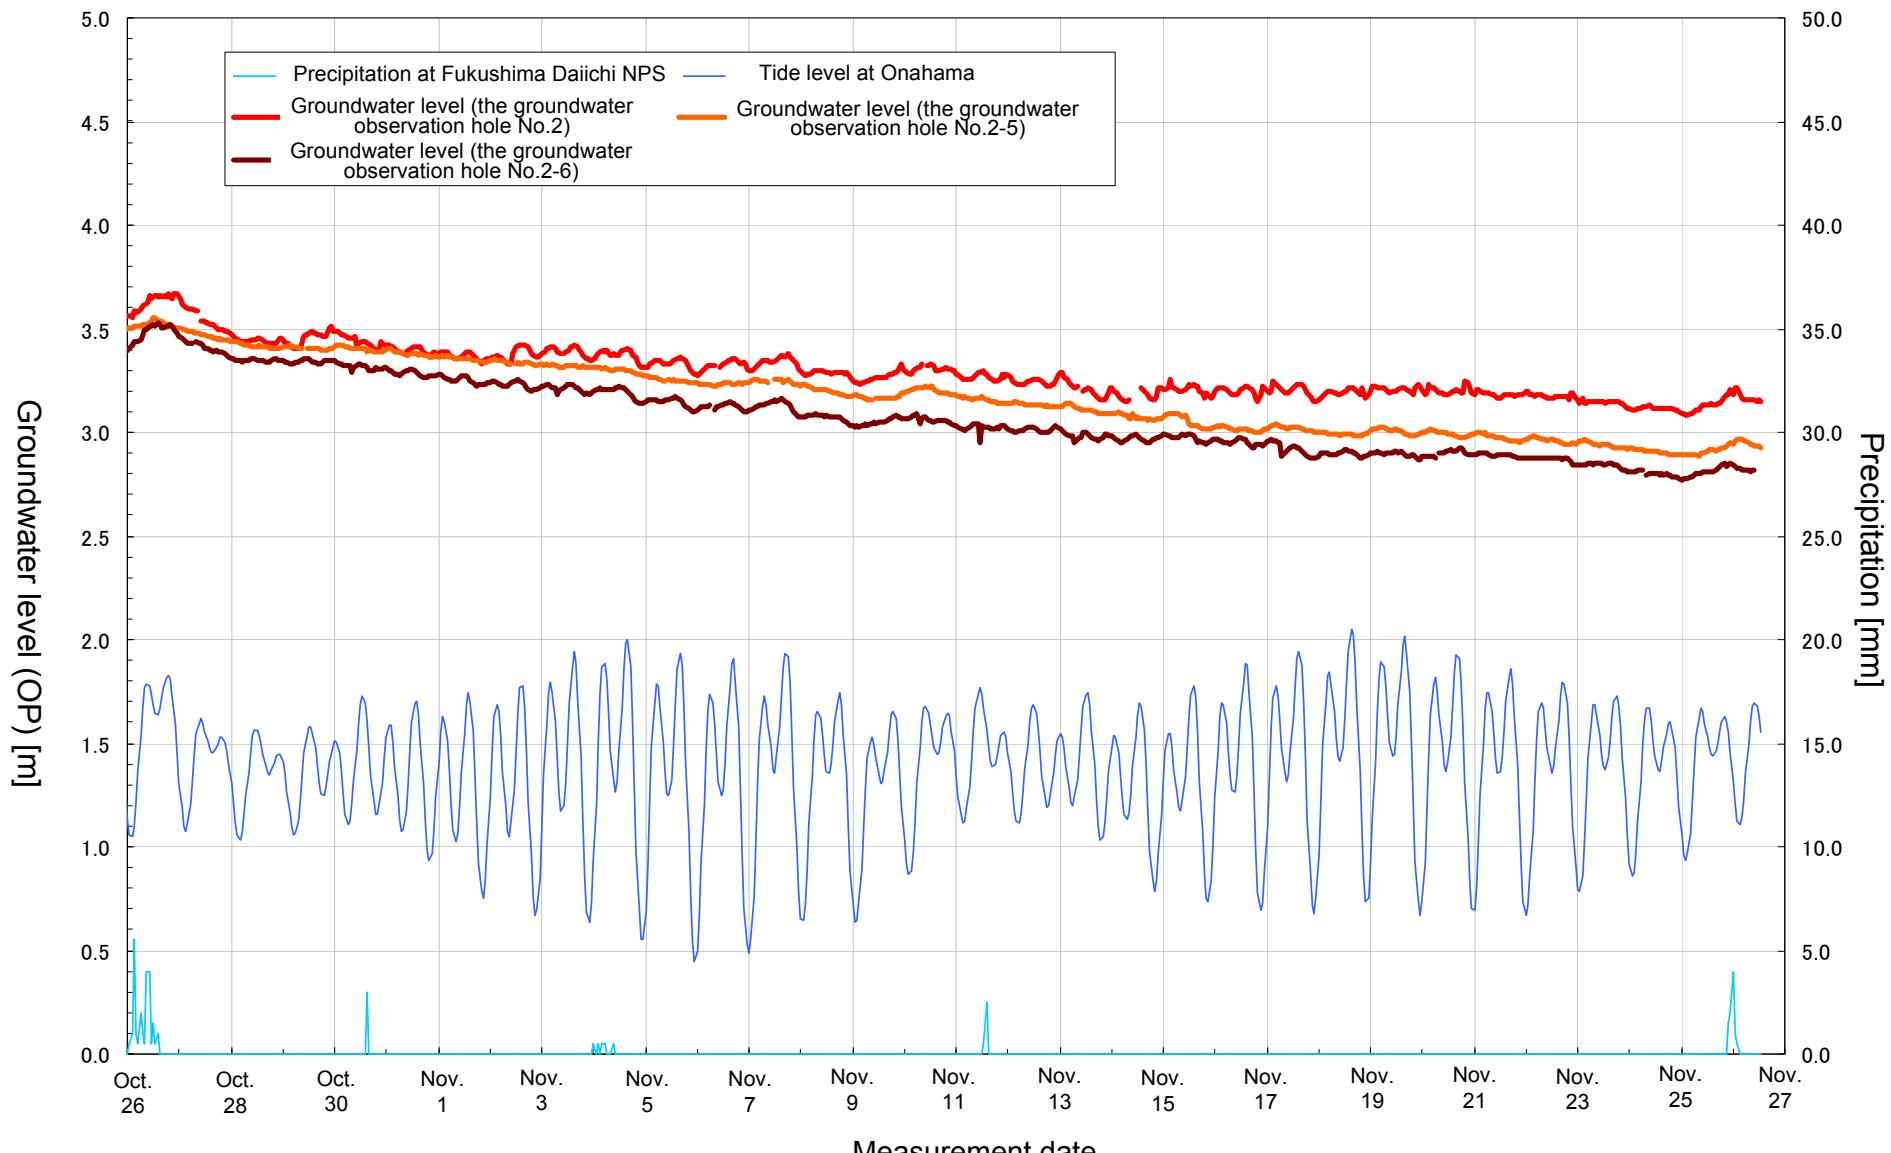
Movement in groundwater (Between Unit 2 and 3: From Oct. 26 to Nov. 26)

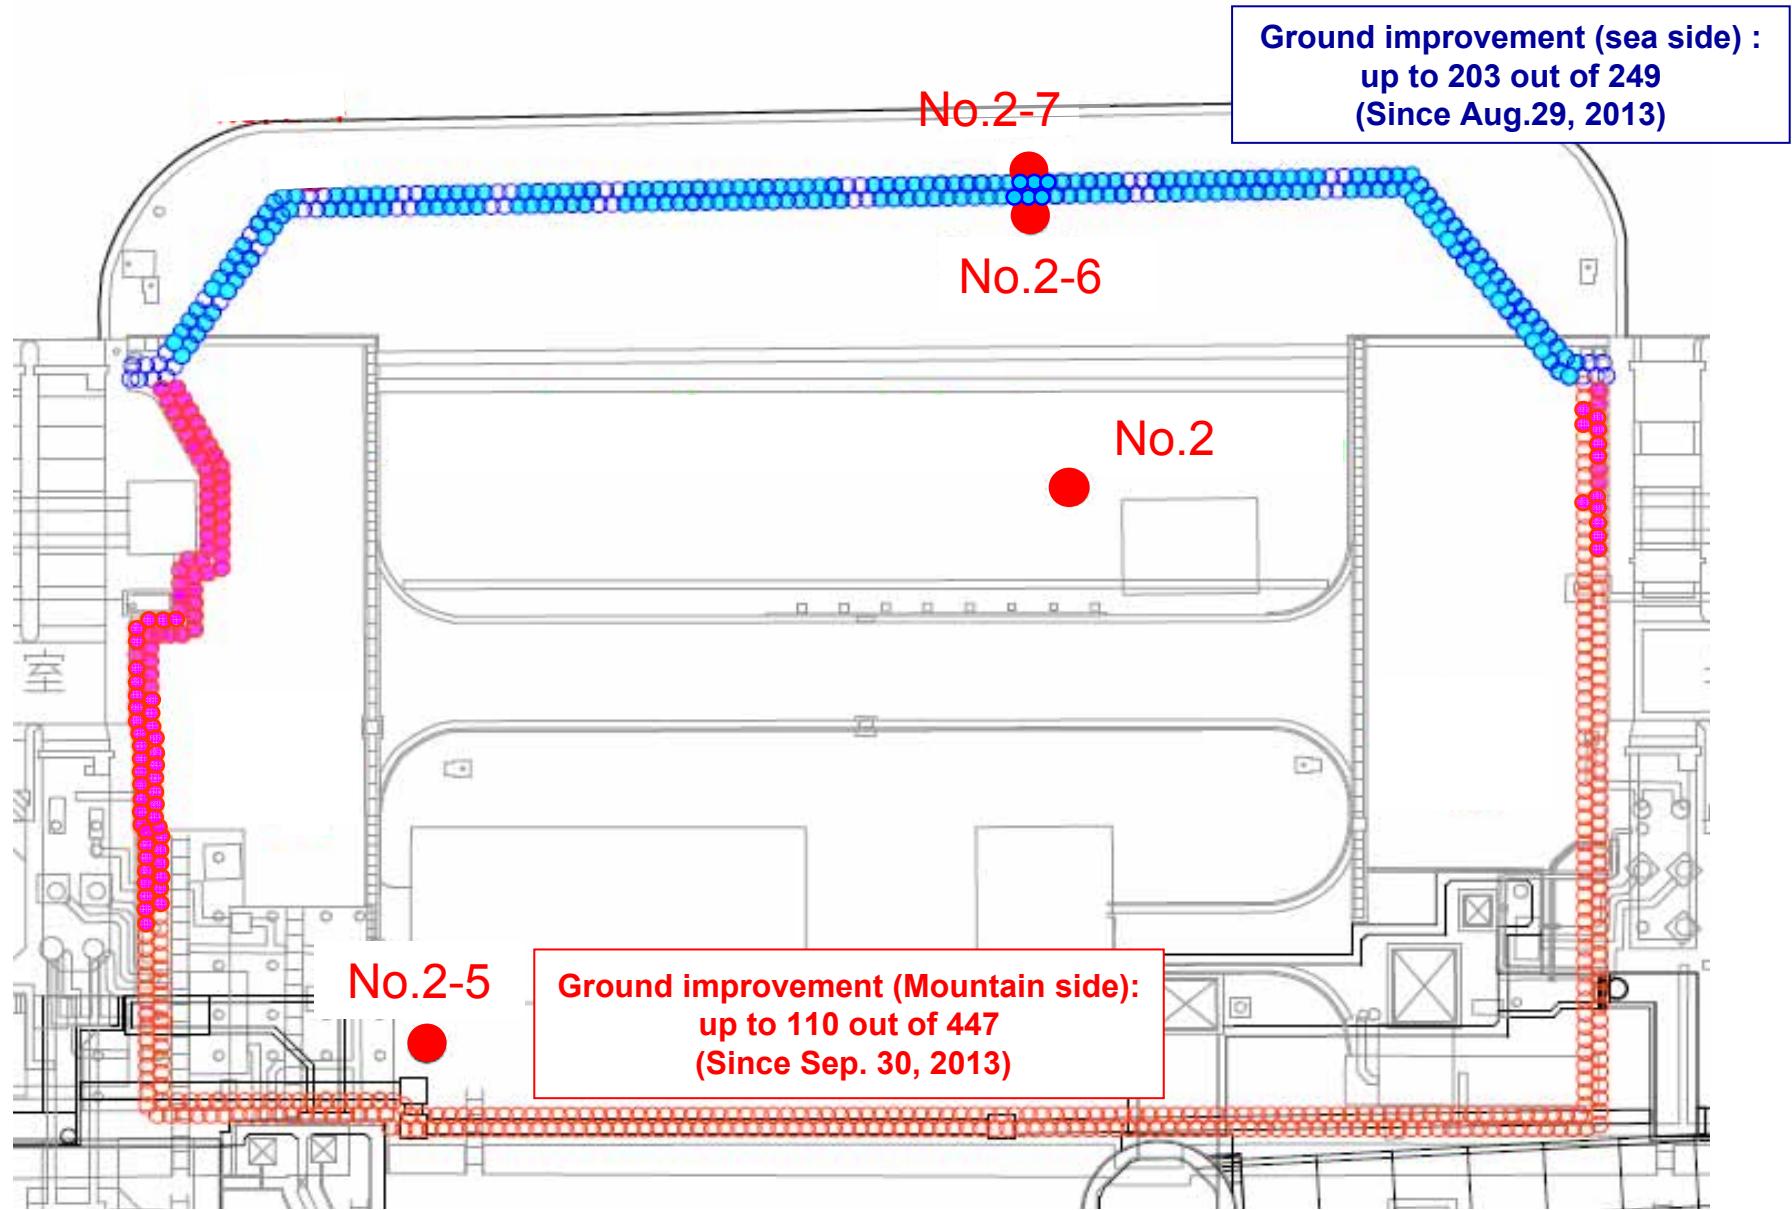
Progress in the ground improvement work between Unit 2 and 3 (As of in the morning on Nov. 27)

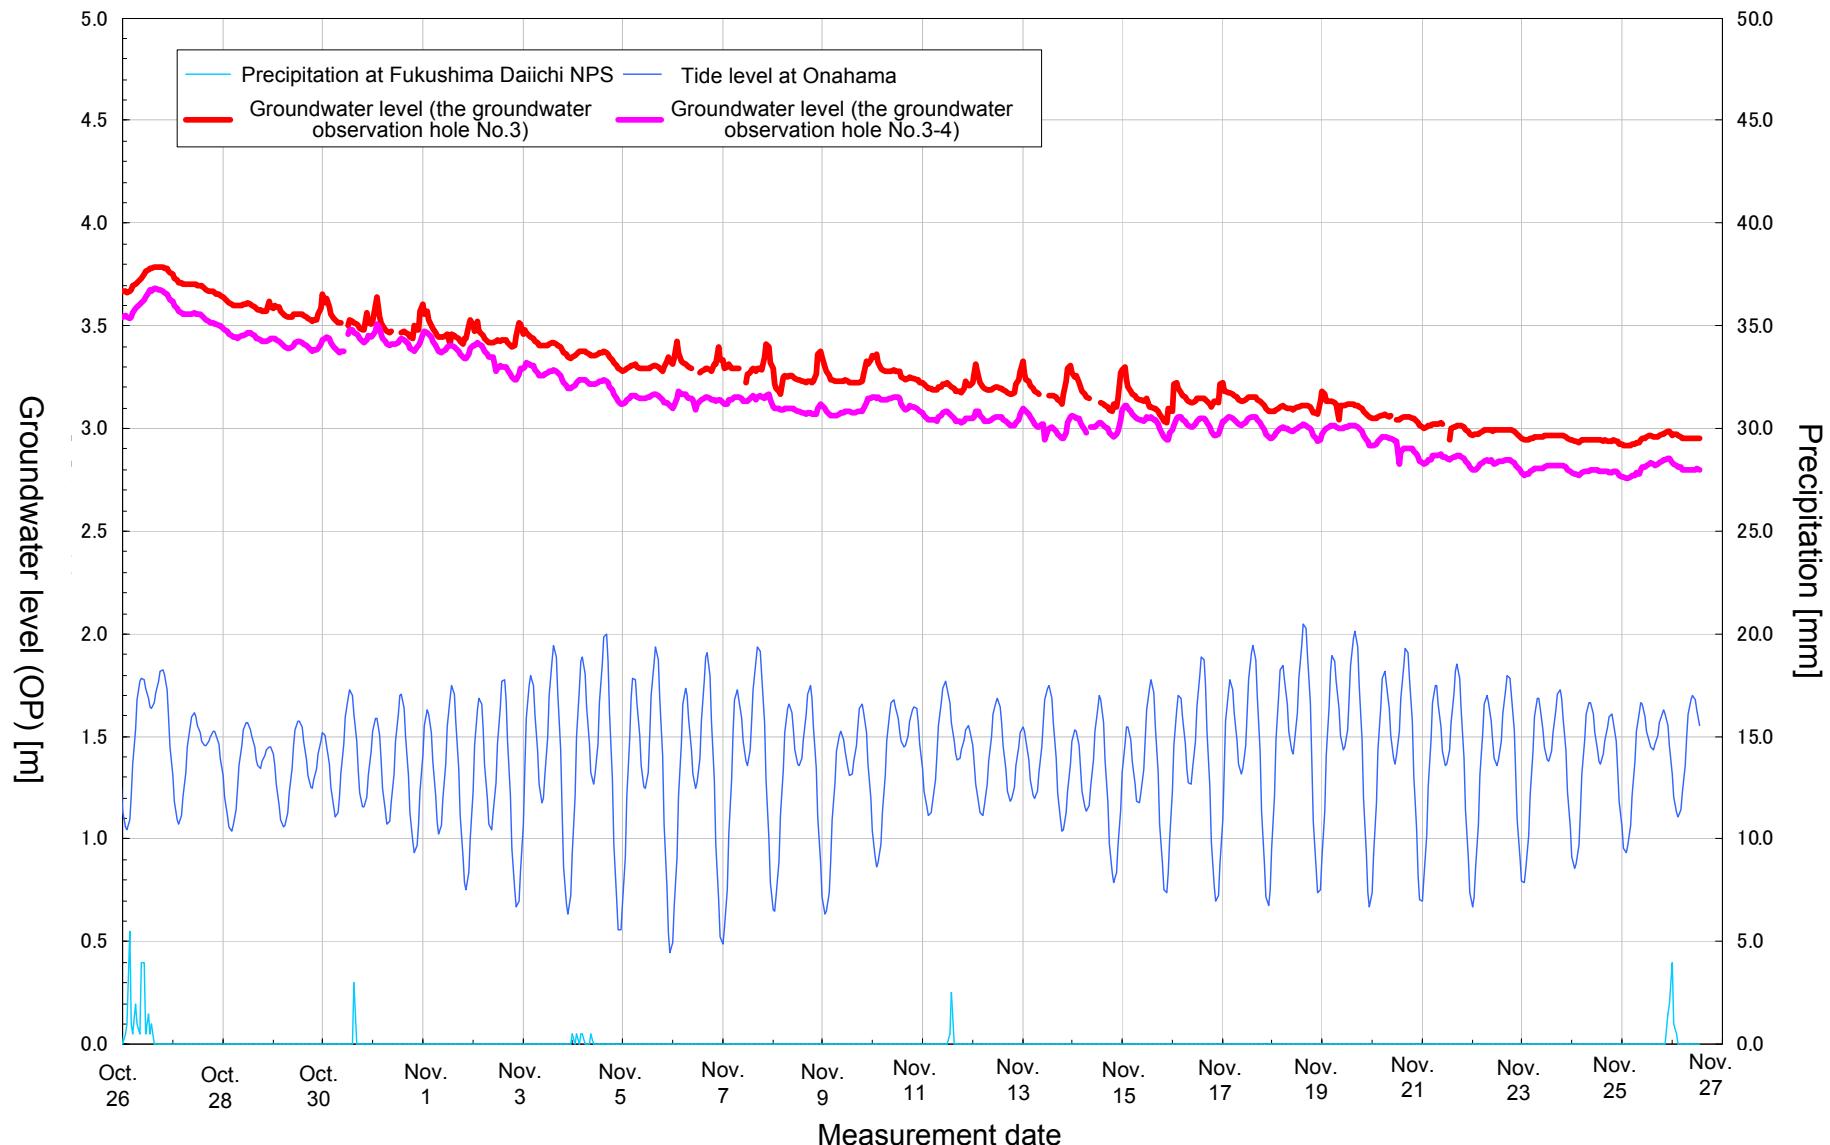
Movement in groundwater (Between Unit 3 and 4: From Oct. 26 to Nov. 26)

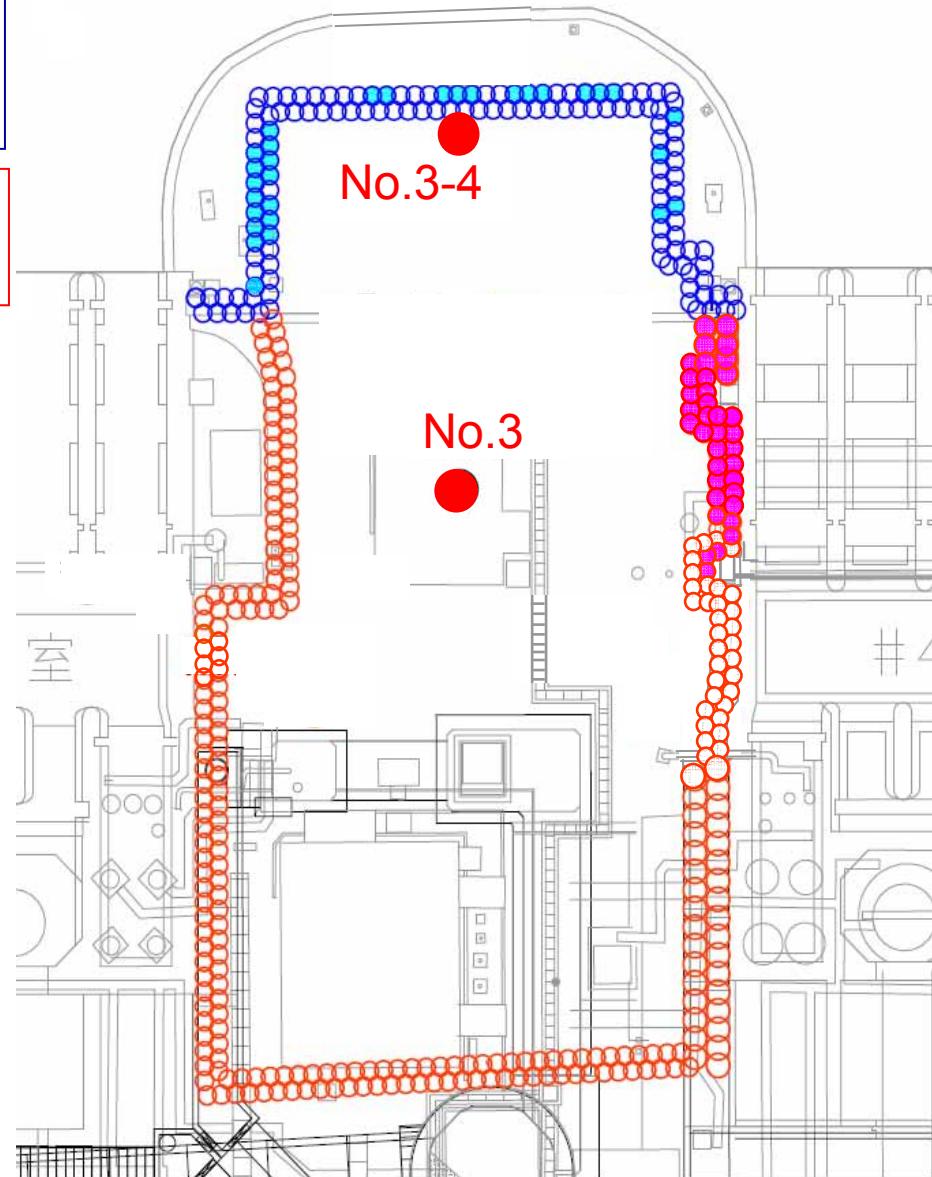
Progress in the ground improvement work between Unit 3 and 4 (As of in the morning on Nov. 27)

Ground improvement (sea side):
up to 30 out of 132
(Since Aug. 23, 2013)

Ground improvement (mountain side):
up to 36 out of 273
(Since Oct. 19, 2013)

* The work area is subject to change due to the on-site situation.
