**Fukushima Daiichi Nuclear Power Station
Unit 1 Reactor Building Torus Room
Investigation Result (June 26, 2012)
(Pipe Penetration Area on the First Floor of R/B)**

**June 27, 2012
Tokyo Electric Power Company**

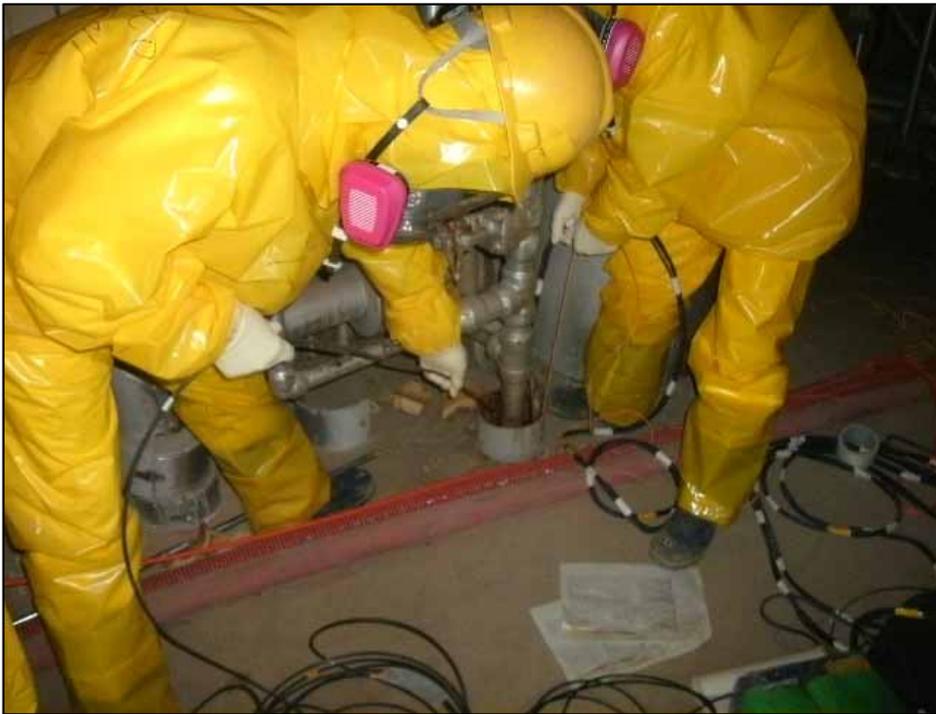
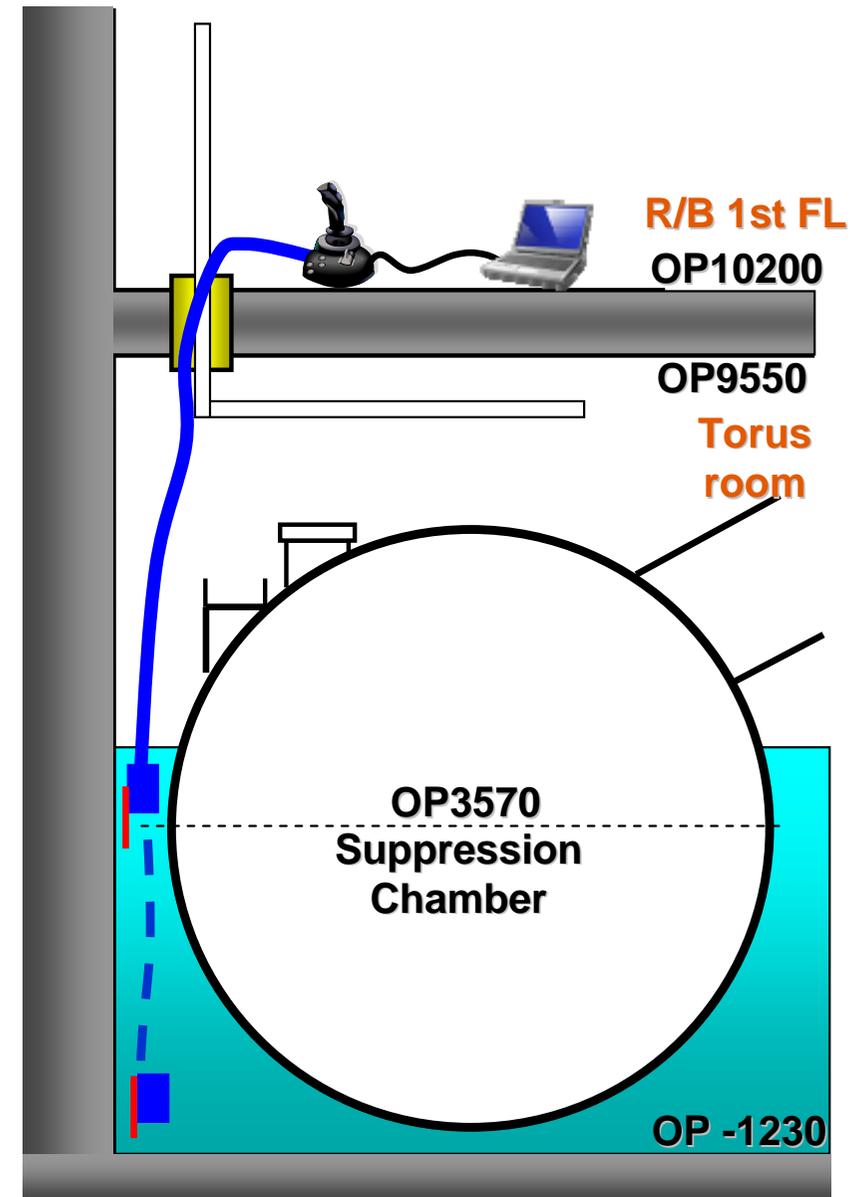
1. Investigation Method

CCD camera, thermometer and dosimeter were inserted from the pipe penetration opening

* The gap between the pipe and the floor penetration sleeve: Approx. 50mm

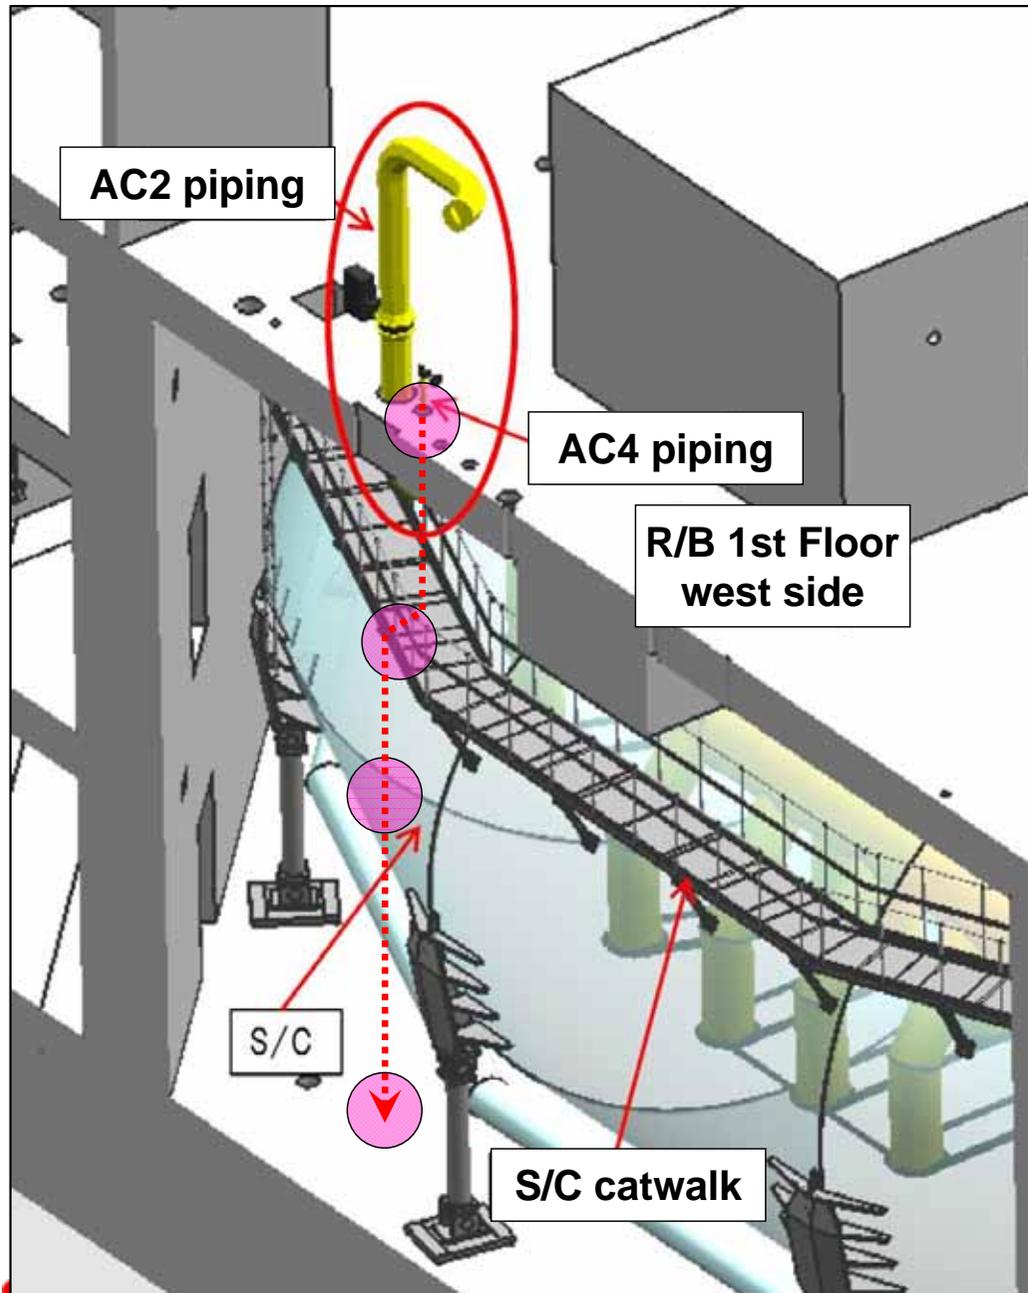
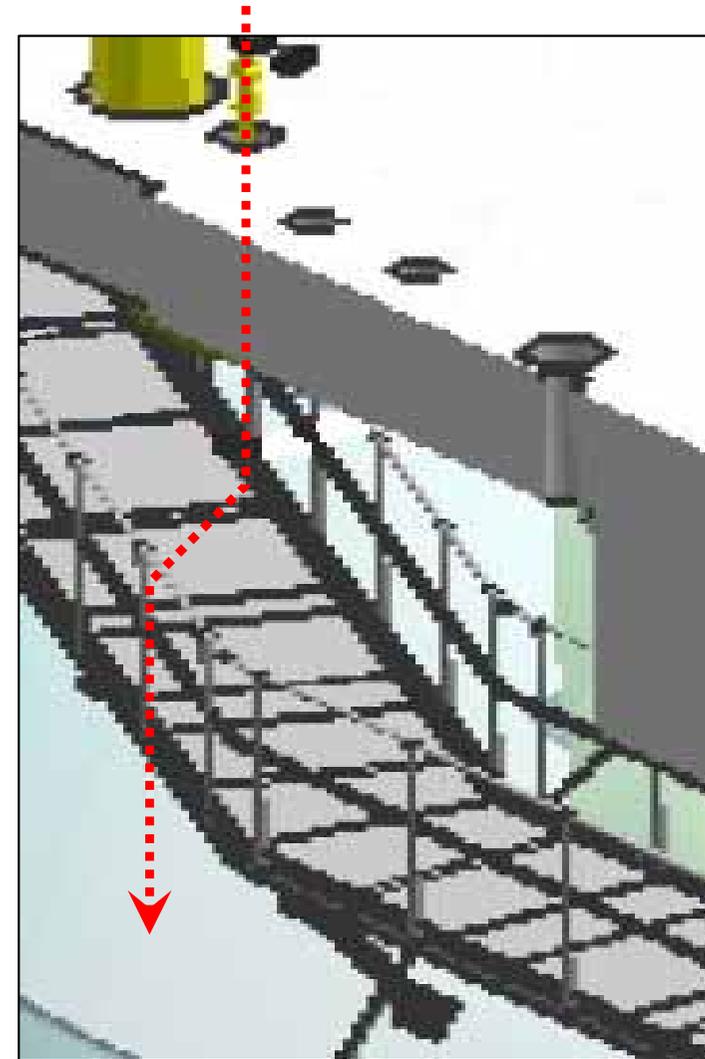
2. CCD Camera Insertion Route

The camera needs to be inserted so that it avoids the catwalk handrail. (It interferes with the handrail if it's inserted straight down.)

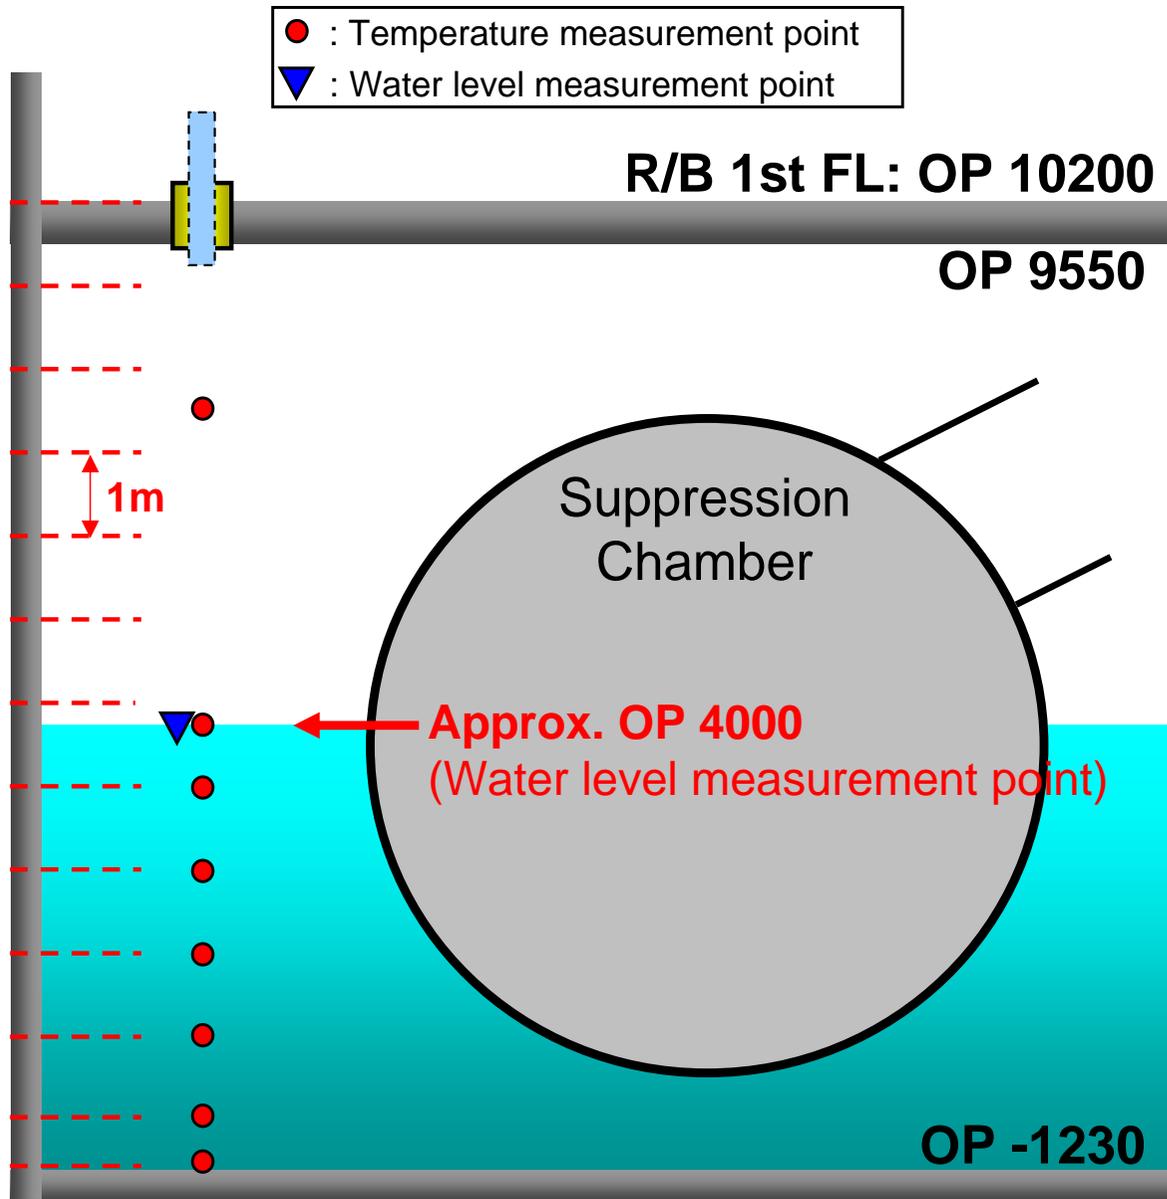
(Reference) Water Level/Temperature Measurement Result

| | OP.7700 | 28.8 |
| | OP.4000 | 37.2 |
| | OP.3200 | 34.0 |
| | OP.2200 | 34.0 |
| | OP.1200 | 34.8 |
| | OP. 200 | 34.1 |
| | OP. -800 | 32.4 |
| | OP.-1230 | 32.0 |

*R/B ambient temperature: **Approx. 22**

*Water level at the triangle corner of the mid basement: **OP.4617**

*Error must be taken into account when calculating OP as it is calculated based on the length of cable inserted.

1. Accumulated water level

Approx. OP. 4,000

2. Accumulated water temperature

Approx. 32-37 while the Torus Room temperature was approx. 28.8 .

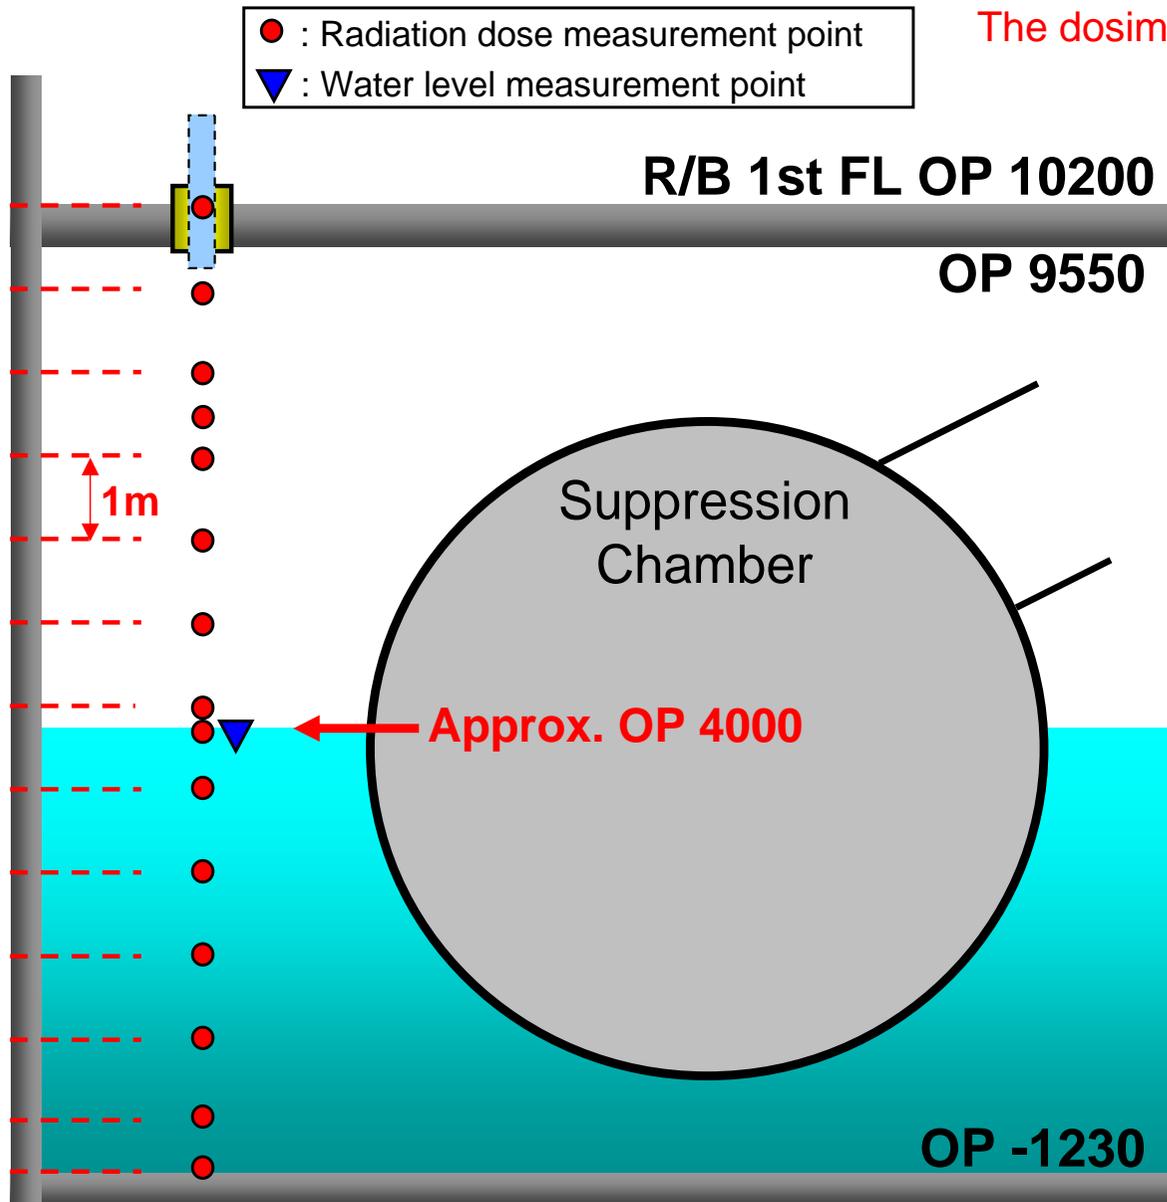
(Reference) Radiation Dose Measurement Result

The dosimeter seems to have failed during the measurement.

| | OP.10200 | 19.5mSv/h |
| | OP.9200 | 625mSv/h |
| | OP.8200 | 1290mSv/h |
| | OP.7700 | 1440mSv/h |
| | OP.7200 | 1410mSv/h |
| | OP.6200 | 2030mSv/h |
| | OP.5200 | 4520mSv/h |
| | OP.4200 | 10300mSv/h |
| | OP.4000 | 8190mSv/h |
| | OP.3200 | 3550mSv/h |
| | OP.2200 | 2770mSv/h |
| | OP.1200 | Indicated order values of $10^8 - 10^9$ |

*Error must be taken into account when calculating OP as it is calculated based on the length of cable inserted.

3. Radiation dose of the accumulated water

The radiation dose measured in the Torus Room was 19.5 - 10,300mSv/h. However, the dosimeter seems to have failed as it indicated order values of 10^8 - 10^9 mSv/h during the measurement and the values did not change until the dosimeter was brought back up.

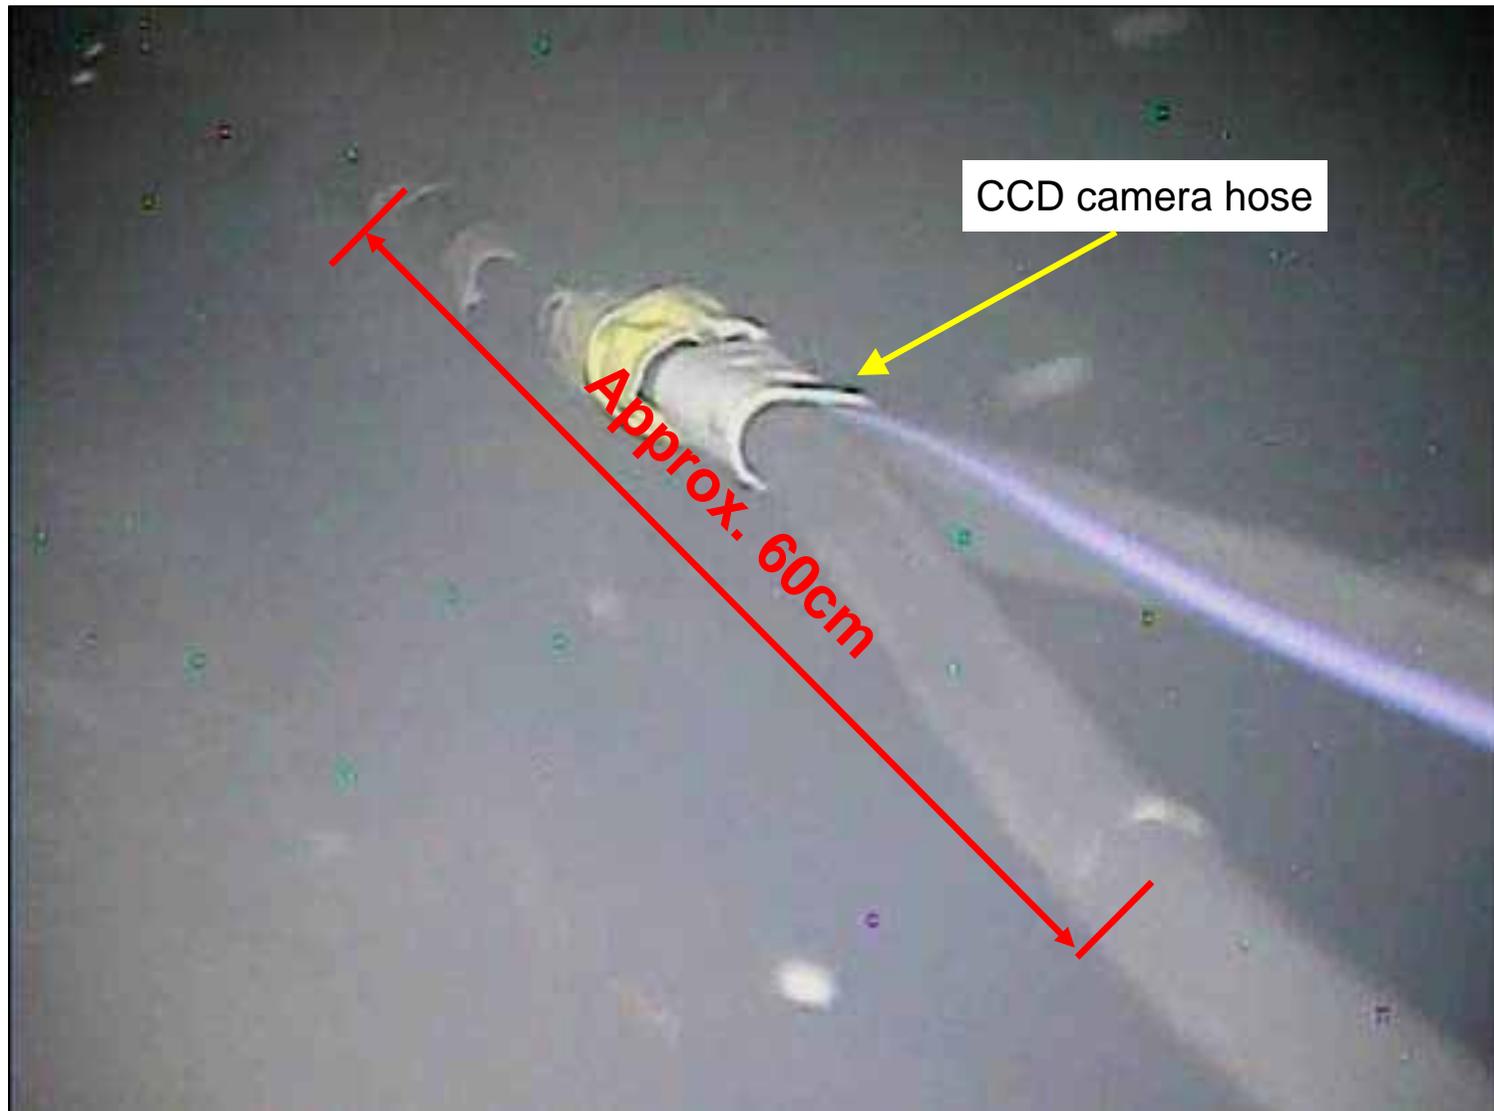
(Reference) Transparency of the Accumulated Water

Transparency confirmed at (at least) 60cm down from the surface

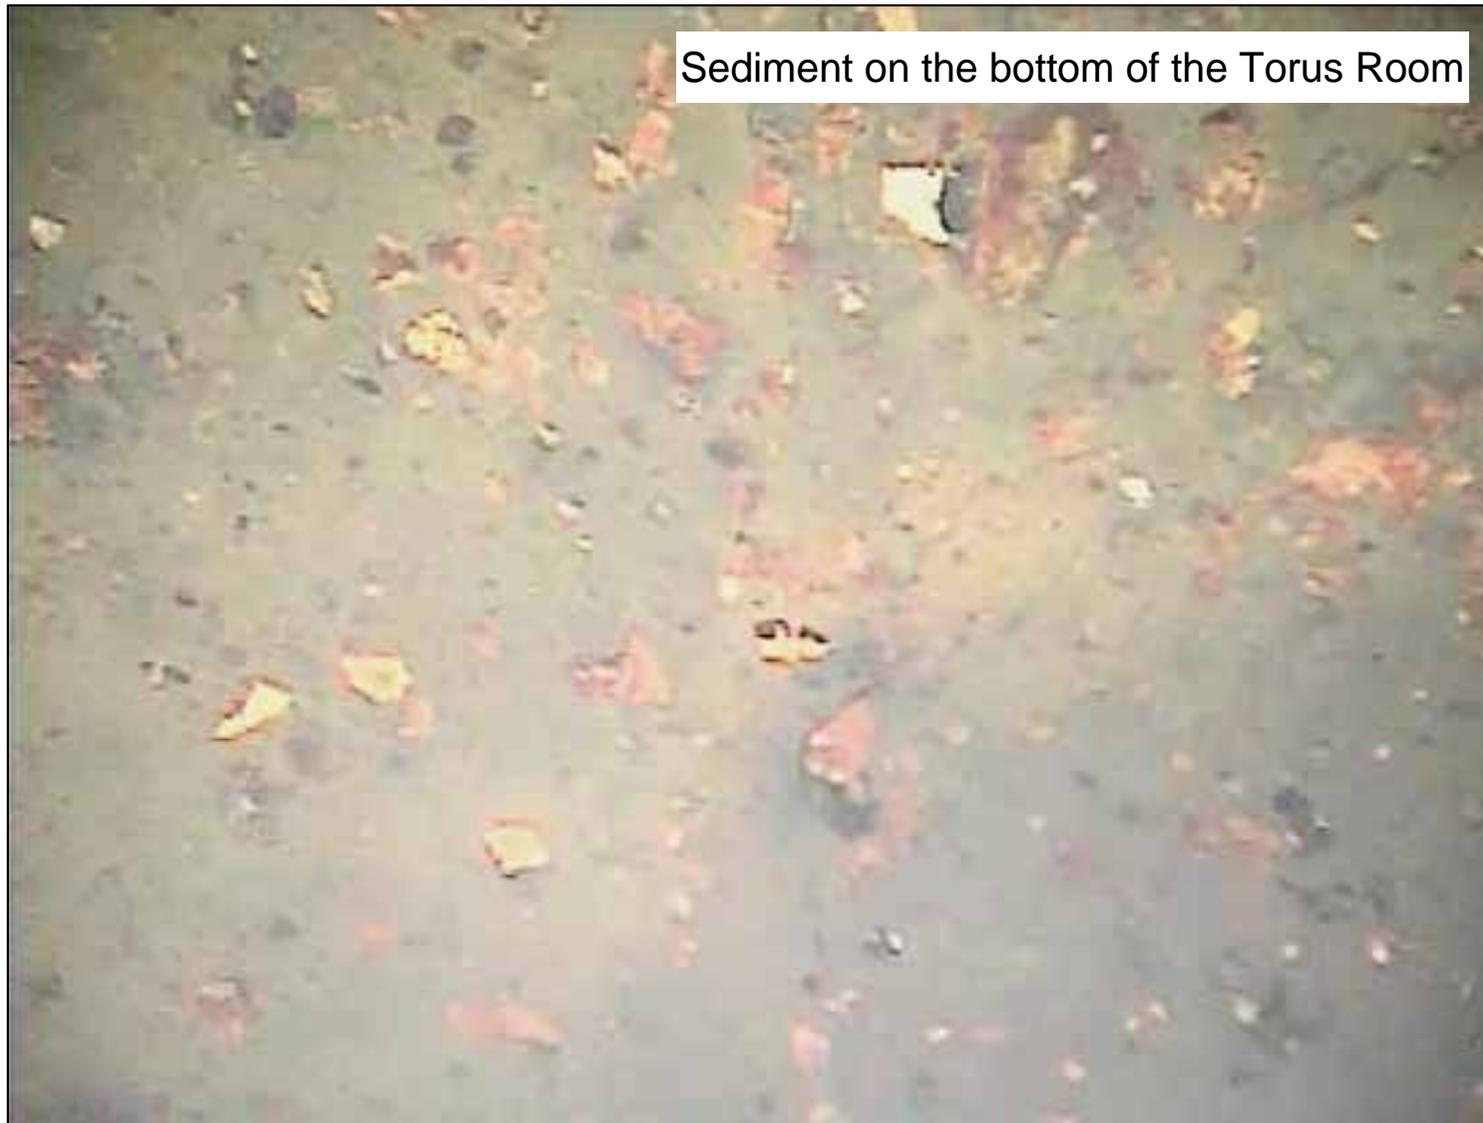
(Reference) Sediment on the Bottom of the Torus Room

Floating sediment confirmed when the equipment touched the wall or the bottom surface
