# Fukushima Daiichi Nuclear Power Station Investigation Results for the inside of the Unit 3 Personal Access Lock and Past Investigation Results for each penetration

October 30, 2025

Tokyo Electric Power Company Holdings, Inc.

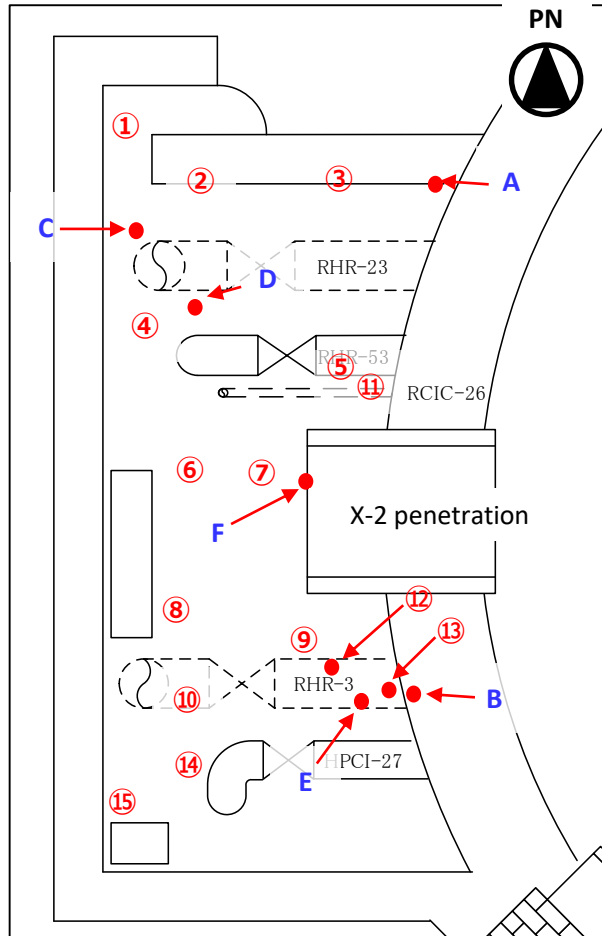
P/A room Dose measurement locations

- The maximum dose rate measured inside the P/A room was 1,120mSv/h (floor surface dose).

No.	Measurement height		notes
	FL+1.5m	FL+0.05m	
①	4.78	11.8	—
②	8.08	22.3	
③	33.6	25.0	
④	16.7	40.0	
⑤	29.5	102	
⑥	31.9	55.5	
⑦	29.0	53.9	
⑧	35.6	45.2	
⑨	113	315	
⑩	35.8	60.2	
⑪	-	145	
⑫	-	540	
⑬	-	1120	
⑭	35.2	358	
⑮	35.0	(FL+0.85m)	Measurement by SPOT
A	26.7	(FL+1m)	Wall surface measurement
B	316	(FL+0.3m)	Wall surface measurement
C	11.2	(FL+0.55m)	Pipe surface measurement
D	12.6	(FL+1m)	Pipe surface measurement
E	218	(FL+0.55m)	Pipe surface measurement
F	15.5 (FL+1.5m)	20.4 (FL+0.75m)	X-2 penetration surface measurement

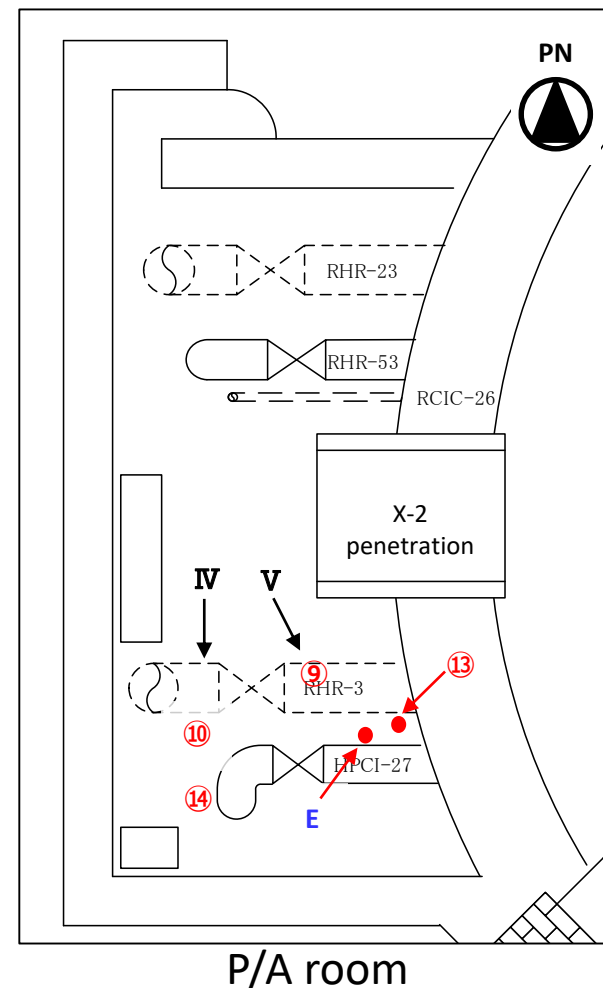
- A strong hotspot of max 1,120mSv/h was confirmed near the floor on the south side of the X-2 penetration.

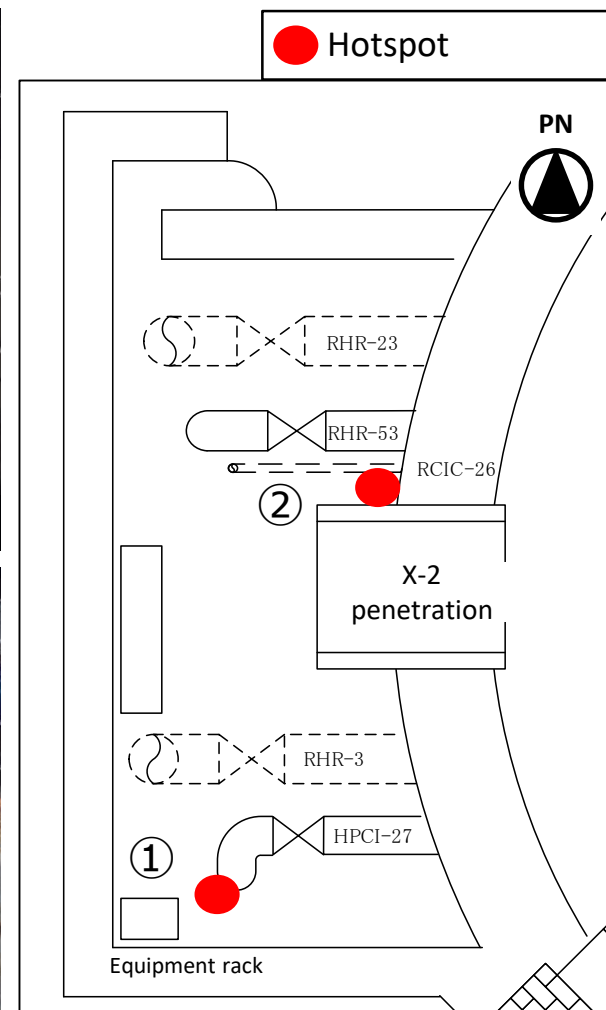
P/A room

- Dose measurement results show hot spots to exist in the same locations where high doses were measured.
- Hotspots were mainly found on the floor.

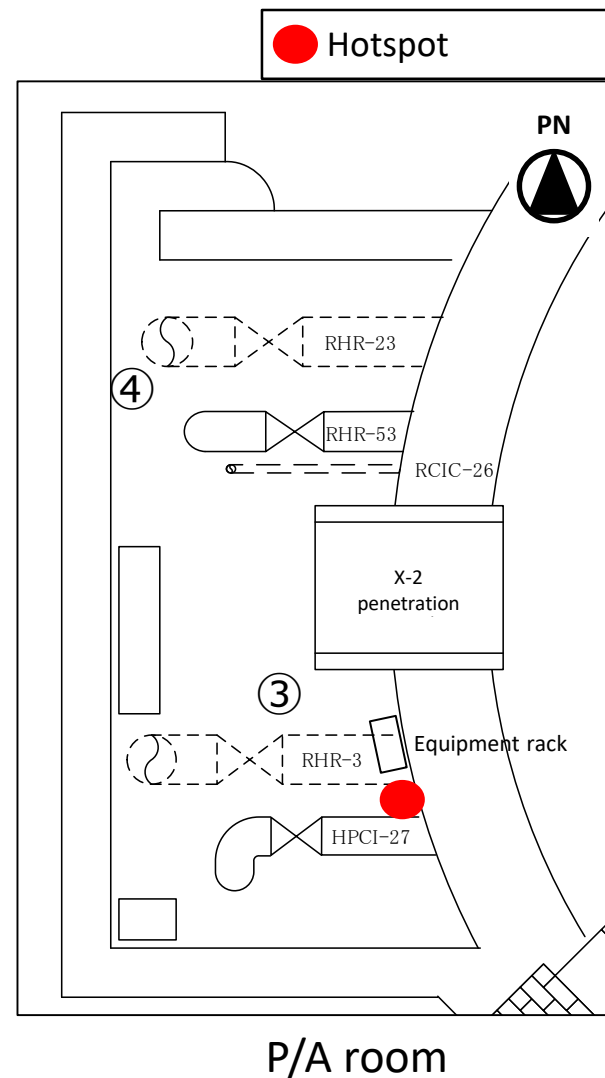
- Dose measurement results show hotspots to exist in the same locations where high doses were measured.
- G/I measurement ④ hotspot is assumed to contribute greatly to the doses from the back of the P/A room.

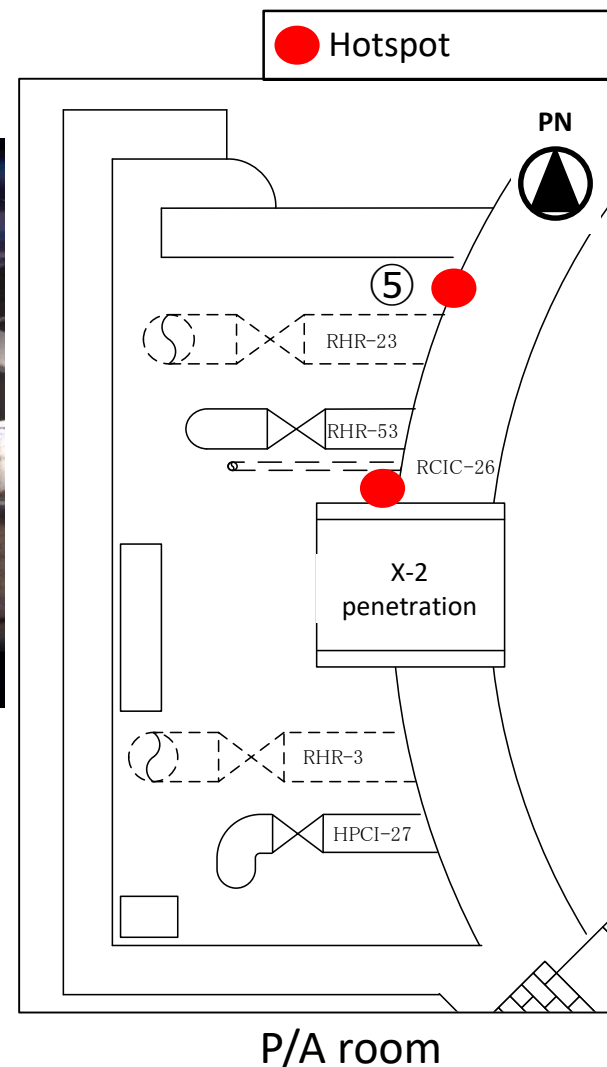
- G/I measurement ⑤ hotspot was found in the direction of the upper penetration (X-13A) and the RHR-53 piping.
- The hotspot in the direction of the RHR-53 piping is assumed to be a contribution from the hotspot found on the north side of the X-2 penetration behind the piping.

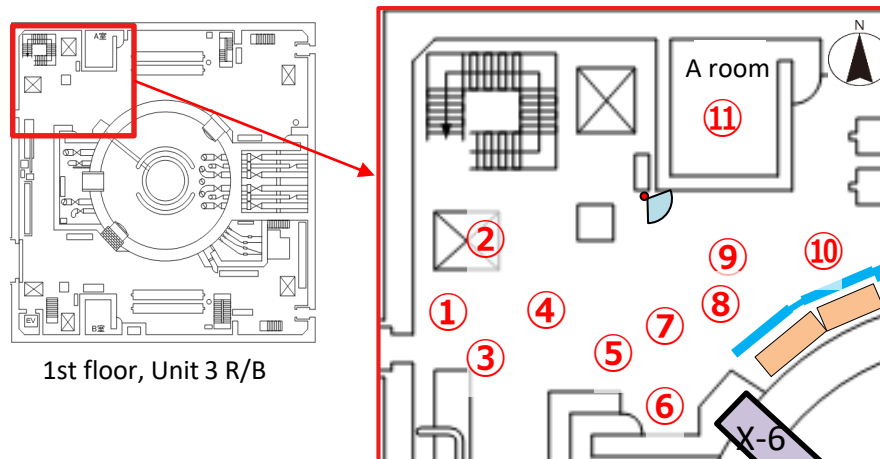
- The HCU (north side) is greatly affected by doses from the jet pump instrument rack, and it is not clear whether there are any other radiation sources.
- The HCU and jet pump instrument rack, which are the main radiation sources, have been shielded, and the air dose rate around the X-6 penetration is between 3~5mSv/h, thereby prohibiting workers from remaining in the area for a long period of time.

Location	Measurement (mSv/h)
	Air dose (1.5m above the floor)
①	2.49
②	2.99
③	2.98
④	2.72
⑤	3.32
⑥	4.62
⑦	3.36
⑧	5.16
⑨	4.27
⑩	4.15
⑪	0.96

- Dose reduction measures for the jet pump instrument rack closest to the X-6 penetration are being deliberated.
- Due to the difficulty of work implementation, it is expected that much time will be needed to reduce doses in the HCU.

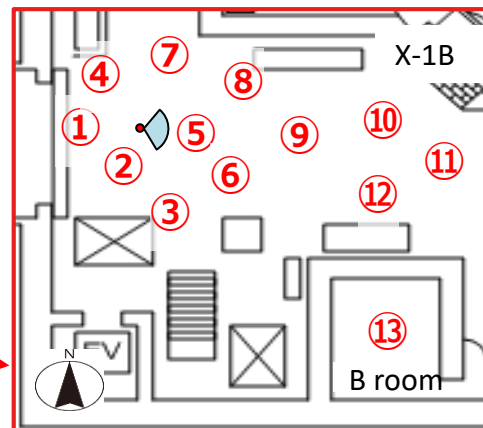
- The dose contributions from the HCU (south side) and parts of the floor are substantial, and it is not clear whether there are any other radiation sources.
- The HCU, which is the main radiation sources, has been shielded, and the air dose rate around the X-1B penetration is between 5~8mSv/h, thereby prohibiting workers from remaining in the area for a long period of time.

Location	Measurement (mSv/h)
	Air dose (1.5m above the floor)
①	6.67
②	5.78
③	5.66
④	6.32
⑤	6.37
⑥	7.42
⑦	6.46
⑧	7.59
⑨	6.42
⑩	6.62
⑪	7.32
⑫	7.32
⑬	3.21

- Since floor surface contamination is concentrated around the places where existing panels are installed and the edges of the walls, we are deliberating the removal of the existing panels.
- Due to the difficulty of work implementation, it is expected that much time will be needed to reduce doses in the HCU.

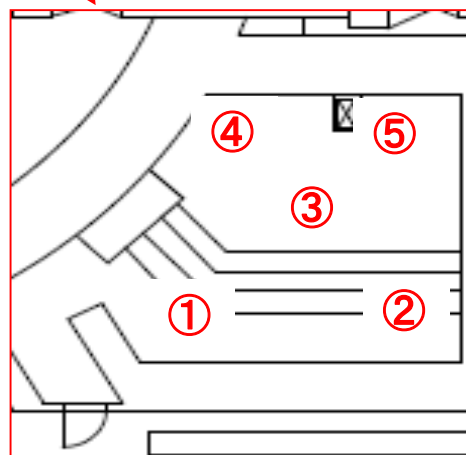
⇒ Average dose of 1.2mSv/h has been achieved

Location	Air dose measurements (mSv/h)		
	Prior to decontamination October 2023	After decontamination December 2024	After shielding February 2025
①	8.0	7.5	0.7
②	10	4.0	0.7
③	10	7.5	1.6
④	—	8.0	1.8
⑤	—	5.0	1.0

- ① Equipment and sludge removal
- ② Wall decontamination through water spraying
- ③ Pressure wash stripping decontamination of floor surfaces
- ④ Decontamination through mechanical stripping
- ⑤ Shield installation

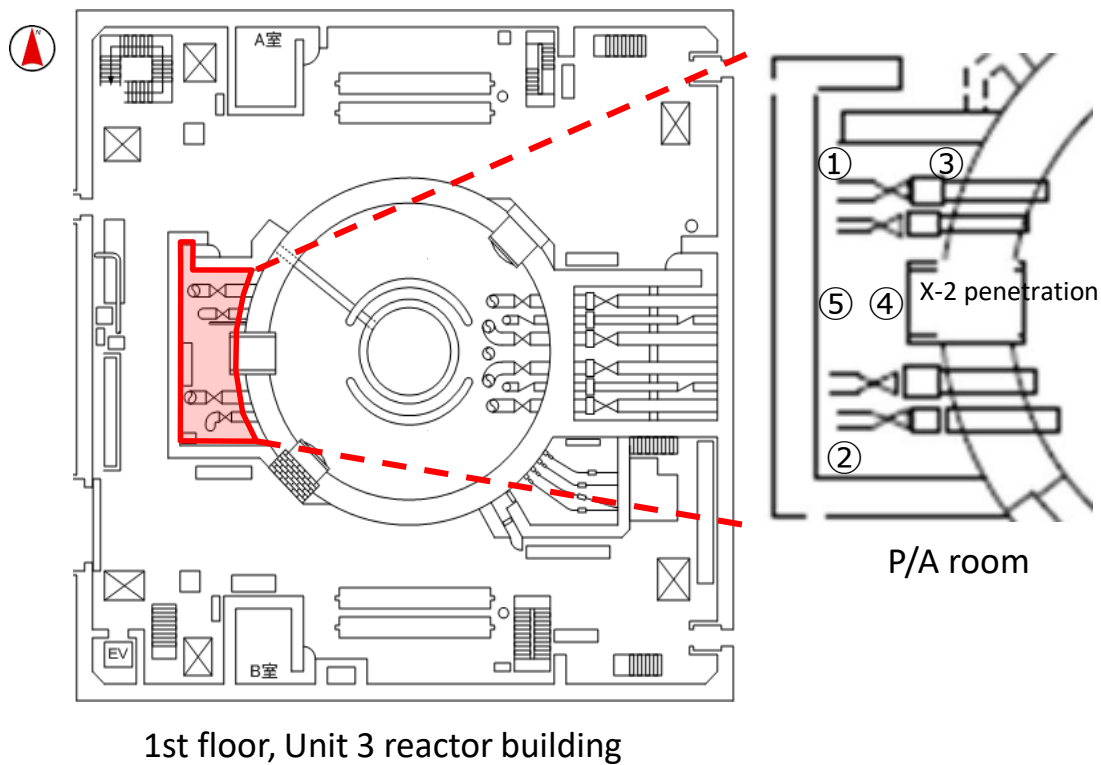
- The investigation in 2016 of the inside the P/A room confirmed high doses.

Measurement point	Air dose equivalent rate (mSv/h)
①	13
②	80
③	50
④	60
⑤	80

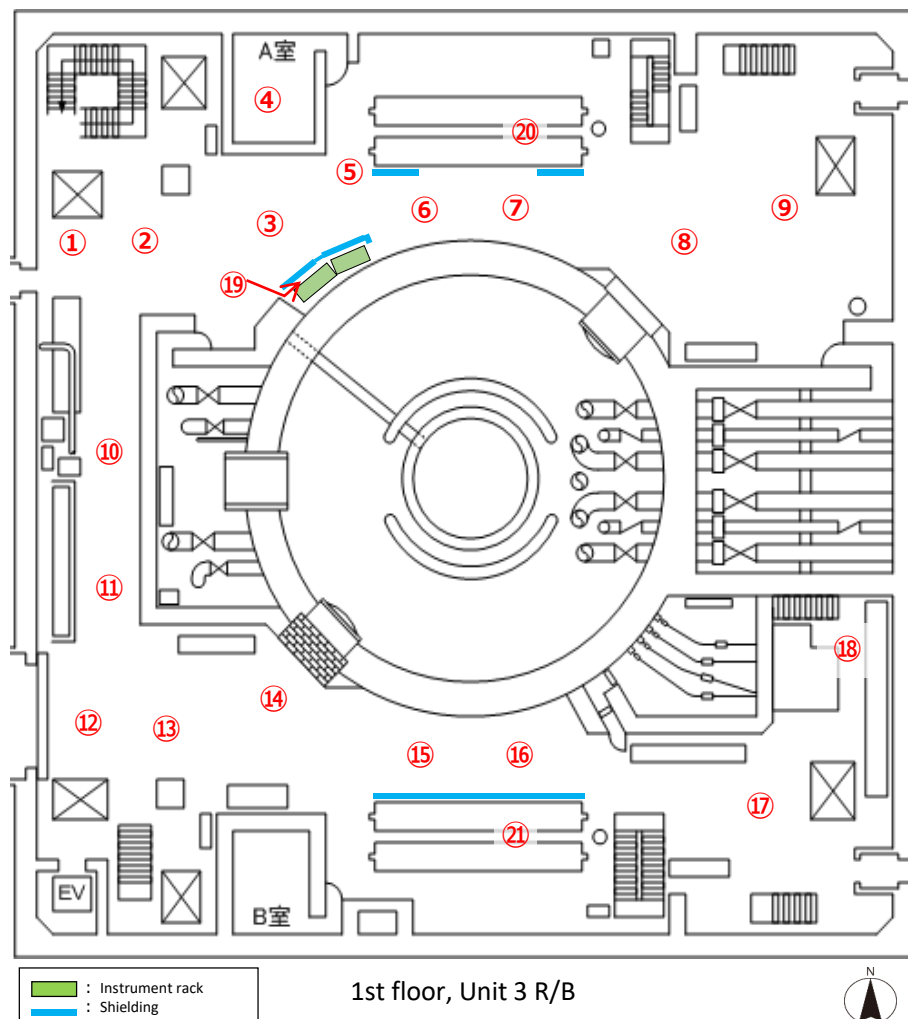
- Air dose rates inside the building
  - Dose rates of greater than 10mSv/h measured in the vicinity of the north/south HCU. Air dose rates in all other areas were between 1~8mSv/h.

Location	Measurements (mSv/h)	
	Air dose (1.5m above the floor)	Surface dose(0.05m above the floor)
①	2.49	2.36
②	2.72	2.04
③	4.27	3.19
④	0.96	0.68
⑤	7.63	4.20
⑥	12.5	6.48
⑦	9.86	5.48
⑧	8.28	6.76
⑨	6.70	4.51
⑩	3.14	2.44
⑪	5.67	8.19
⑫	5.78	5.04
⑬	7.42	6.34
⑭	6.62	5.02
⑮	14.0	7.90
⑯	12.0	6.05
⑰	3.41	2.12
⑱	7.80	7.97
⑲	19.0	-
⑳	76.1	-
㉑	78.9	-

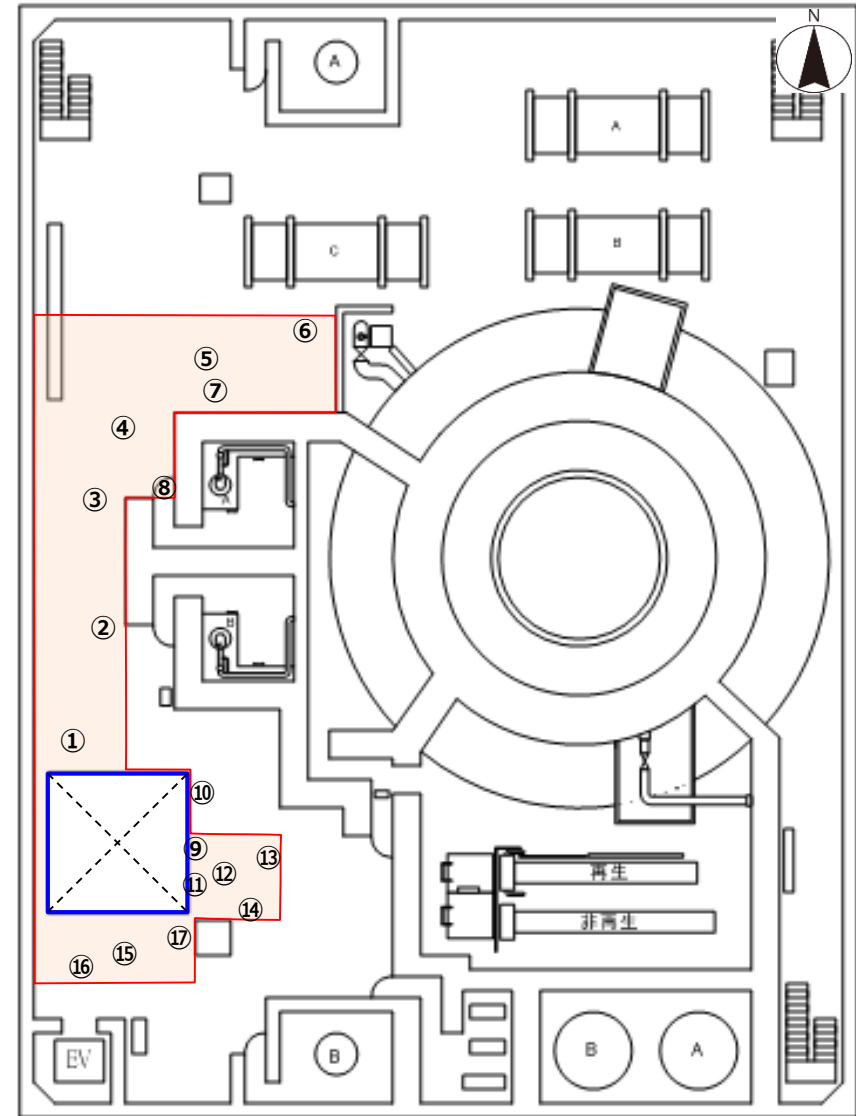
Unit 3 R/B 2nd Floor

- Air dose rate inside the building
- Dose rates on the 2nd floor were confirmed to be between approx. 3~10mSv/h

Measurement location	Height of measurement ※Based on elevation of second floor (T.P.17264)	Dose rate [mSv/h]
①	Approx. 750mm	5.39
②		5.65
③		4.67
④		8.61
⑤		7.84
⑥		8.12
⑦		10.5
⑧		3.48
⑨	Approx. 850mm	4.64
⑩		4.75
⑪		4.60
⑫	Approx. 750mm	6.31
⑬		7.34
⑭		6.24
⑮	Approx. 850mm	7.67
⑯		7.93
⑰		7.20

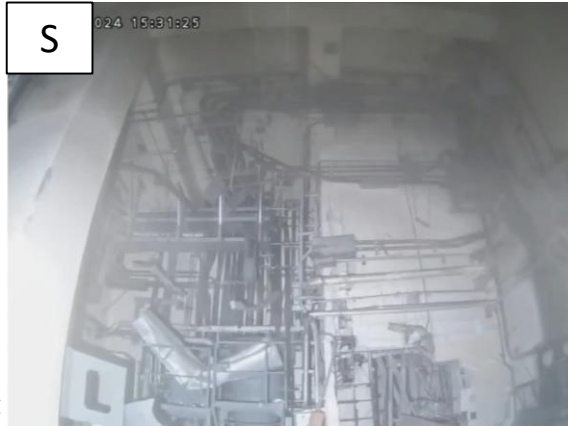
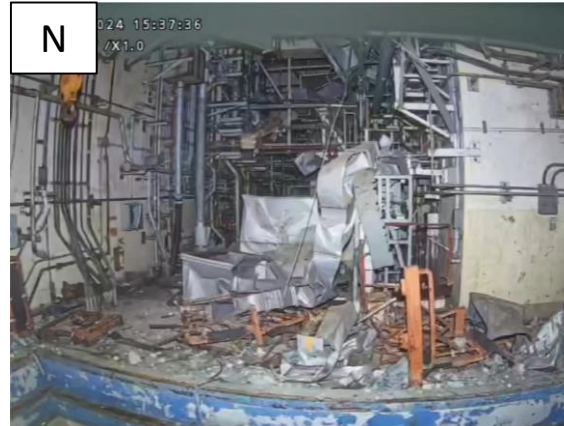
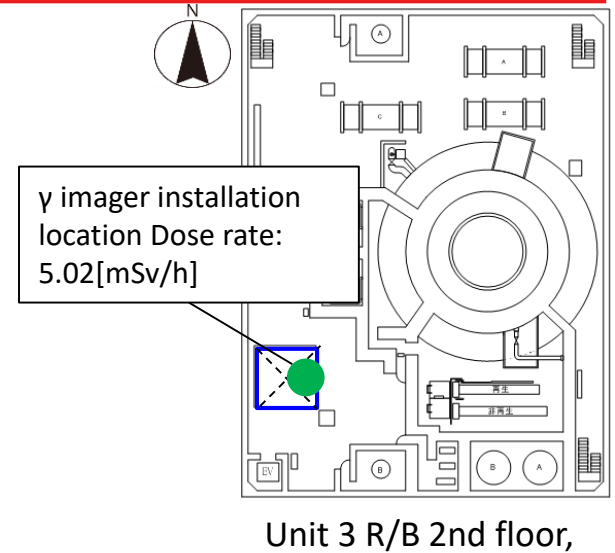
- $\gamma$  ray distribution by  $\gamma$  imager measurement.
- On the 2nd floor, it was confirmed that the hot spot was around the rubble near the floor.

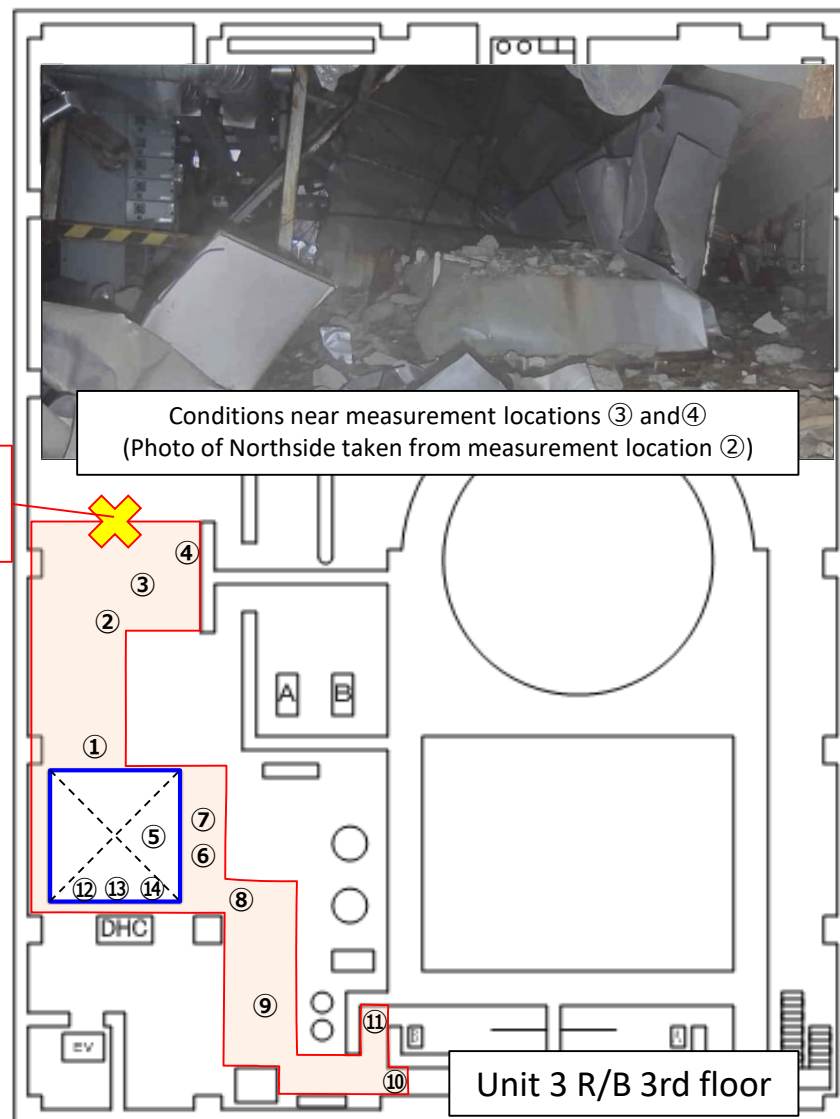
- On the 3rd floor high-dose rates of over 20mSv/h were measured at measurement locations ②, ③, and ④

North side inaccessible due to rubble, etc.

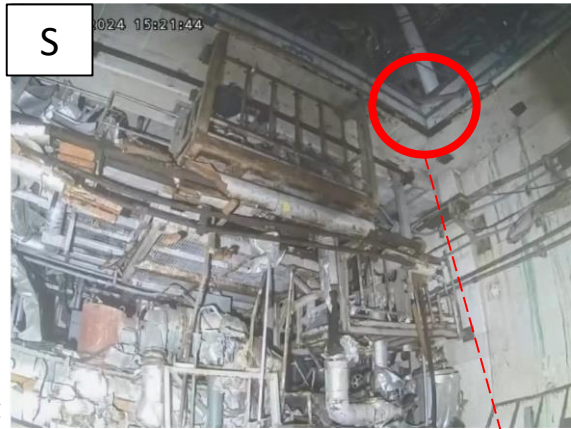
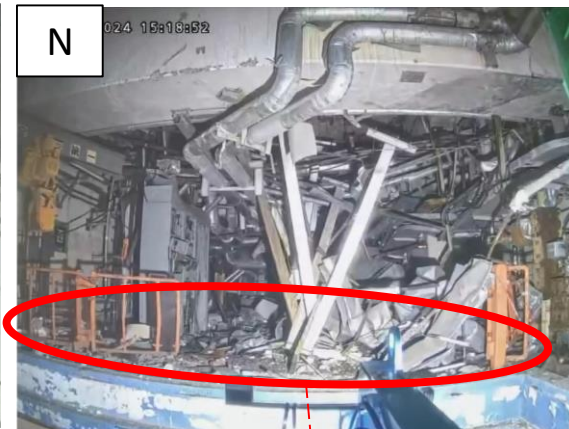
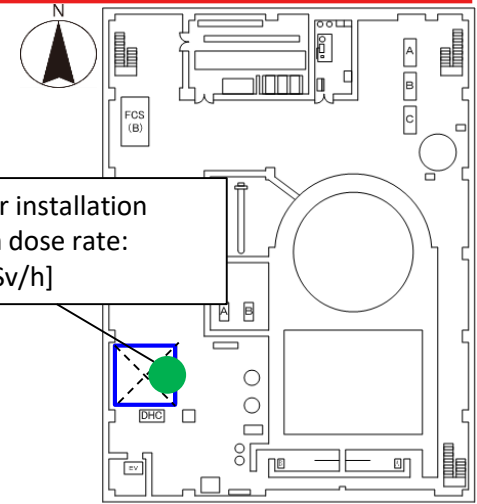
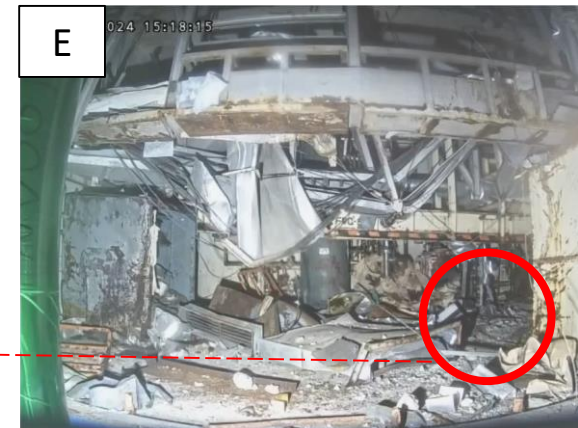
- $\gamma$  ray distribution by  $\gamma$  imager measurement
- On the 3rd floor, it was confirmed that the hot spot was around the edge of the top of the equipment hatch and around the rubble near the floor.

$\gamma$  imager installation  
location dose rate:  
7.89[mSv/h]

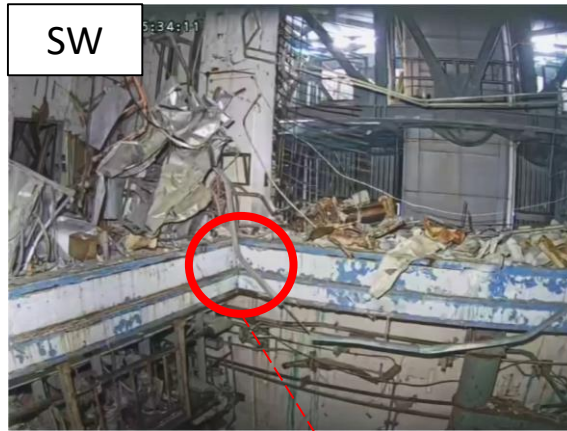
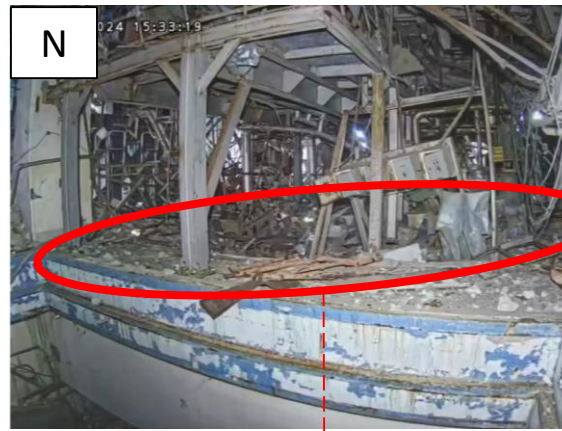
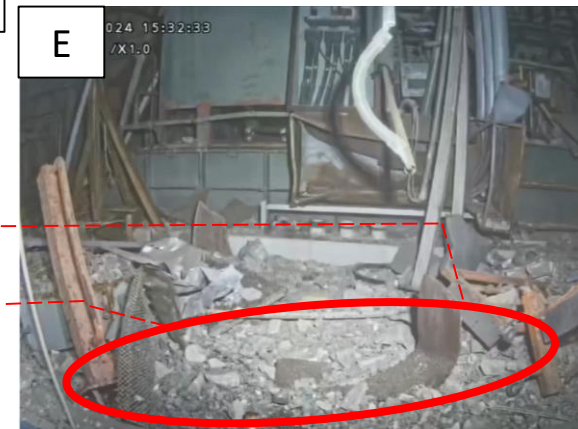
- Gamma ray distribution by gamma imager measurement
  - On the 4th floor, it was confirmed that the hot spot was around the rubble near the floor.
  - Since the intensity of the hot spot on the 3rd floor are relatively weak, it is assumed that dose rates on the 4th floor are higher
