The integrity evaluation of the reactor building at unit4 in the Fukushima Daiichi nuclear power station

May 2012

Government and TEPCO's Mid-to Long Term
Countermeasure Meeting Management Council

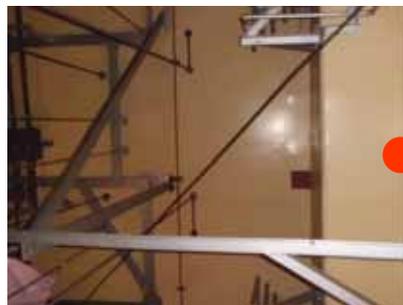
Photo View from lower floor (Before concrete placement)

Water injection status into the spent fuel pool was confirmed by the camera attached to the tip of the concrete pump vehicle. And also, it was confirmed that there is no leakage of the 2nd floor, which is underneath the spent fuel pool.

As the results of the visual inspection inside R/B, it was confirmed that there was no damage to the shell wall on the 1st and 2nd floor. As for the 3rd floor, the shell wall was enough thick (1855mm). Hence it was also evaluated that there was no damage.

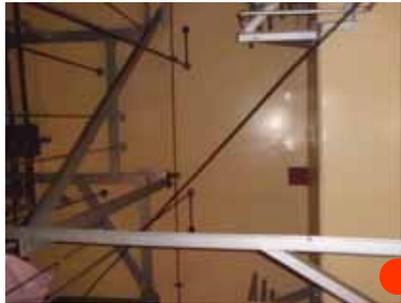
Photo View from lower floor
(Before concrete placement)

- We installed a support structure at the bottom of the spent fuel pool. This increased the seismic safety margin by an extra 20 %.

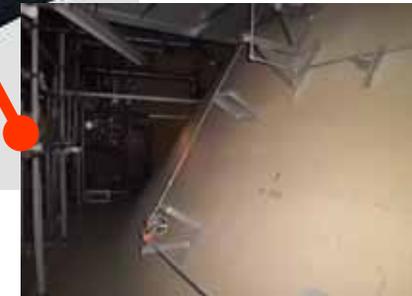
Photo Surface of the 2nd
floor shell wall
(Before concrete placement)

Photo May 21, 2011 Photo June 15, 2011 Photo May 20, 2011
Completed reinforcement on July 30, 2011

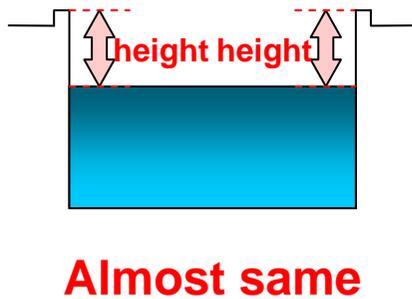
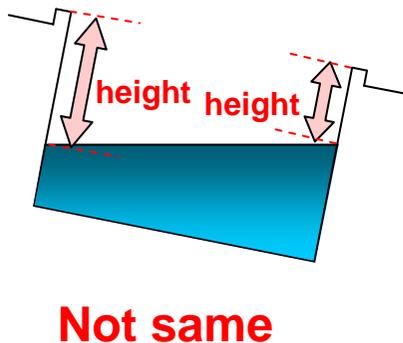
Measurement Point (on the 5th floor)

- We measured the distance between the water surface of the spent fuel pool and the floor surface of the building, and confirmed that the building has not tilted

1) not tilted

2) tilted

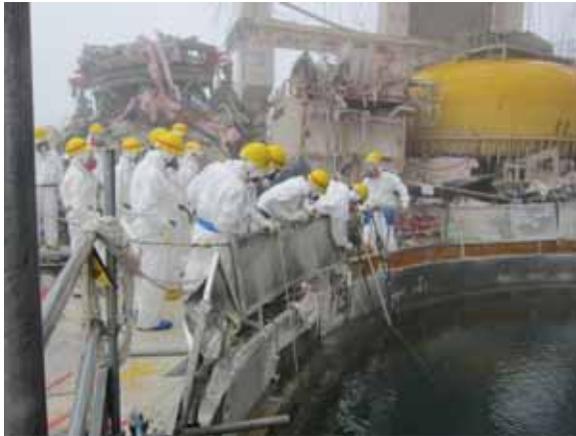
- Vice minister Nakatsuka and government officers made a visitation of unit 4 reactor building and confirmed the building structural integrity on April 23, 2012.

Confirmation of the reactor well on the fifth floor of Nuclear Reactor Building Unit 4

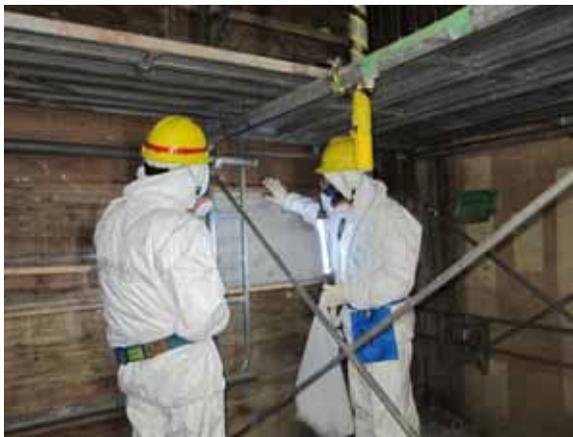
Confirmation of support structure installed at the bottom of the spent fuel pool on the second floor of Nuclear Reactor Building Unit 4

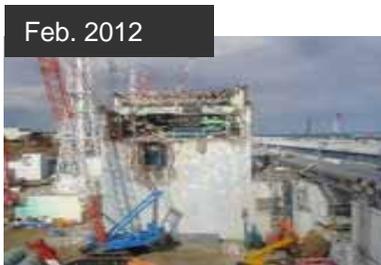
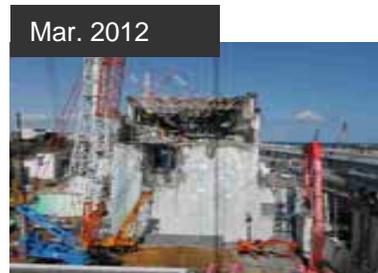
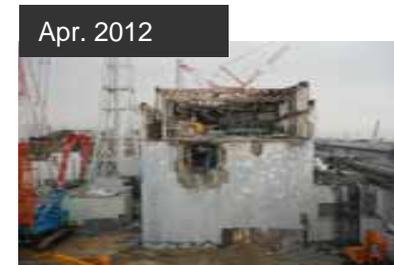
Full view (South side)

July 2011

April 2012
