Status of investigation on estimating situation of cores and containment vessels

1. Introduction

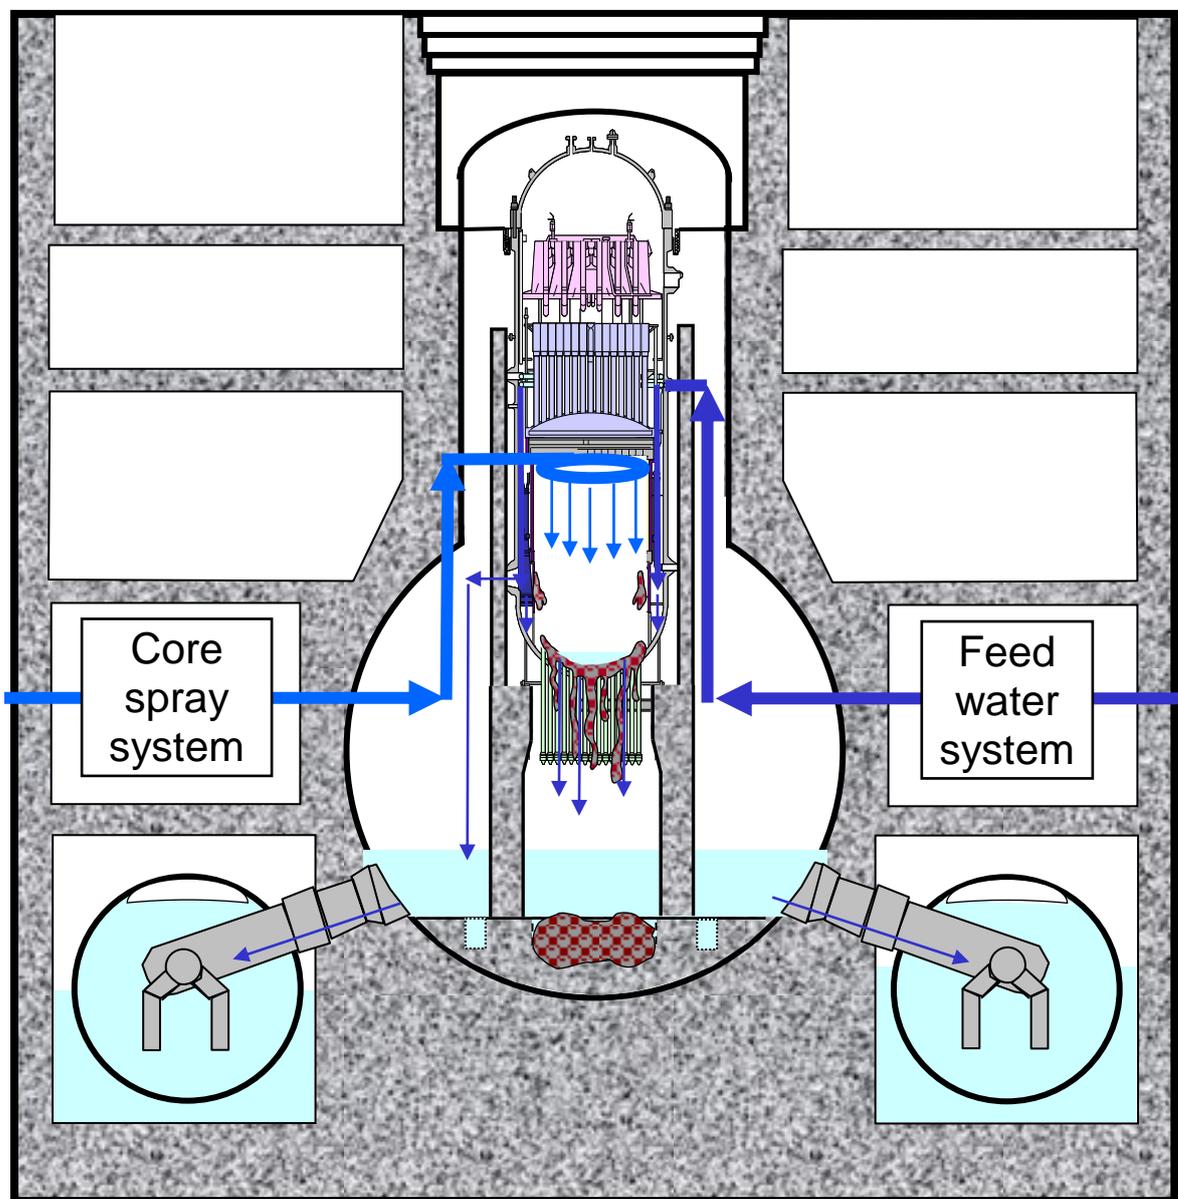
Figure 1-1 Estimated conditions of the core and PCV of Unit-1

(Note) Estimated conditions of the core and PCV are not updated from the previous report. The illustration does not accurately represent a quantitative image for the size, etc. of debris

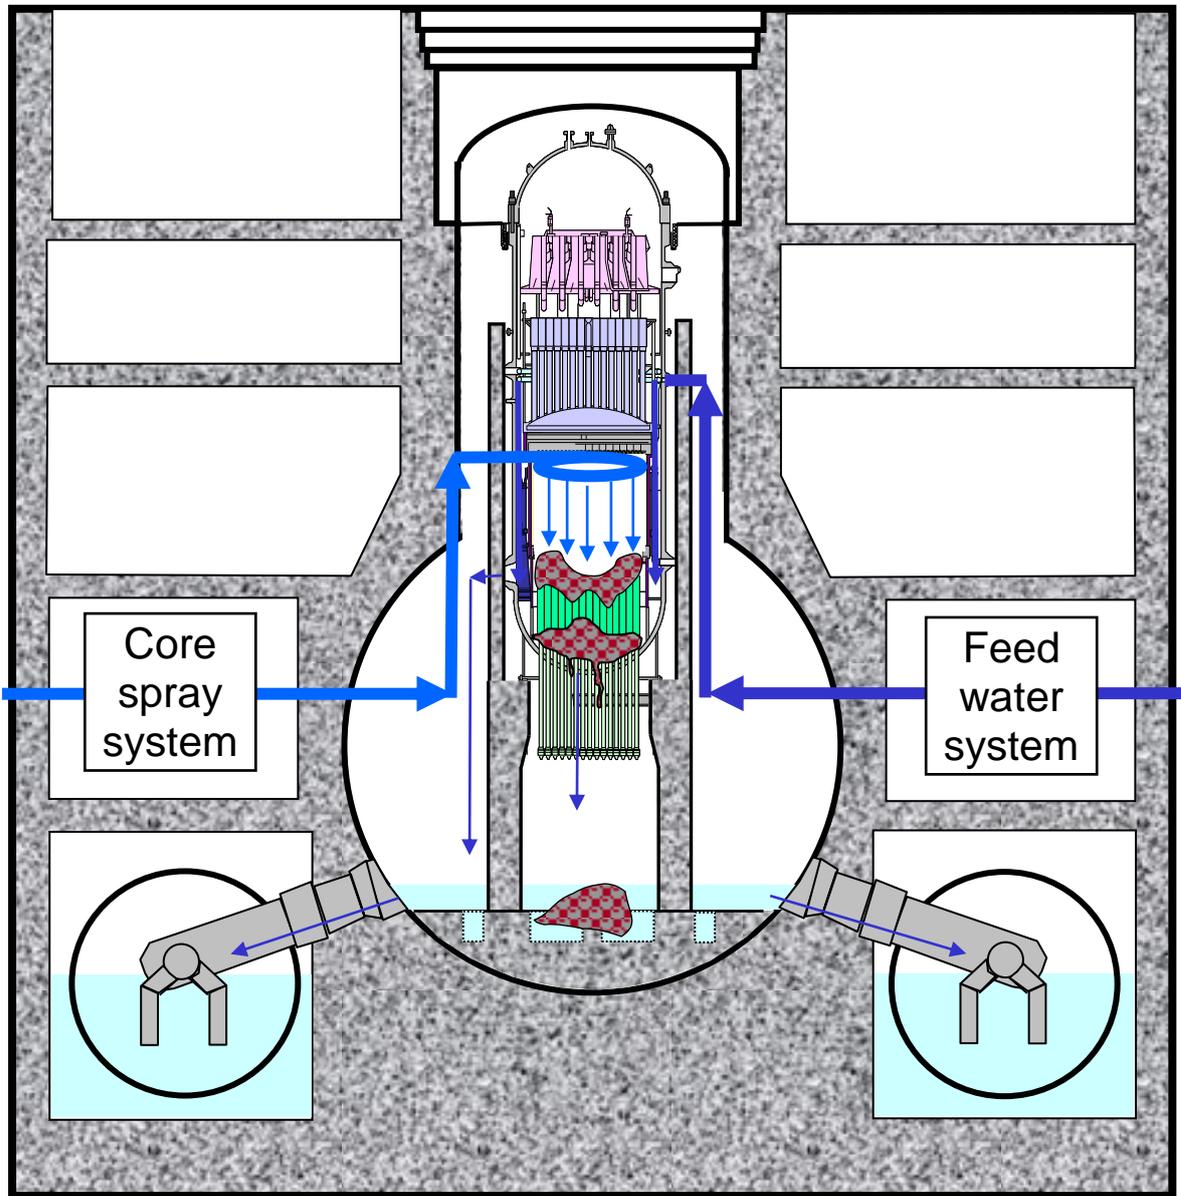
Figure 1-2 Estimated conditions of the core and PCV of Unit-2

(Note) Estimated conditions of the core and PCV are not updated from the previous report. The illustration does not accurately represent a quantitative image for the size, etc. of debris

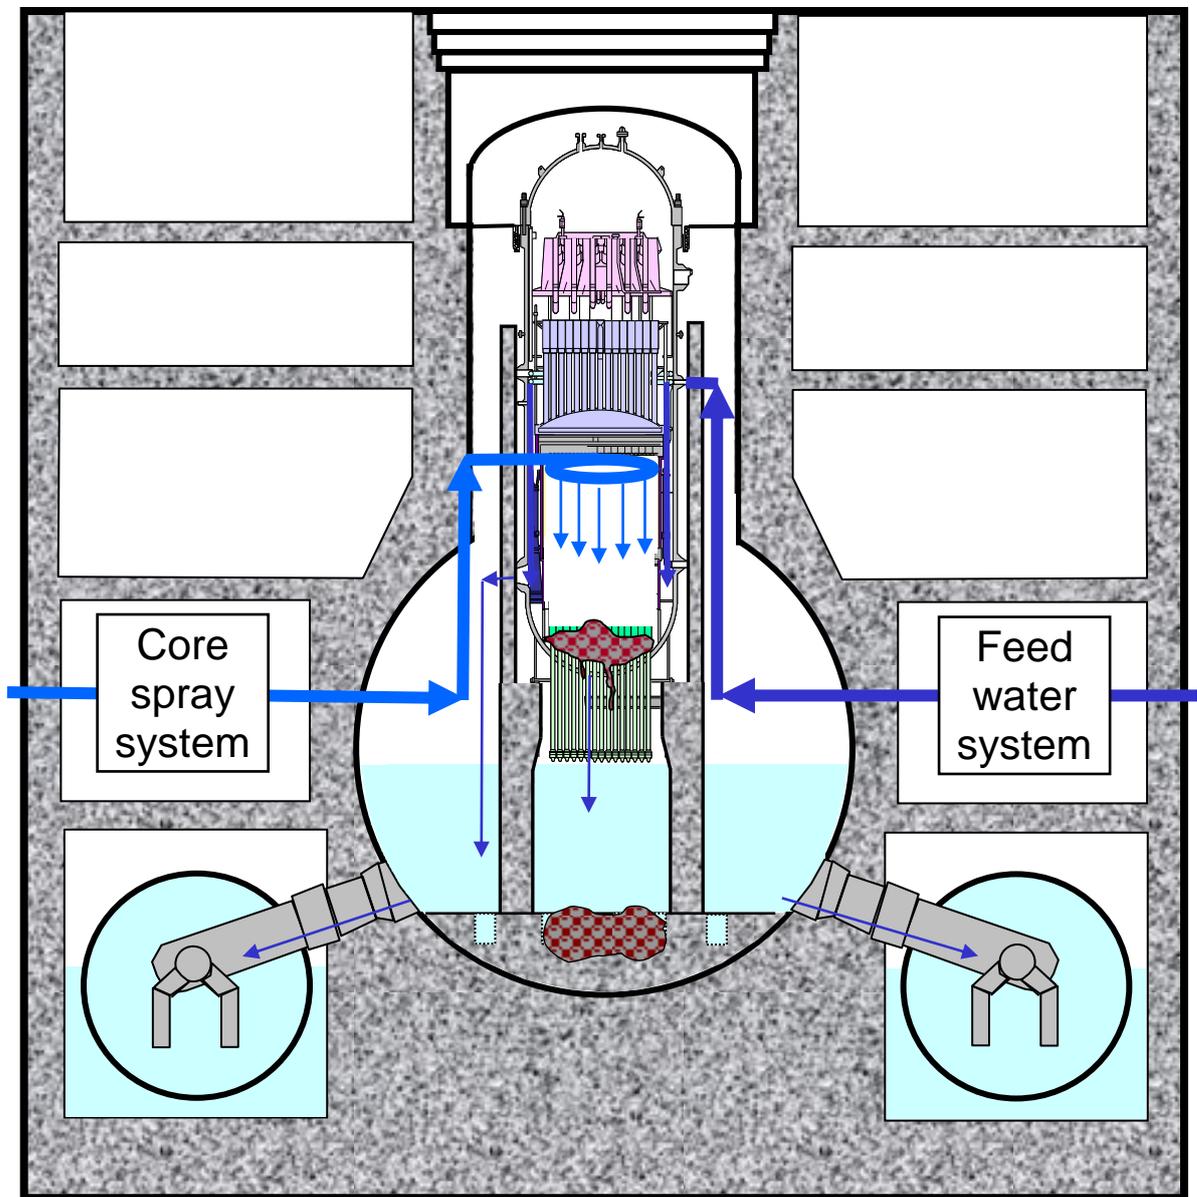
Figure 1-3 Estimated conditions of the core and PCV of Unit-3

(Note) The fallen debris on the PCV pedestal was shown larger this time, incorporating the analysis results of the case that sufficient water injection to the reactor had not been possible before the operator manually stopped the HPCI. The illustration does not accurately represent a quantitative image for the size, etc. of debris.

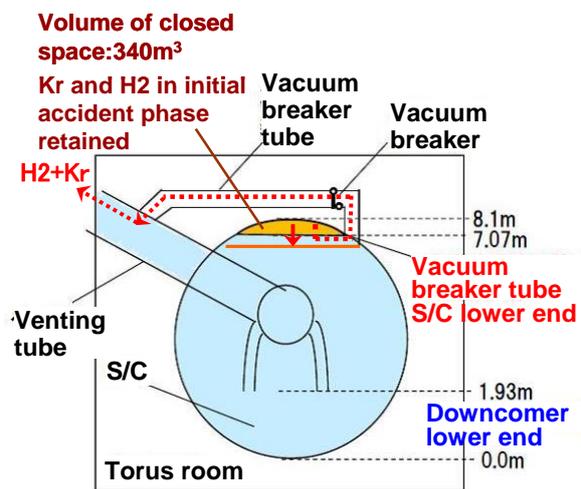
Figure 2-2 Closed space in gaseous phase inside S/C of Unit-1

In September 2012, a nitrogen gas injecting test was conducted into the suppression chamber (S/C), in which the theory was demonstrated that hydrogen gas and Kr-85 generated in the early stage of the accident and retained in the S/C upper space pushed down the S/C water level and were discharged to the DW through the vacuum breakers. This helped to confirm that the S/C was currently almost filled with water (the level at around the lowest end of the vacuum breaker tube [2] (Figure 2-2).

This test was conducted with an intention to explain the phenomenon of the intermittent increase of hydrogen gas concentration and Kr-85 radioactivity measured by the containment gas control system of Unit-1 that has been seen since April 2012. This intermittent increase was assumed to occur in the following sequence: When the S/C water

level drops, residual gas left in the closed space in the upper S/C is discharged to the D/W through vacuum breakers, and then the S/C water level rises and stops the gas discharge. In this hypothesis, Kr-85 is understood to originate in the early phase of the accident, because Kr-85 is a long half-life fission product and its amount cannot be explained as being newly produced by spontaneous fission, etc.

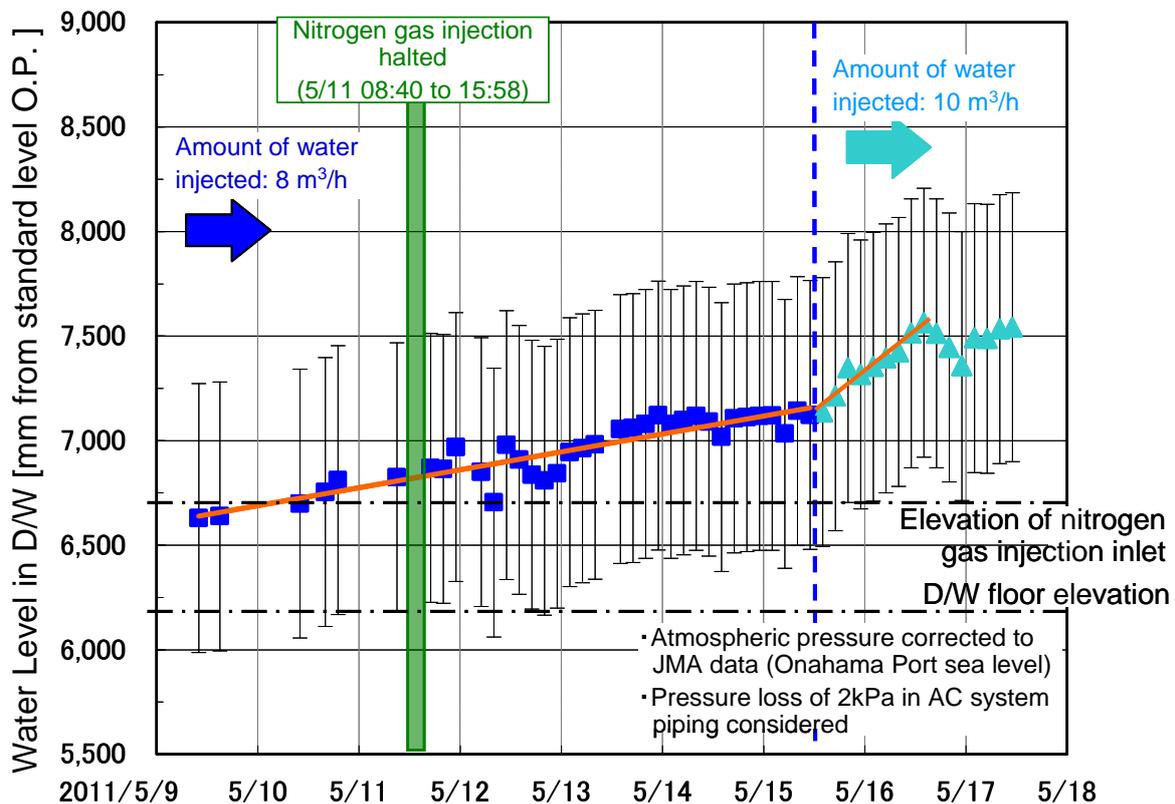
Figure 2-5 Estimated PCV water level changes during flooding operation of Unit 1 (May 2011)

Meanwhile, the water leakage down to the S/C surface around both sides of the vent tube X-5E indicates the possibility of water leaks from the vacuum breaker tube (its bellows, for example) immediately above the vent tube. This elevation of the vacuum breaker tube is about the same level as that of the upper limit of PCV water level which was reached in an attempt to flood the PCV by increasing the amount of water injected in May 2011; where the PCV water level was calculated from the injected nitrogen gas pressure. The nitrogen gas pressure was stopped from changing at a specified level, which means the PCV water level was leveled off, i.e., an indication of leak hole existence at the level (Figure 2-5) [5].

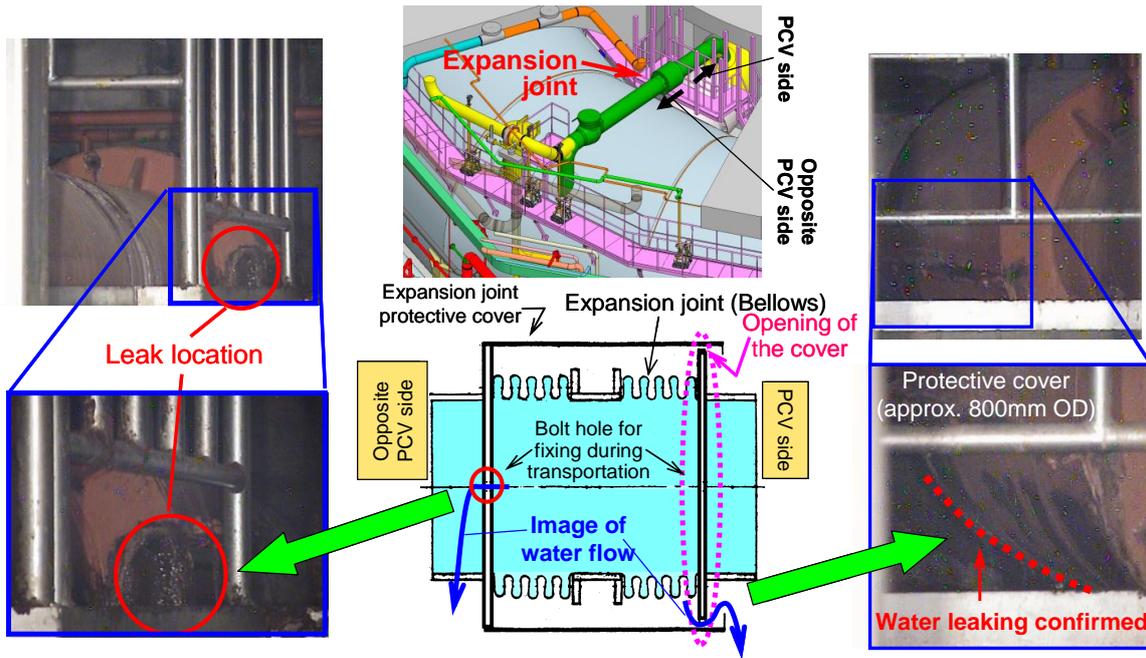
Illustration of Expansion joint (Bellows) for vacuum breaker tube

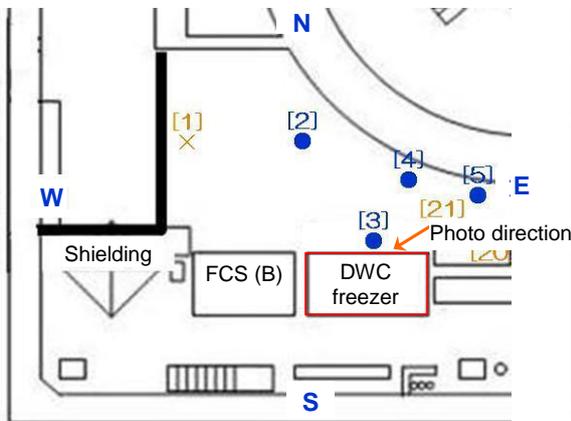
Figure 9. Layout

In December 2013, contamination was surveyed on the first floor of the Unit-1 reactor building by radiation dose measurements and gamma camera images taken using a robot. It was found that contamination was relatively high on the Atmospheric control system (AC) piping and Drywell humidity control system (DHC) piping (Figure 2-8) [8].

Hot spots confirmed along piping

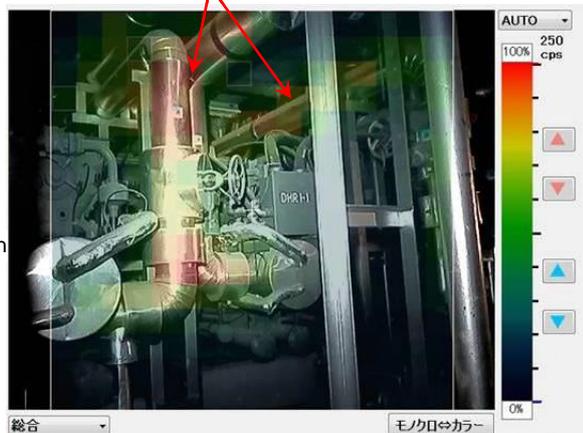
Figure 10. Gamma camera image taken near the DWC freezer

(Gamma camera image taken near the DWC system piping in the reactor building 1st floor)

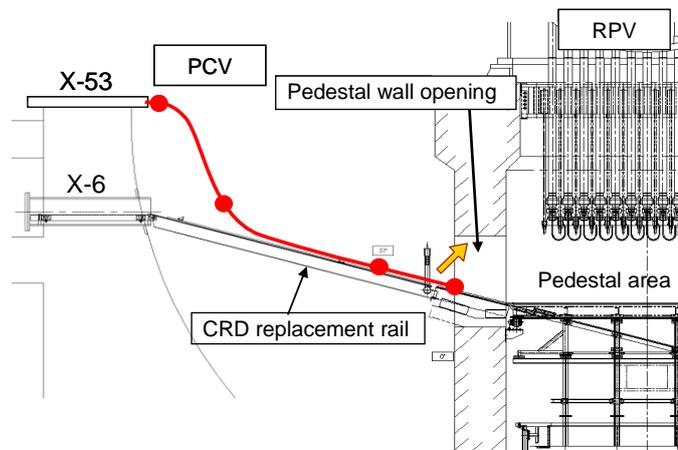
Figure 3-2 Survey areas inside Unit-2

In July and August 2013, a survey was conducted inside the PCV of Unit-2, when instrumentation was introduced through the PCV piping penetration X-53 (reactor building first floor) to take camera images and make dose and temperature measurements in the vicinity of the control rod drive mechanism (CRD) replacement rail and pedestal opening (Figure 3-2) [10].

Dosimeters measured the dose rates as far as the top of the CRD replacement rails. The values were about 45 – 80 Sv/h. As supplementary information, dose rates were estimated from the camera image noises; they were about 30 Sv/h near the landing point in replacement rail and

about 36 Sv/h near the pedestal opening. No clear indication was obtained about gaining access to fuel debris, even via the pedestal opening on the CRD replacement rail because access to fuel debris will result in rapid dose rate increase.

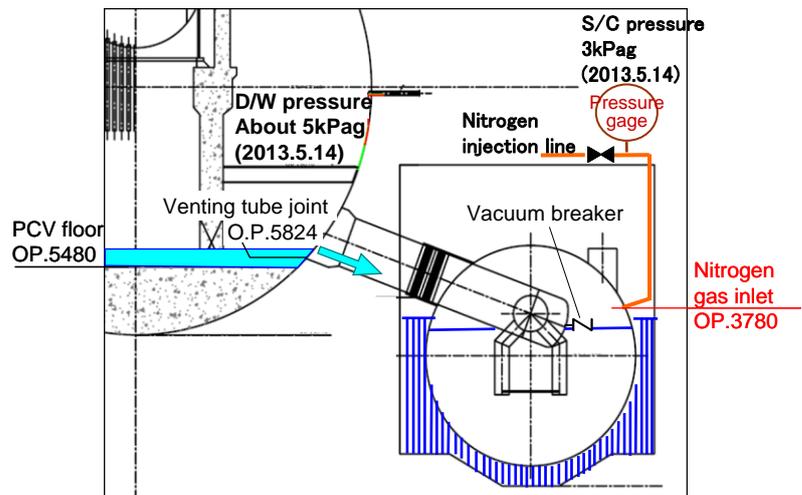
Figure 3-4 Closed space assumed in Unit-2 S/C

The S/C pressure was confirmed to be 3 kPag (as of May 14th, 2013) in a nitrogen gas injecting test into the S/C done in May 2013. The absolute water level in the S/C was not accurately known, but it was confirmed to be approximately on the level of the nitrogen gas inlet (O.P. 3780), because some reasonable pressure due to the water head should exist at the inlet if the S/C were almost filled with water. If the low water level in the

D/W is considered in combination, the water injected into the reactor vessel is considered to have reached the S/C via the D/W and venting tubes. If this hypothesis is correct, the current S/C water level will be on the same level as that of water retained in the torus room [11] (Figure 3-4).

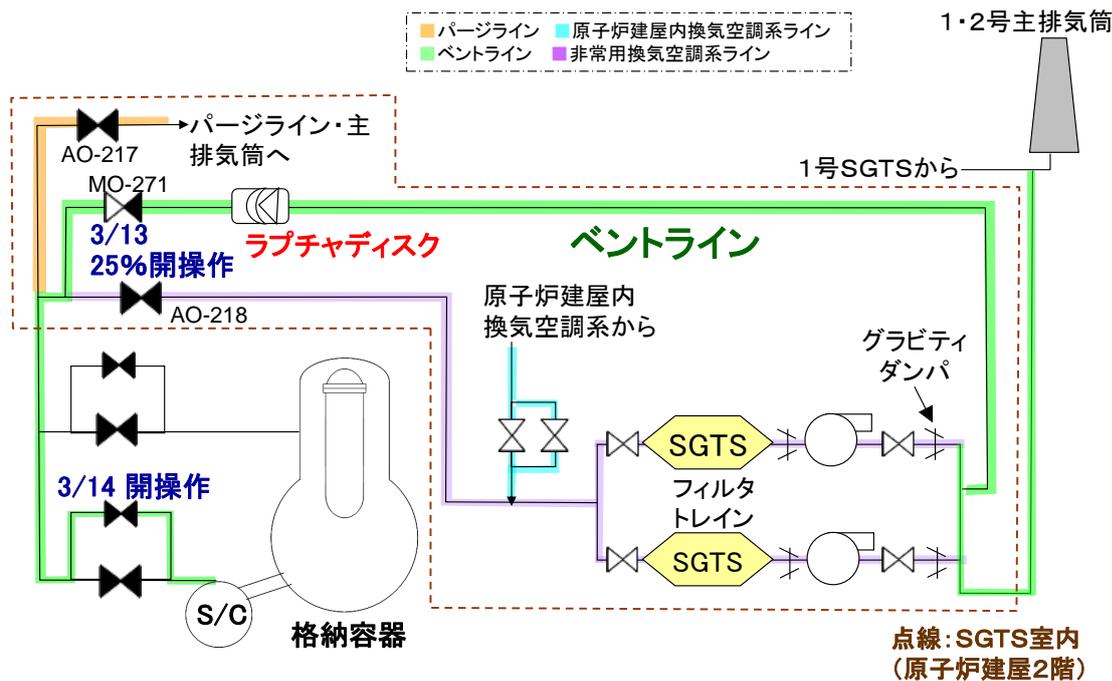
Figure 3-8 System configuration relevant to the rupture disk

Figure 3-8 illustrates the system configuration for venting from the primary containment vessel (PCV) to the Unit-1&2 stack. The green line is the venting line to release the PCV pressure when it exceeds its design pressure. This venting line bypasses the SGTS filters mounted, as early as the very beginning of the construction phase, on the emergency heating and ventilation air conditioning system. This venting line is also connected to the purge line as well as the reactor building heating and ventilation air conditioning (RB HVAC) system line. Valves in the figure are shown in black when fully closed, or when the opening aperture is unknown, and white when fully opened. The opening aperture of the valve (MO-271) located immediately upstream from the rupture disk was recorded as being operated to 25% mid-open position as of March 13th, 2011. The valve continues to hold the state even now. On the other hand, the valve immediately downstream on the S/C side of the PCV was operated to open its large and small vent valves until March 14th, 2011, but their real states when the venting line pressure reached the rupture disk working pressure remain unknown.
