- **Further validation regarding preparatory work for full-scale fuel debris retrieval of Unit 3 and the way forward**
- **Deliberation of preparatory work for fuel debris retrieval of Units 1 and 2**

Further validation regarding preparatory work for full-scale fuel debris retrieval

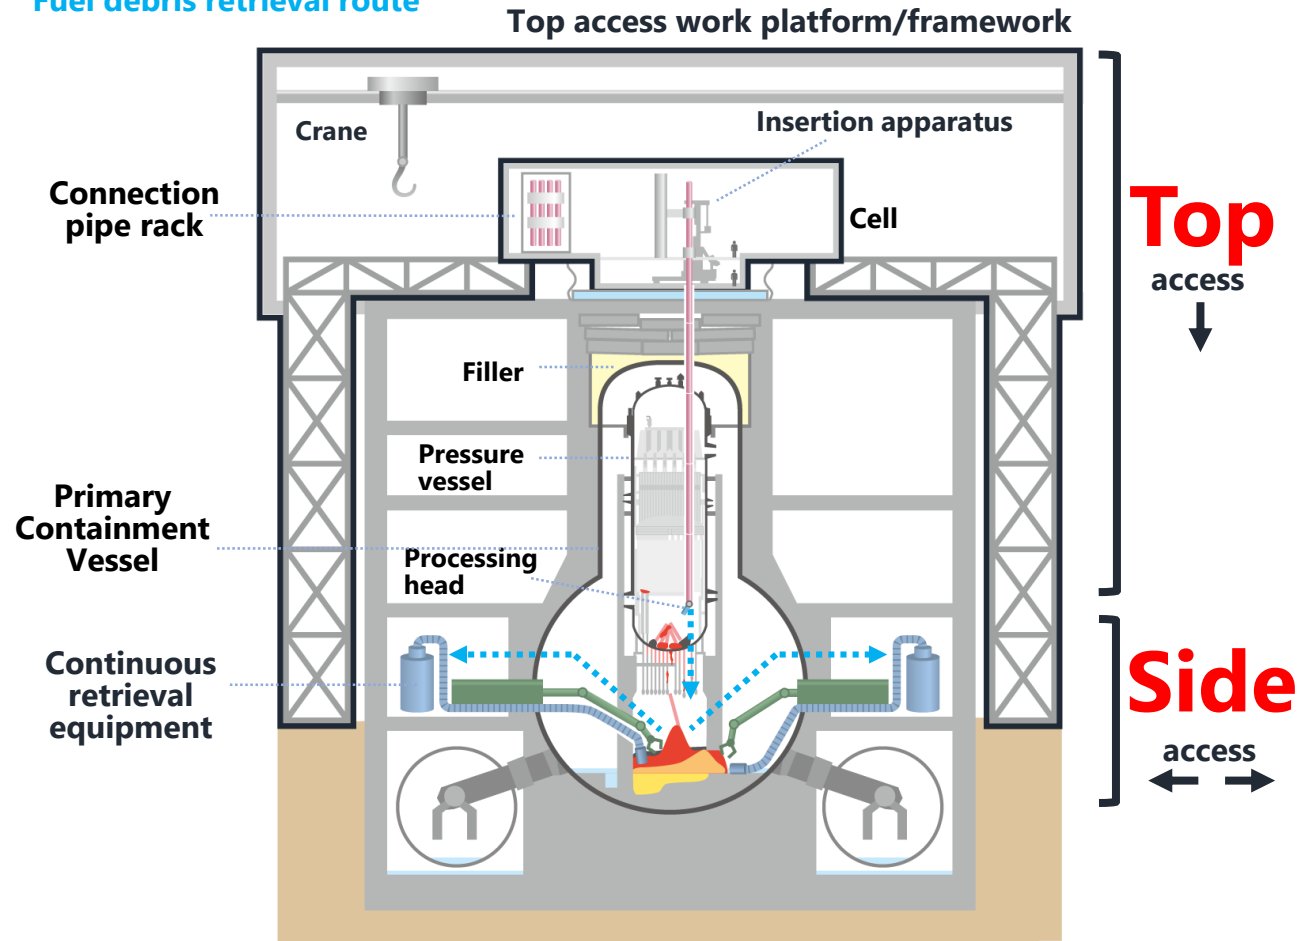
Of preparatory work for full-scale fuel debris retrieval of Unit 3, the following four points were organized as items requiring further validation. Each item shall be validated.

.....→
Fuel debris retrieval route

- Dose reduction of reactor building
⇒ Whether the planned decontamination work can reduce radiation doses

- Support structure for top access
⇒ Whether it can safely accommodate the top access equipment with sufficient margin
- Treatment of shield plug
⇒ Whether a method that avoids removing the shield plug by filling the well can be implemented
- Demolition and removal of Unit 3 radioactive waste treatment building (radwaste building)
⇒ Whether it is feasible to carry out the relocation and removal of the accumulated water transfer system and equipment, and the retrieval of used resin in parallel

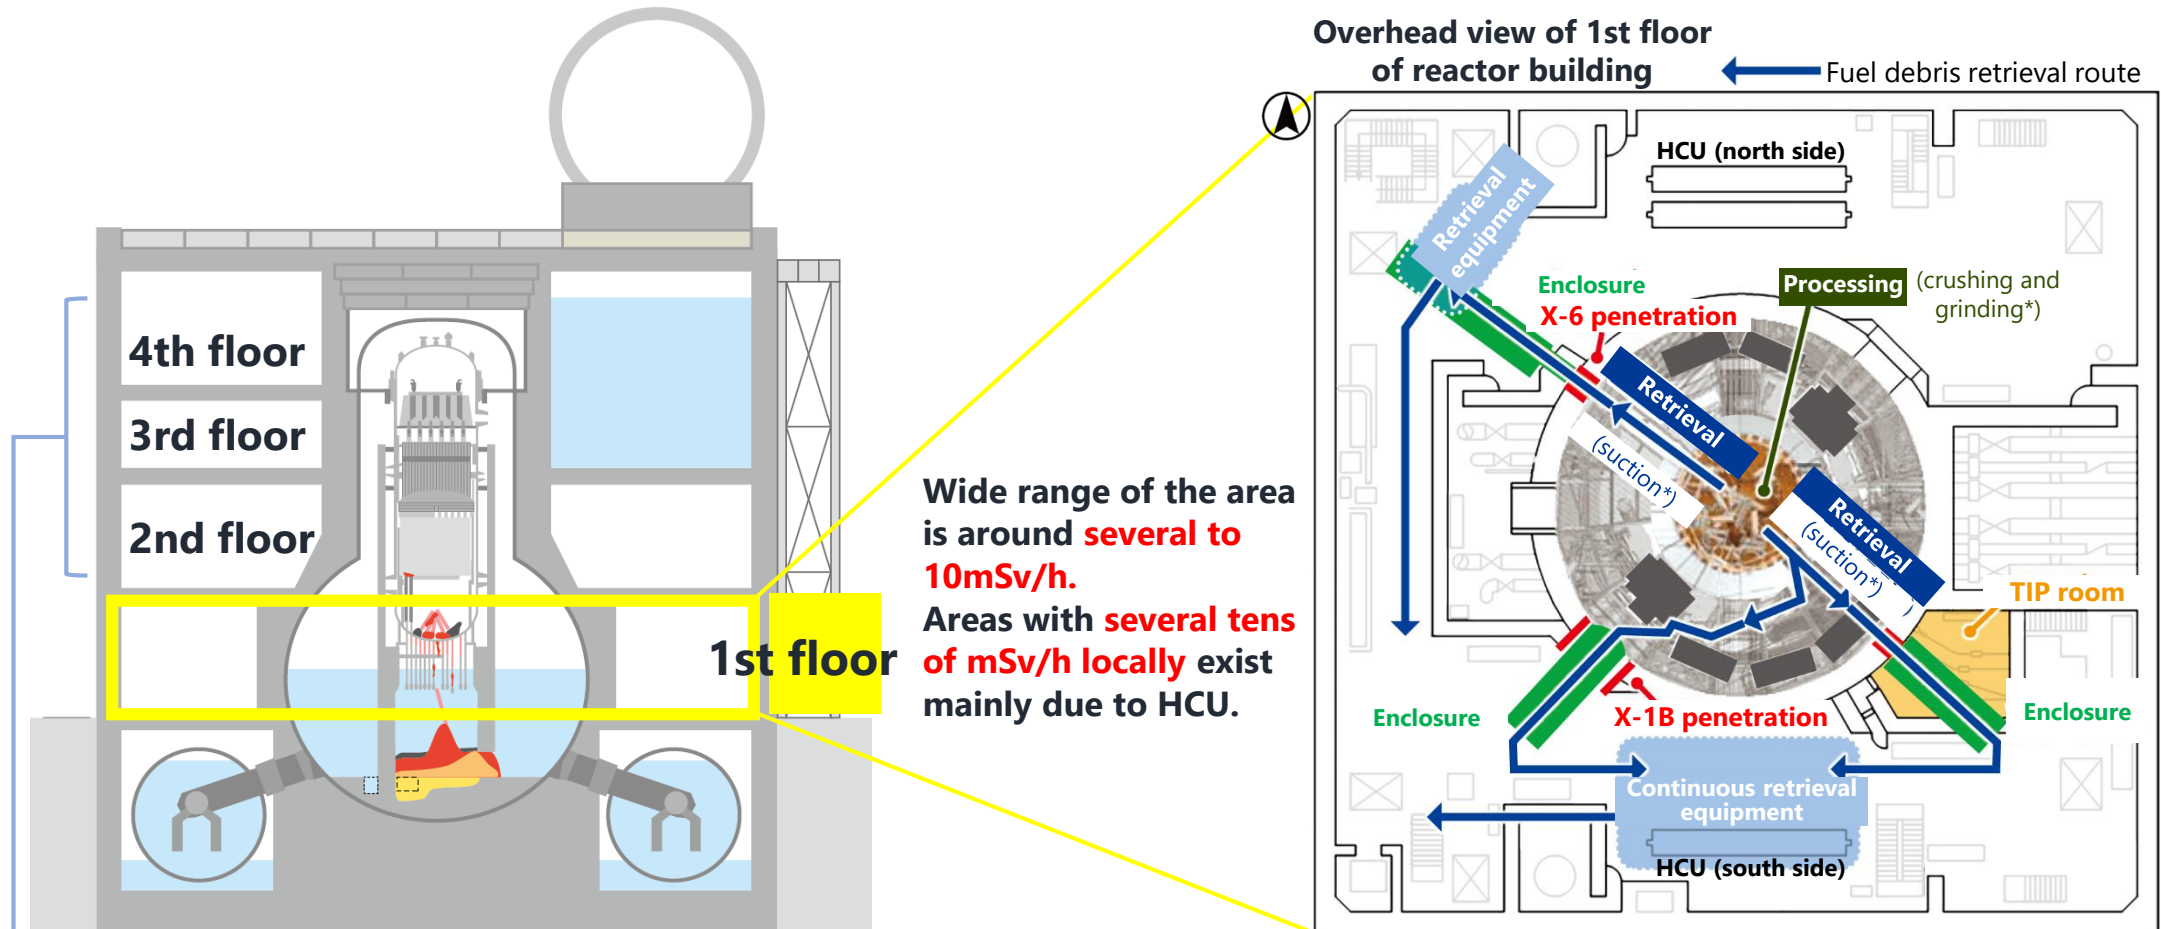
Dose reduction of reactor building (policy for further validation)

For side access fuel debris retrieval, dose needs to be reduced for the 1st floor of the reactor building where “side access equipment” is to be installed.

4th floor: Part of the ceiling has collapsed. Both the rubble and dose levels are more severe than the 3rd floor, and it is inaccessible by humans.

3rd floor: The site cannot be investigated due to much rubble, and dose is higher than the 2nd floor.

2nd floor: Rubble remains. Although it is several mSv/h in some areas, range with several tens of mSv/h is wider than the 1st floor.

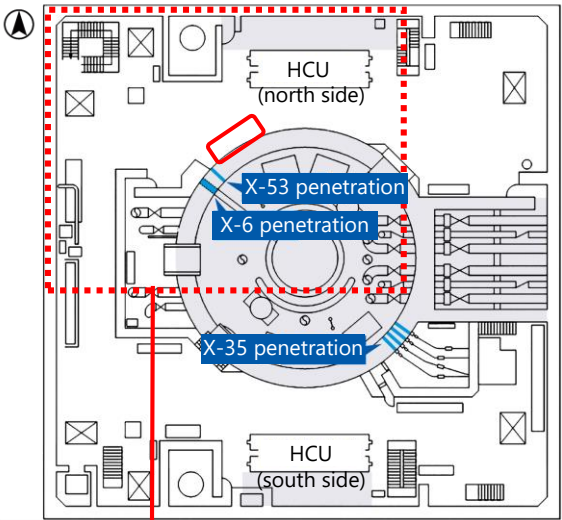
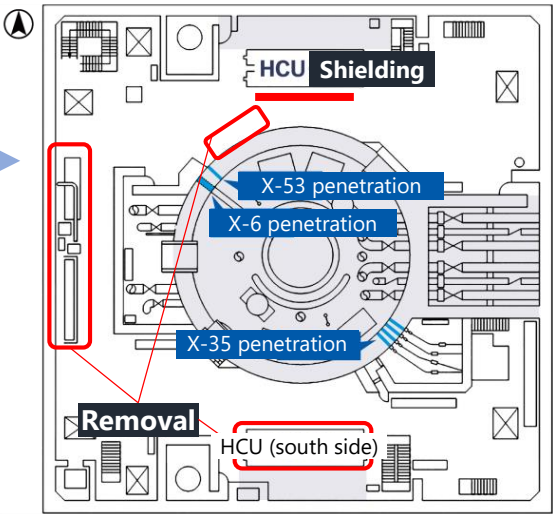
Dose reduction work and simulation image (1st floor of Unit 3 reactor building)

Detailing of dose reduction work

- Shielding
- Removal etc.

Simulation

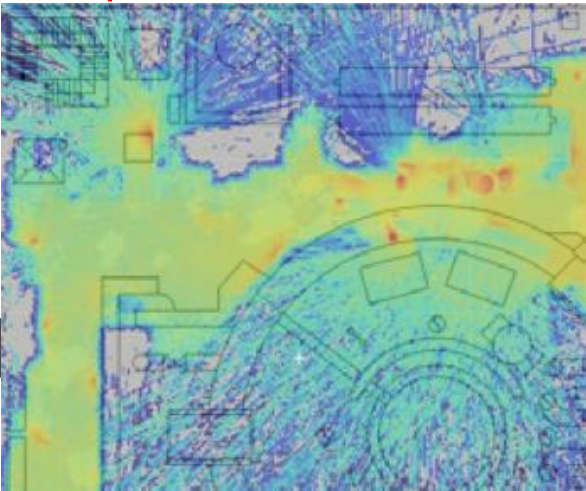
Distribution of air dose rate ($\mu\text{Sv/h}$)

*This result is under development and may change in the future.

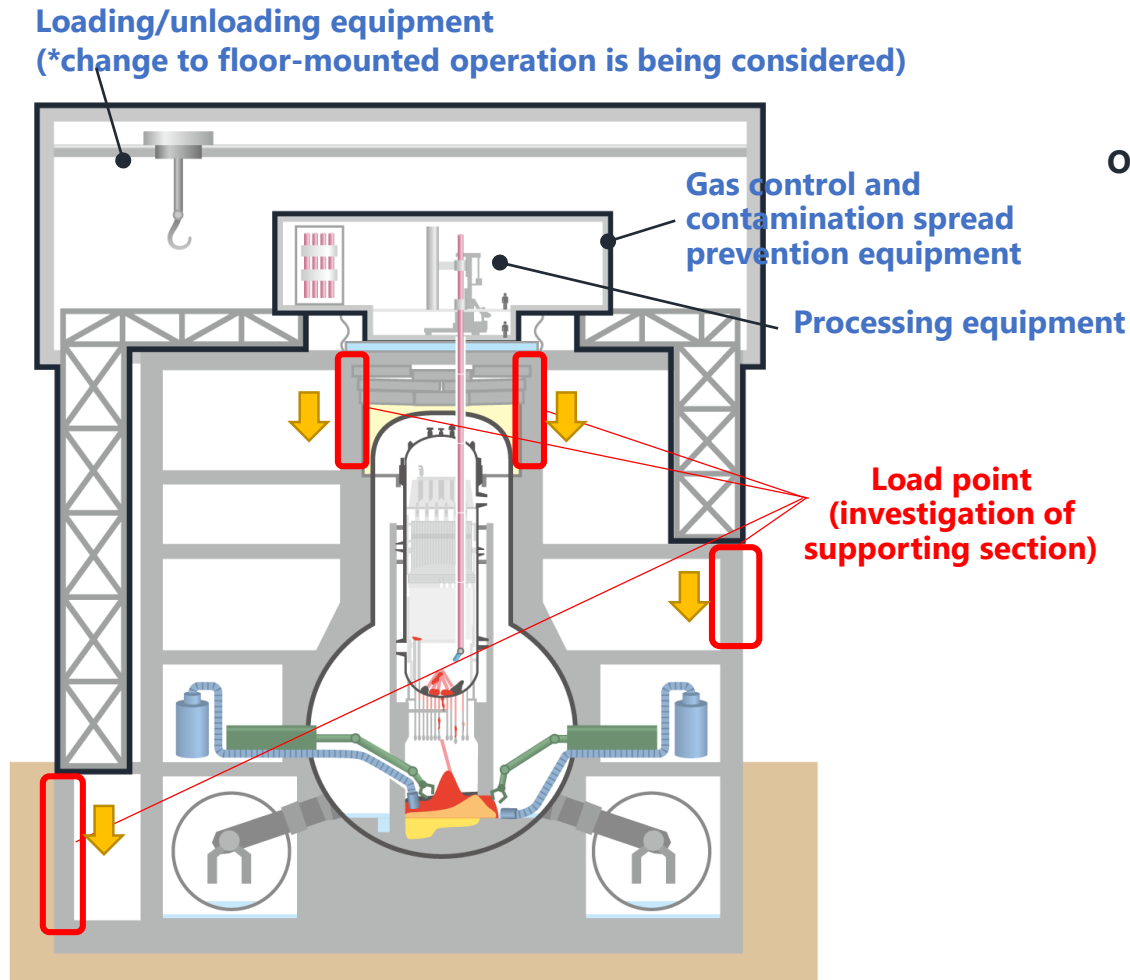
▼ Image of top access equipment in the east-west framework plan

In the east-west framework plan, the reactor building will support the framework and top access equipment. Load margin for the supporting section of the reactor building shall be validated.

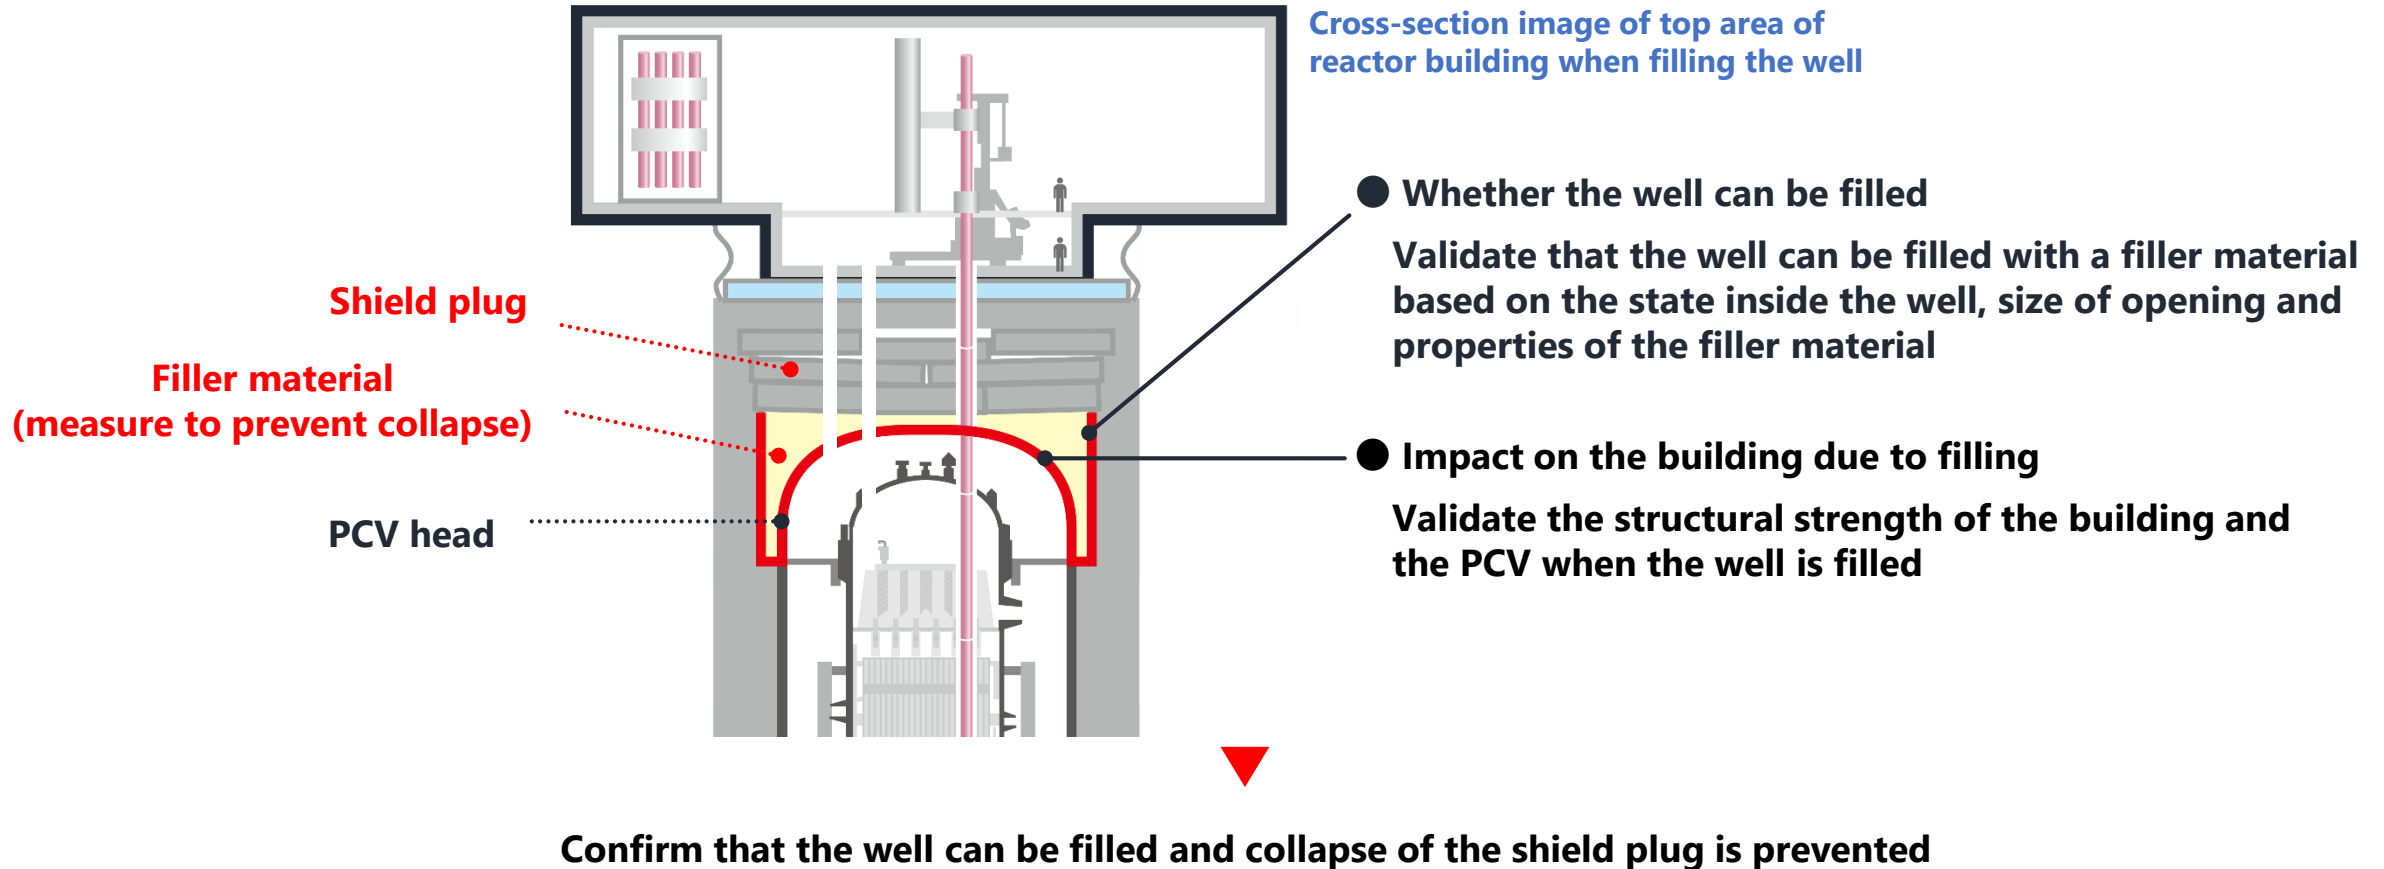
Fuel debris retrieval will be carried out by drilling multiple holes in the shield plug. In order to prevent the shield plug from collapsing during the operation, we plan to fill the well (between the shield plug and the Primary Containment Vessel (PCV) head) with a filler material. It shall be validated whether the well can be filled from the following aspects.

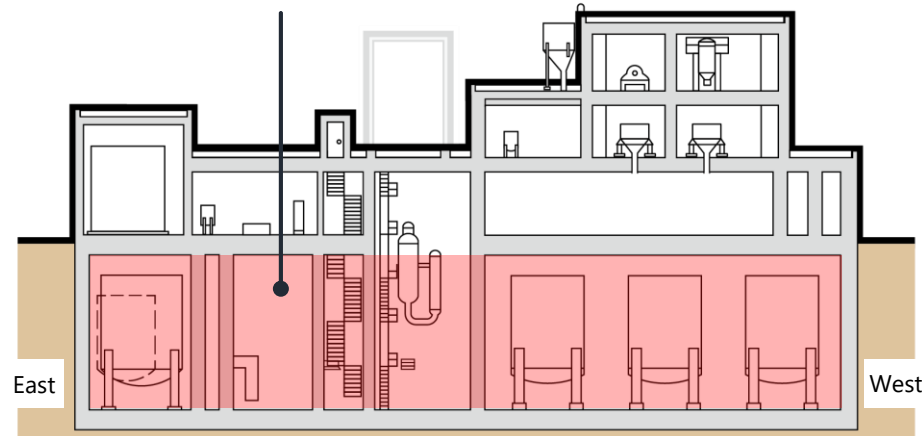
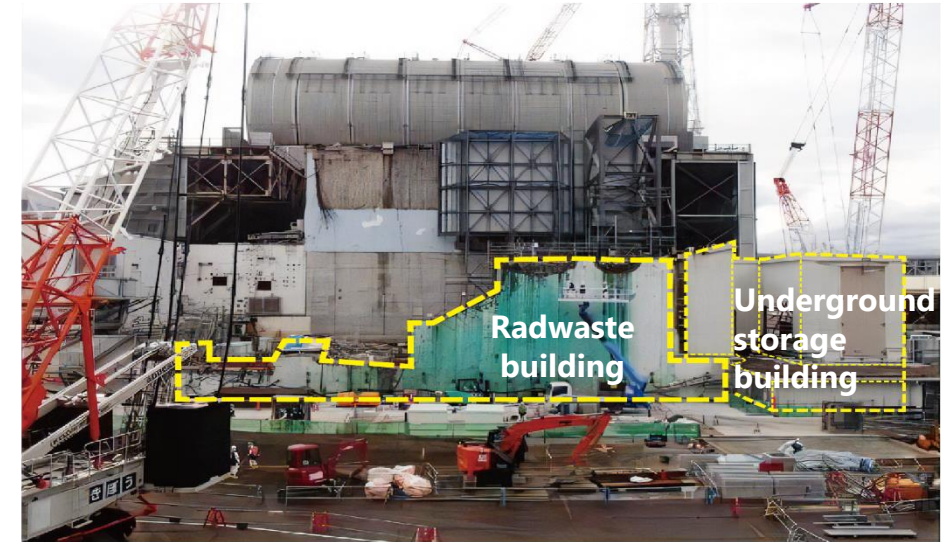
▼ Cross-section image of Unit 3 radwaste building

Demolition and removal of other equipment

(Since the basement floors are under high dose, equipment removal work needs to consider dose reduction and use of remote-control devices)

Confirm that parallel work for Unit 3 radwaste building can be conducted as well as its workload

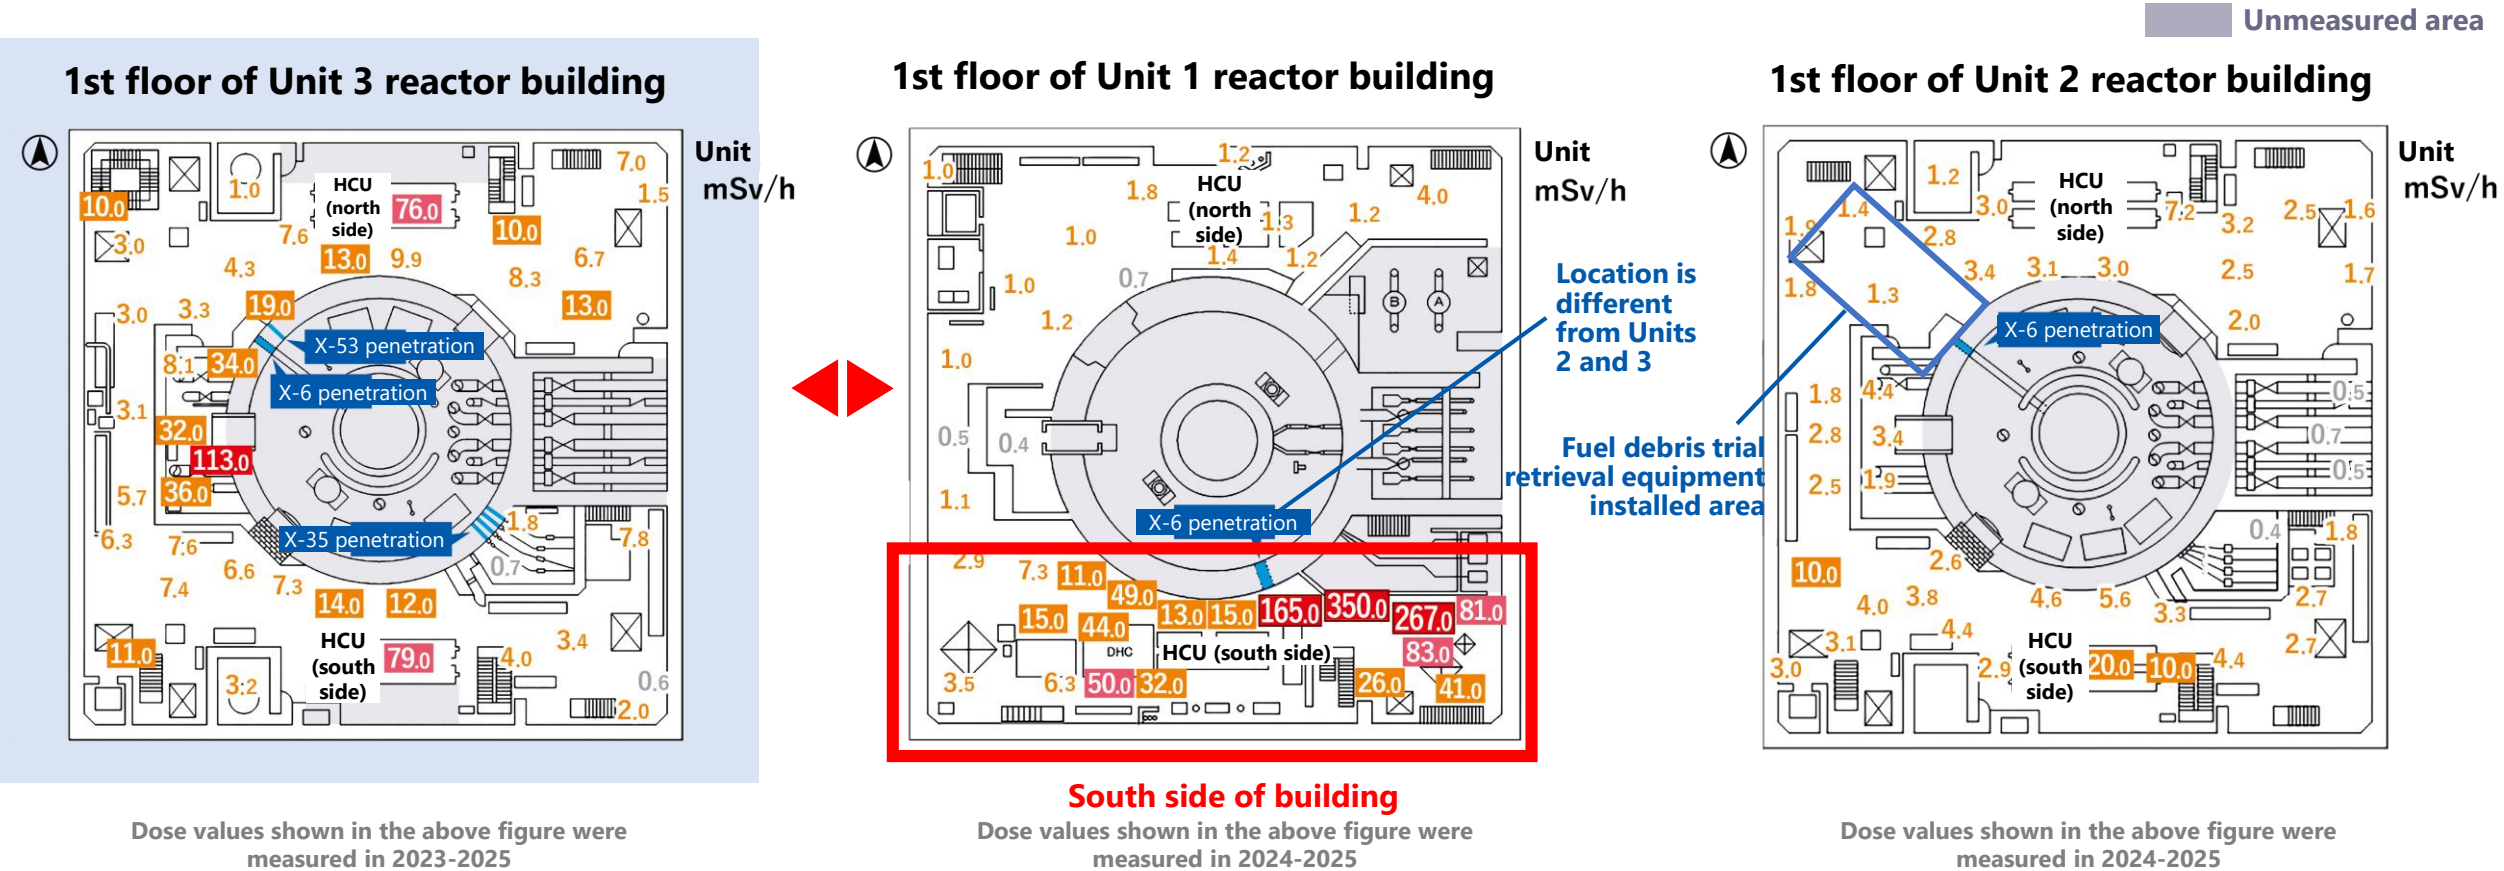
Comparison and deliberation regarding conditions inside the reactor buildings

The first floor of the respective reactor buildings has the following characteristics.

- Unit 3: Radiation level is high overall, and the dose rates around the north and south HCU are several tens of mSv/h
- Unit 1: Radiation level is low overall, but the dose rates on the south side where the X-6 penetration locates are several tens to hundreds of mSv/h
- Unit 2: Radiation level is in between that of Units 1 and 3 overall, and dose reduction has relatively advanced on the west side

Based on the above, **dose reduction work for the south side of the 1st floor of Unit 1 shall be deliberated.**

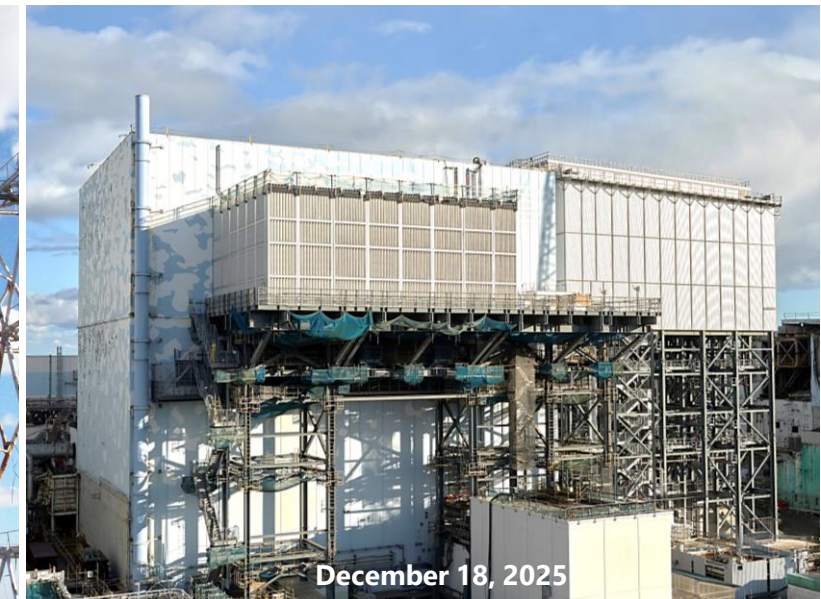
Situation of Unit 2 reactor building

Installation of large cover

- Unit 3: Floors above the third floor were damaged due to the explosion. A fuel removal cover has been installed, and fuel removal from spent fuel pool has been completed
- Unit 1: The top of the operating floor has collapsed due to the explosion, but levels below the operating floor remain. A large cover has been installed for fuel removal from spent fuel pool and rubble removal
- Unit 2: There was no explosion and a work platform for fuel removal from spent fuel pool has been installed

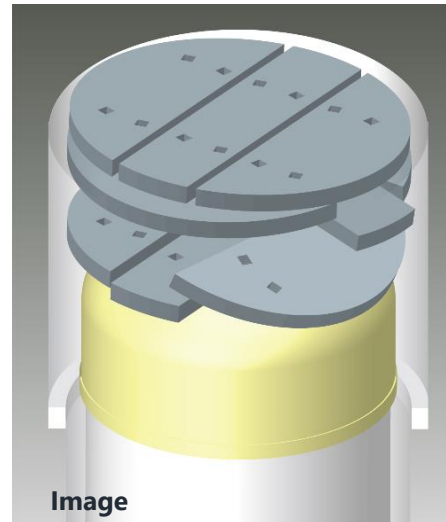
Unit 1 shield plug

Unlike Units 2 and 3, the **shield plug of Unit 1 has collapsed**. Therefore, **treatment of the shield plug shall be deliberated** based on the condition of the reactor building for each unit.

- Unit 3: The shield plug has deformed due to the explosion (Estimated contamination level: 30 PBq)
- Unit 1: The bottommost shield plug has collapsed into the well due to the explosion and has deformed (Estimated contamination level: 0.1–0.2 PBq)
- Unit 2: There is no deformation as there was no explosion, and it exists in a sound state (Estimated contamination level: 40–70 PBq)
