Result of the sampling regarding the water leakage in the area of the concentrated water storage tanks of water desalinations (reverse osmosis membrane) in Fukushima Daiichi Nuclear Power Station (nuclide)

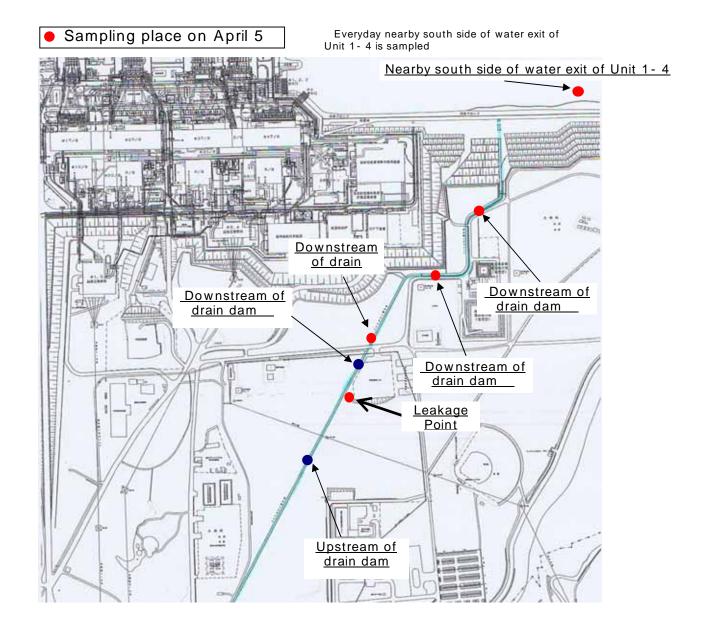
Sampling placeregarding the water leakage at transfer piping between water desalinations (reverse osmosis membrane) and concentrated water storage tank in Fukushima Daiichi Nuclear Power Station
